# Investigation of a Method to Prevent Rock Failure and Disaster Due to a Collapse Column Below the Mine

## Project Overview

The Zhangji coal mine of the Huainan Mining Group is located in Anhui province. The mine is composed of three areas: a central area, north area, and air shaft area. The central and north areas adopt the mining mode of zonal development, ventilation, and centralized coal extraction respectively (Fig. 1). The 1612A working face, which is located on the west side of the industrial square in the north area, was mainly mined out by 2018. According to the 3D seismic, surface drilling, and exposure mapping in the mine roadway, the coal and rock strata within the 1612A workings have a monoclinic structure, with some local waviness. The overall dip angle of the rock strata is 8–14°, with an average of 9.5°. The coal strata may be offset by geologic structure. There were 3 faults exposed in the working face, 7 exposed in the belt transportation roadway, and two faults in the drainage lane. The main stratum and production geological conditions of the working face are shown in Fig. 1.

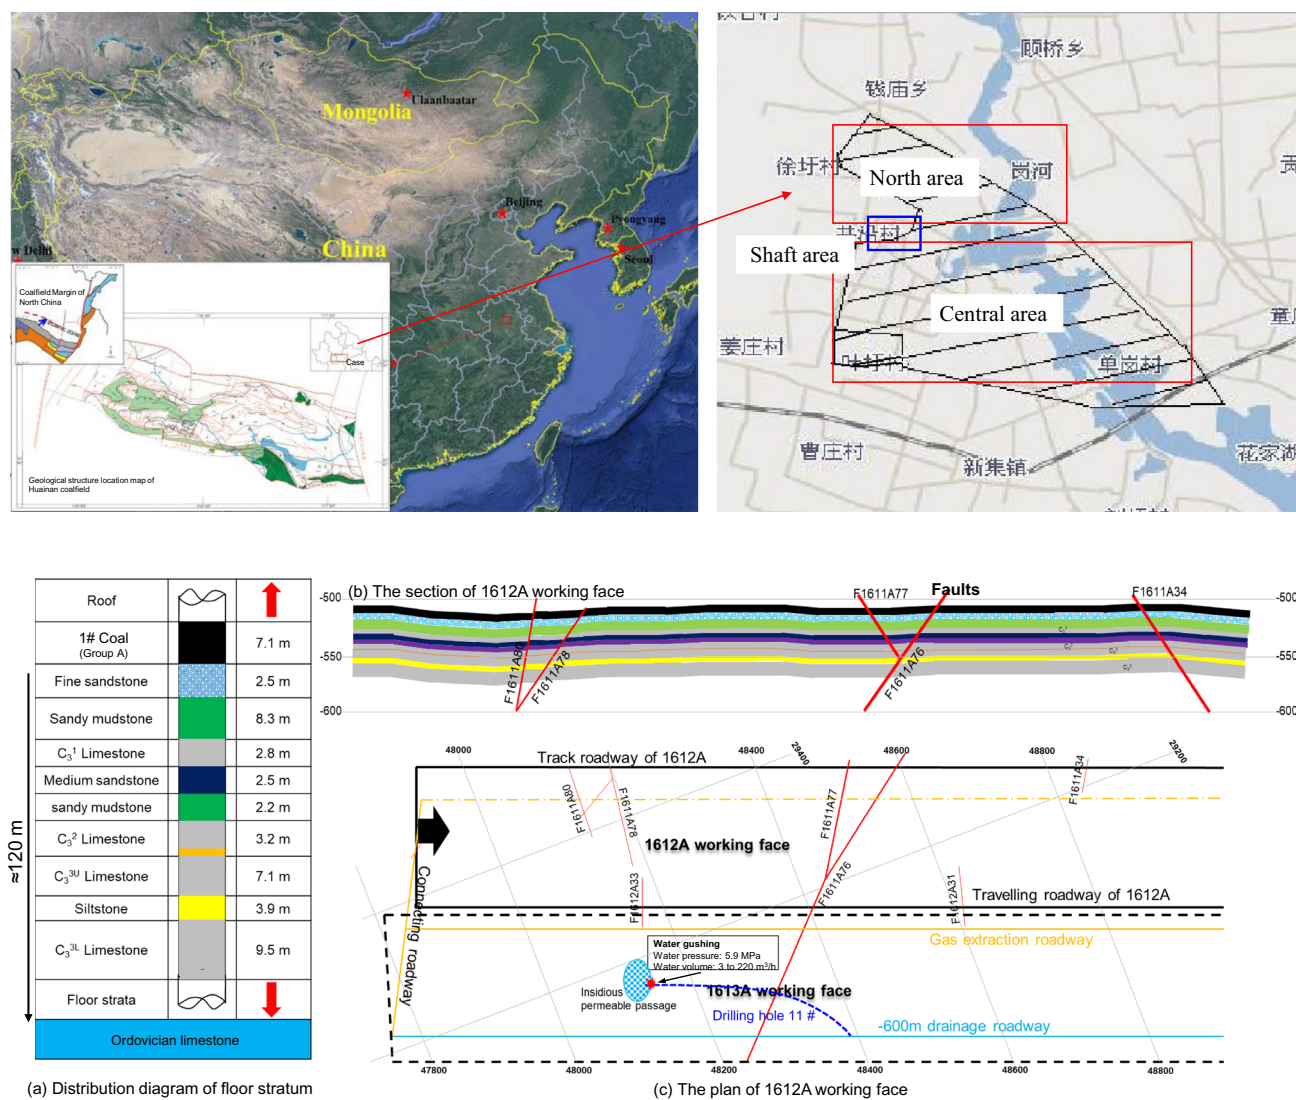
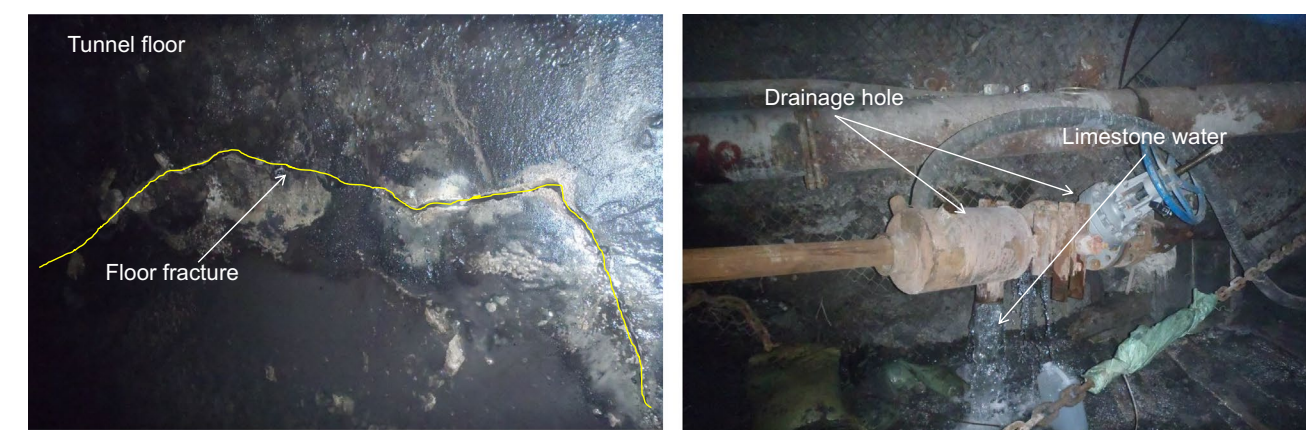
**Fig. 1** Engineering conditions

coal seam. Therefore, the main water hazards of the 1612A working face floor are the Taiyuan limestone ( $C_3I$ ,  $C_3II$  and  $C_3III$ ) and Ordovician limestone (Fig. 1b).

Many faults were anticipated to be exposed in the 1612A track and belt transportation roadways during excavation and it was expected that there might be a small amount of water seepage into the excavation, especially near the faults. No water inflow from the pressurized limestone aquifer was expected and there was no large water leakage inflow from boreholes associated with cross layer and directional long drilling. However, targeted measures to prevent limestone water inflows were recommended due to possible disturbance associated with mining. The working face contains two mining roadways, a floor gas drainage roadway, and a floor limestone drainage roadway. As previously noted, the Ordovician limestone could threaten the working face, especially if possible permeable faults or collapse columns release the confined water and cause an inrush.

During the driving and mining period, a 427 m long directional drilling hole (11#) was advanced in the  $C_3^3$  limestone, along the—600 m drainage roadway of the no.1 coal mining area, as shown in Fig. 1. In April 2018, seepage water was encountered at a depth of about 330 m, and the initial water volume was about 3 m<sup>3</sup>/h (Fig. 1b). After all the drill pipes were pulled out, the stable water volume was 220 m<sup>3</sup>/h, and the water temperature was 40.5 °C. The hole was then sealed, and the stable water pressure was measured as 5.9 MPa in the collapse column area. Combined with the measured water quality information, including the pH value, the content of anion and cation, and solid substances, the source was identified as Ordovician limestone water.

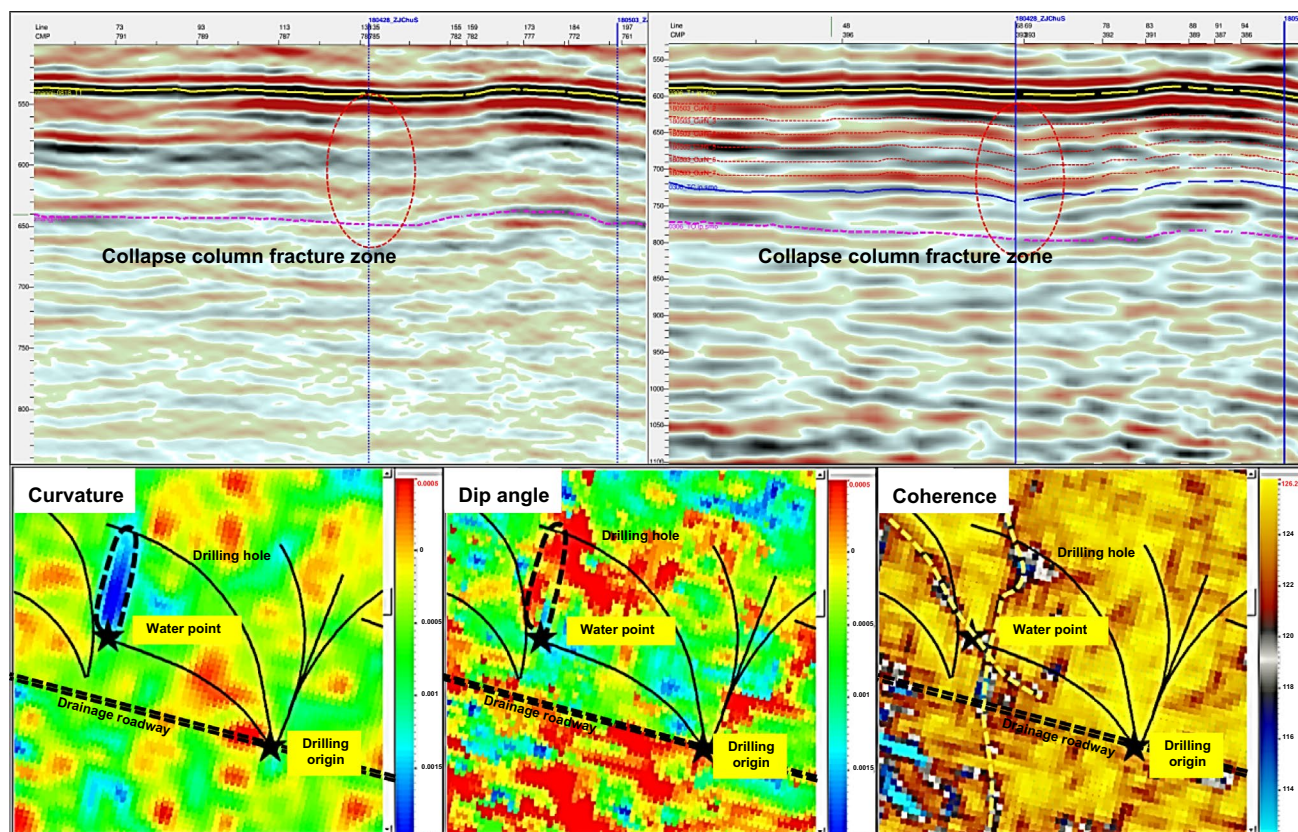
**Fig. 6** Seismic migration profile along the track of directional hole

The interpretation of the 3D downhole seismic test is shown in Fig. 6. The section on the top left shows pre-stack time migration; the area below the seepage points in directional hole (red dotted ellipse) #11 shows weak bending and amplitude weakening characteristics. The anomaly is easy to miss because of the small variation relative to the background signals. The top right of Fig. 6 shows a later section of pre-stack depth migration; the same position inside the red ellipse shows a more obvious in-phase depression. Through detection of sensitive seismic attributes, a potential collapse column was identified. Our interpretation of the restack depth migration profile shows an anomaly in the area below the borehole 11# seepage area. Additional signal processing, shown in the lower half of Fig. 6, from left to right presents

part of borehole 11# seepage is located adjacent to an elliptical maximum negative curvature attribute anomaly area (left-most bottom figure). The low value of the minimum coherence attribute anomaly shows an “X” intersection (right), which is suspected to be a conjugate shear fault.

According to the monitoring results from the mine workings, it was inferred that there is local ground subsidence related to the conjugate shear fault identified in Fig. 6. This anomaly is suspected to be a developing collapse column fracture zone. Further drilling revealed that there was a thin fault zone at a depth of about 53 m that appears to be able to conduct water and could be the site of a future water inrush. In this area, the fractures are distributed in blocks and are closely connected with the lower fault zone. With further drilling exploration to verify the original borehole data and the multi-attribute interpretation of 3D seismic data, namely coherence, curvature, dip angle, phase and texture, a developing elliptical collapse column with a length of 53 m and a width of 35 m was delineated (Fig. 6).

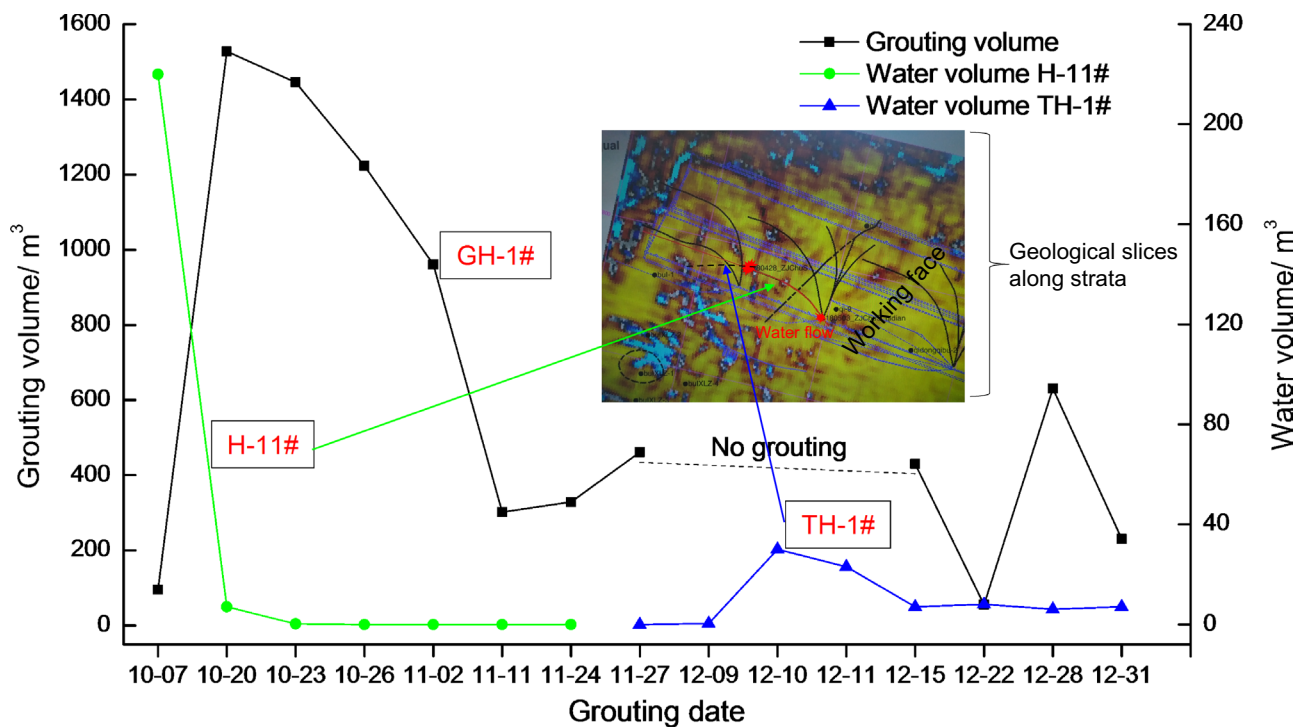
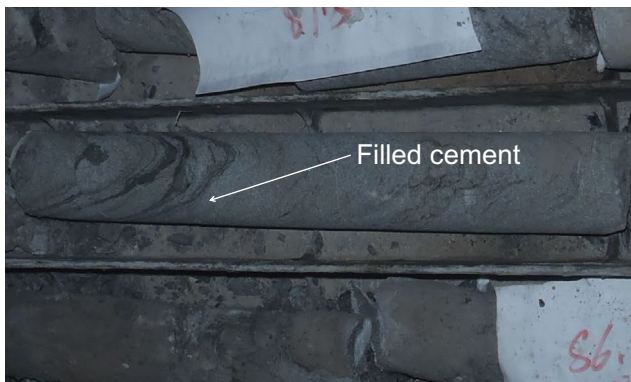
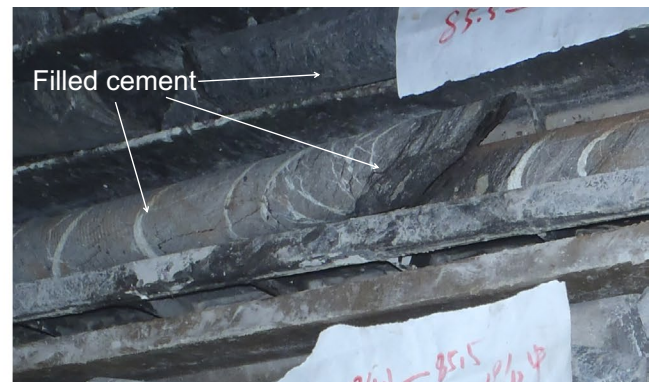
**Fig. 9** Grouting in coal floor

Figure 9 shows the real-time observation of seepage from hole H-11# after the grouting; the seepage flow decreased in response to multiple grouting injections (from 7 m<sup>3</sup>/h to 0). Verification hole TH-1# also showed minimal seepage after grouting.

Rock core within the grouted horizons was obtained from drill holes in the drainage roadway to further verify the grouting in the floor rock mass, as shown in Fig. 9. It can be seen that the fractures in the rock mass were filled with cement, and the broken rock had its permeability decreased and was strengthened by the cement slurry. According to previous research (Ren et al. 2021), initial grouting from the main hole achieves preliminary plugging in the dominant fractures first. Then, as water seepage and pressure decrease, the slurry diffuses into secondary fractures to fill and block the whole area. Therefore, after grouting, it can be seen from the coring that the floor rock is in a relatively stable state.

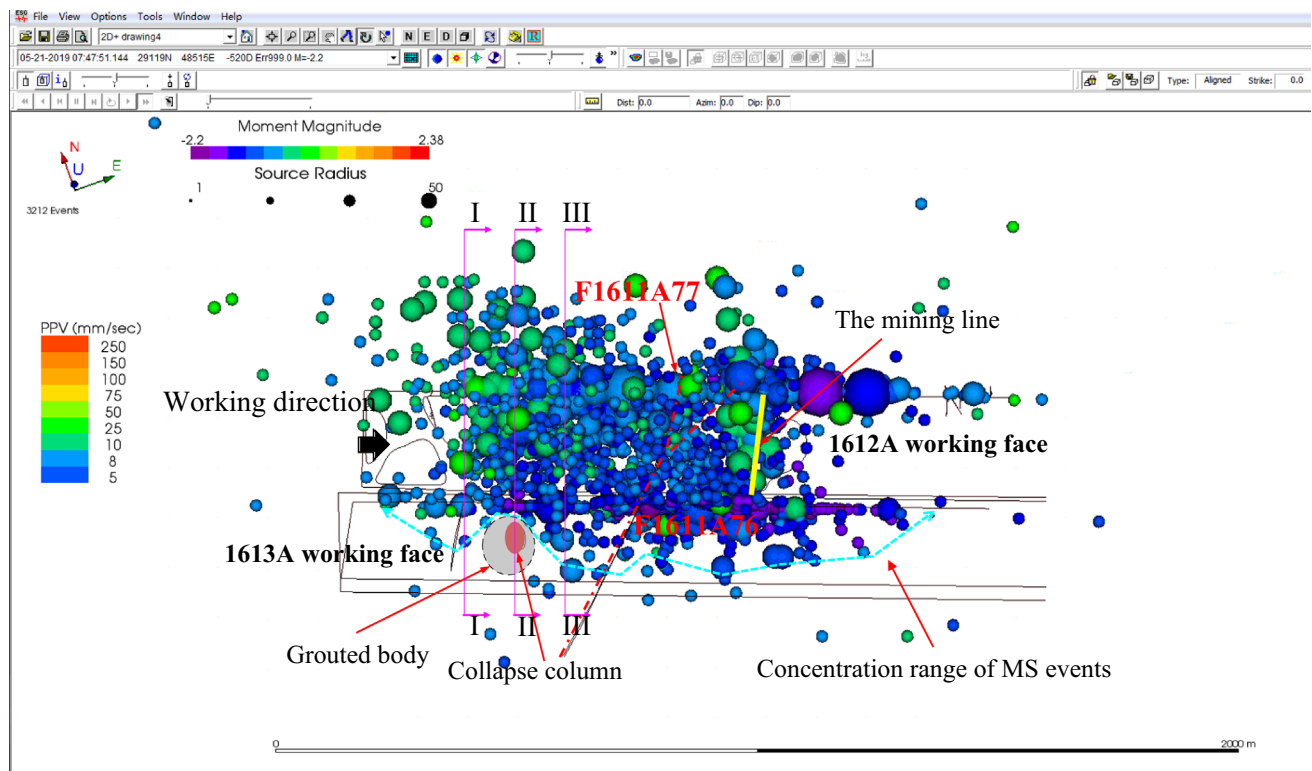
Fig. 10 MS events in stope

The MS monitoring system has been operating in the mine since the end of February 2019. The monitoring focuses on the grouted area from near the potential collapse column to the end of working face, shown as the mining line in Fig. 10, which also shows the location of the potential collapse column (red ellipse) and grouted rock in the stope. By analyzing the distribution of MS events in the rock surrounding the coal seam, it can be seen that the disturbance caused by coal mining affects the adjacent stope, including the collapse column area. MS events are widely distributed in the non-grouted areas (e.g. sections I–I and III–III), suggesting some regional micro-fracturing in the rock. However, in the location of the grouted zone (II–II), there were no MS events recorded, which indicates the improved stability of the grouted rock.

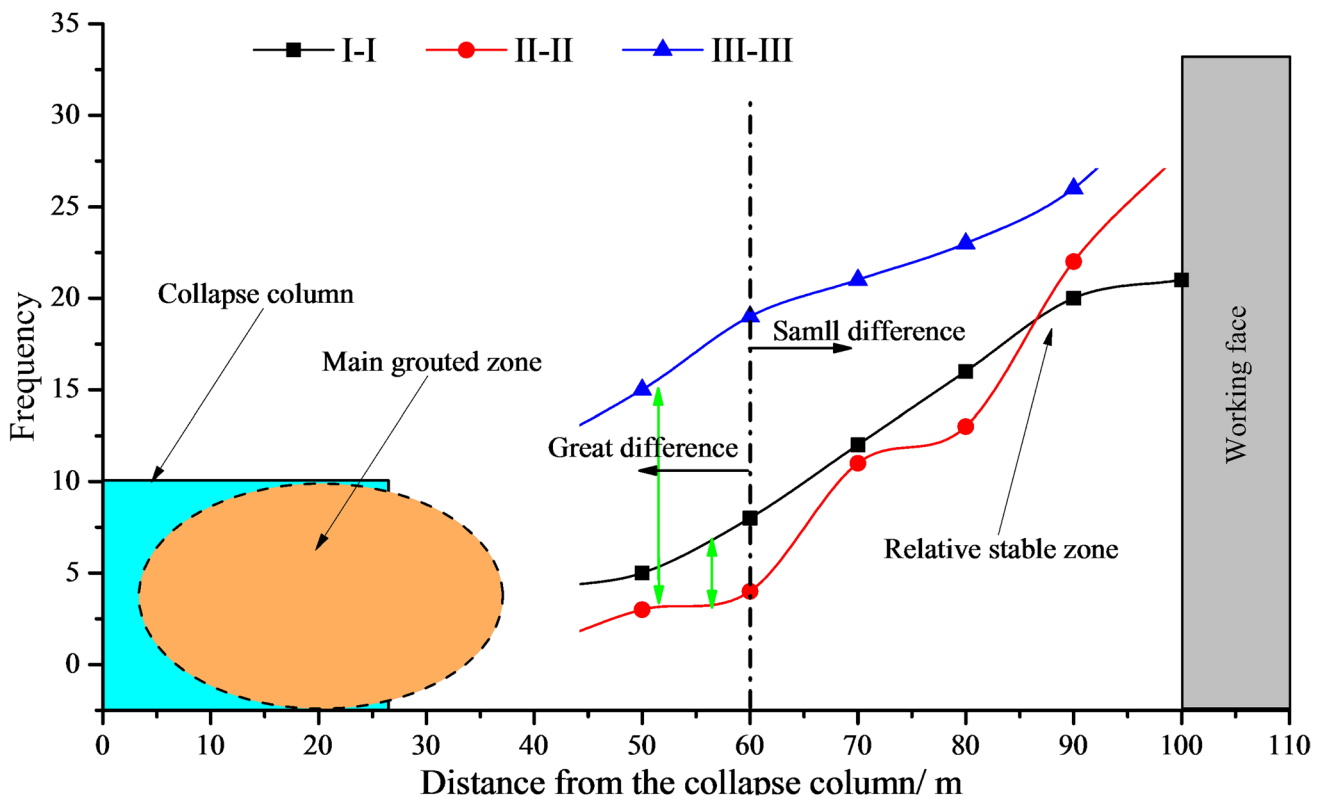
Fig. 11 Frequency of the MS events along the distance

To analyze the mining disturbance, the number of MS events in the floor within radius distances from 10 to 100 m from the center of the grouting zone was obtained (Fig. 11). A significant reduction in the frequency of MS events within 60 m of the grouted zone can be seen. Section III–III had the greatest activity, which is thought to be due to a fault identified in that area. However, section III–III still shows reduced activity within 60 m of the grouted zone. Sections I–I and II–II show similar reductions in activity within 60 m

of the grouted zone; activity increases beyond 60 m and the three sections show similar microseismic activity near the working face.

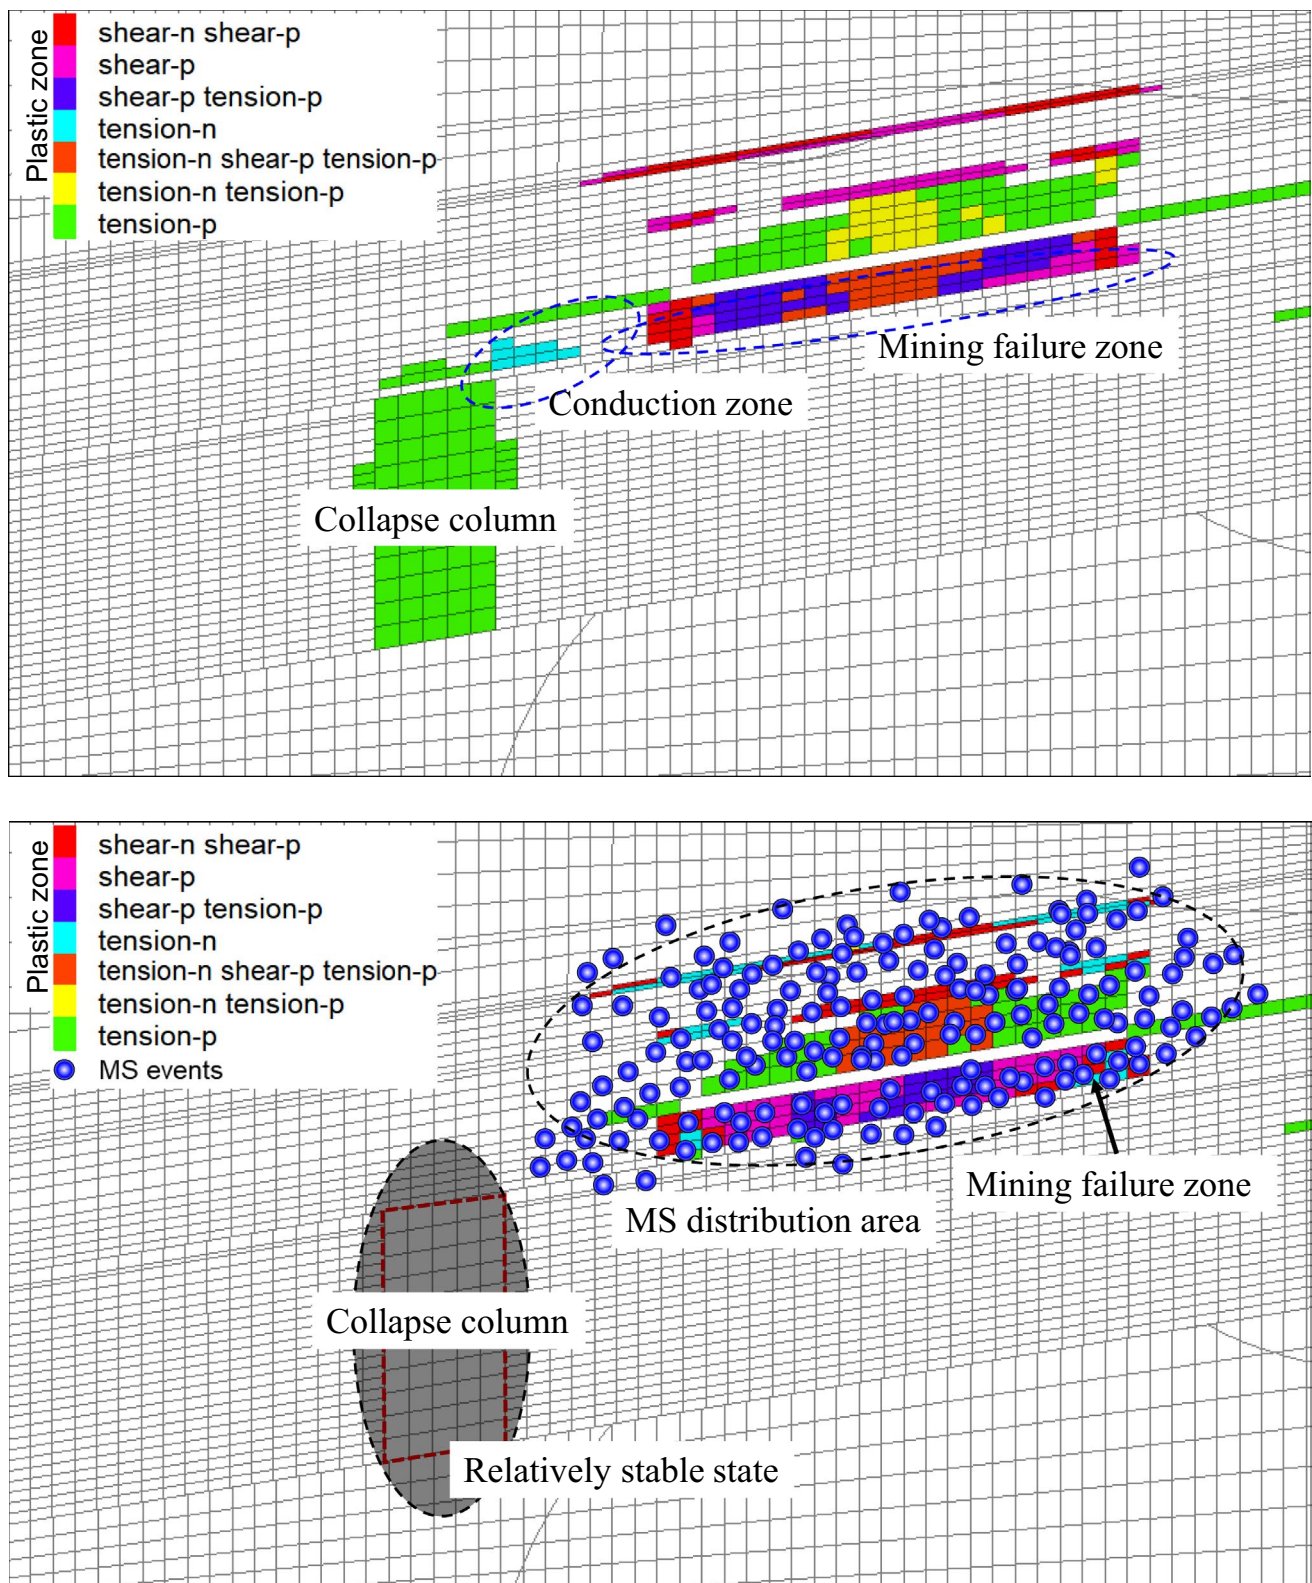
Fig. 14 Distribution of plastic zone in working face after mining

The Flac model identified the distribution of plastic zones in the rock stratum under grouted and non-grouted conditions (Fig. 14). Comparing the two conditions, the rock mass in the area shows opposite states. After grouting, the surrounding rock is relatively stable. In the absence of grouting, seepage pressure from the confined water leads to plastic failure of the potential collapse column and its surrounding

rock (Fig. 14a, b). After mining, the modelled plastic zone further develops and connects to the confined aquifer. The analysis shows that grouting effectively eliminates the plastic zone in the collapse column and surrounding rock. The numerical results are consistent with the MS monitoring from Fig. 14, providing mutual verification. The grouted zone changes the spatial distribution characteristics of MS events, consistent with the measured seismic activity, and limits the damage within the grouted area and surrounding rock.
