The 2019 Brumadinho tailings dam collapse: Possible cause and impacts of the worst human and environmental disaster in Brazil

Luiz Henrique Silva Rotta^{a,*}, Enner Alcântara^b, Edward Park^c, Rogério Galante Negri^b, Yunung Nina Lin^d, Nariane Bernardo^a, Tatiana Sussel Gonçalves Mendes^b, Carlos Roberto Souza Filho^e

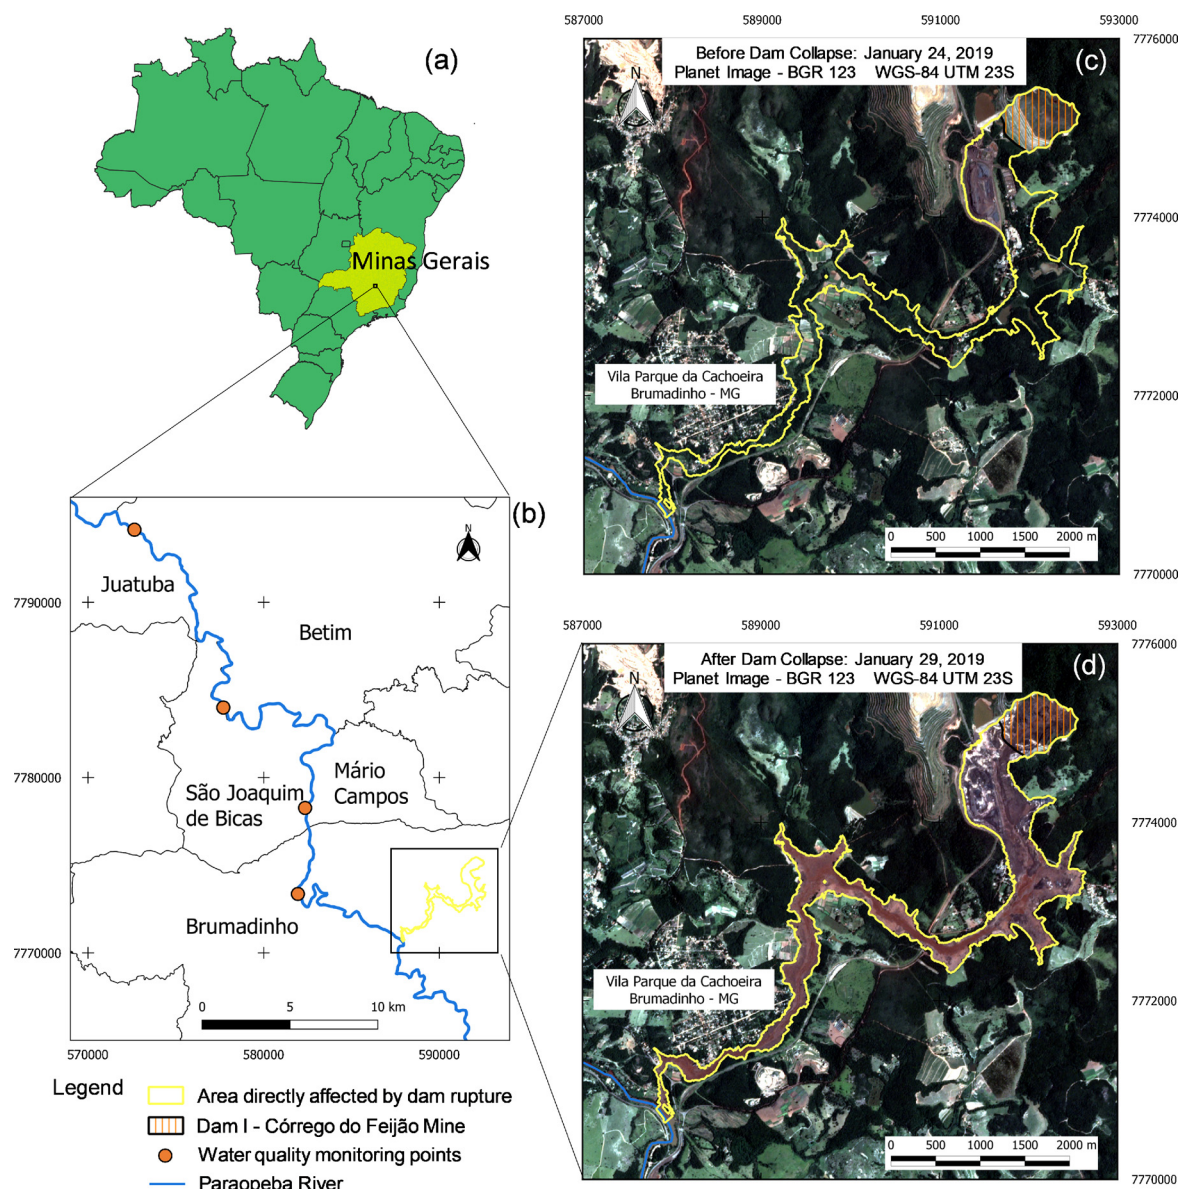
affected by the mudflow (Fig. 1). The mud traveled approximately 10 km, reaching the Paraopeba River. The mud covered an area of $3.13 \times 10^6 \text{ m}^2$, equivalent to 450 football fields. The collapsed dam (Dam I - Córrego do Feijão Mine) had an area of $4.13 \times 10^5 \text{ m}^2$ and approximately 600 m width.

Fig. 1. Study area: (a) Minas Gerais State in Brazil; (b) Paraopeba River and cities near to the accident; (c) before and (d) after images of the dam collapse, indicating the dam location and the area directly affected by the mud wave.

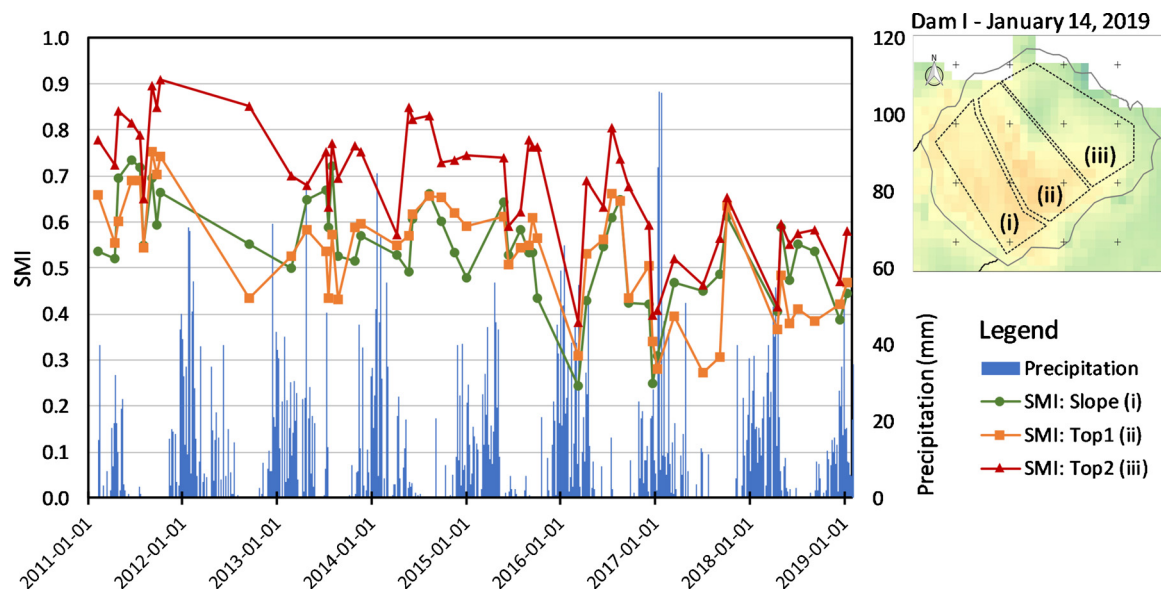
In general, higher SMI values were observed over the Top-of-bench-2 (iii) sector of the dam for the investigated period (Fig. 4). The observed high moisture contents might have implied that this sector was saturated with water. Another behavior observed is the decrease of SMI throughout the dam during the same period. Between 2011 and 2017, Slope (i) and Top-of-bench-1 (ii) showed similar behavior, with consistently lower values compared to Top-of-bench-2 (iii). After 2017, Slope (i) and Top-of-bench-2 (iii) presented similar SMI values. In the rainy season, comparable values were also noted in the three regions. However, in the dry period, the difference between Top-of-bench-1 (ii) and the other regions increases, i.e., the SMI of the Top-of-bench-1 (ii) decreased significantly in comparison to Top-of-bench-2 (iii) and Slope (i). We speculate that the increase in the moisture pattern between the top and the slope sectors, between 2017 and 2019 (i.e. after the dam was decommissioned in 2015), implied that the fill was becoming

Fig. 4. SMI mean value between 2011 and 2019 for the sectors Slope(i), Top-of-bench-1(ii) and Top-of-bench-2(iii) in the Brumadinho tailings dam. Precipitation data from TRMM/Giovanni (giovanni.gsfc.nasa.gov).

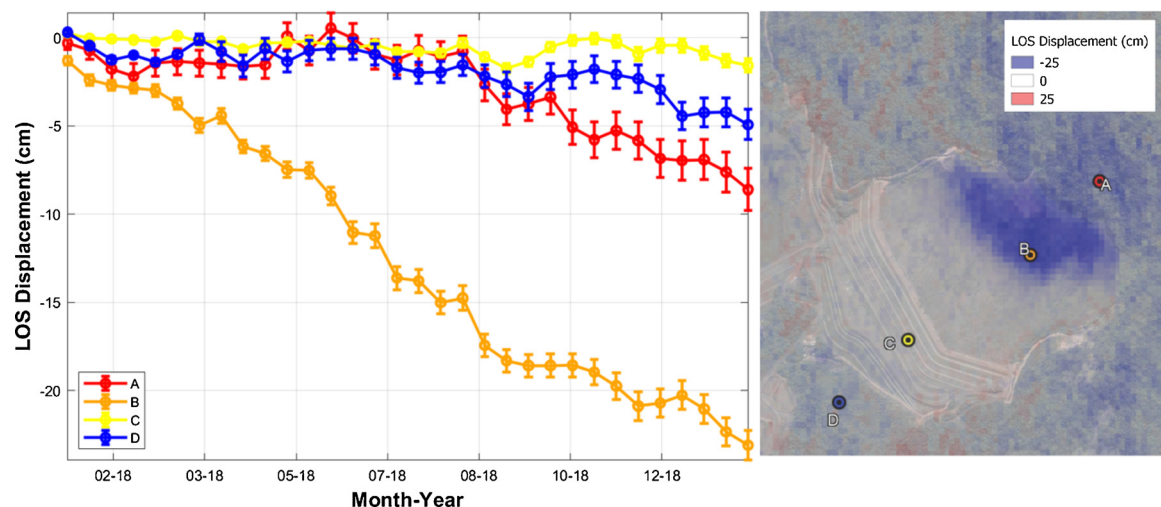
The sector of the dam with significant soil moisture had also sunk over the past few years (Top-of-bench-2, Fig. 4). We also observed the largest LOS displacement in the region, of up to -25 cm between January 2018 and January 2019 (point B in Fig. 5). As there are no concurrent ground-based displacement measurements available, there might remain a slight uncertainty in relation to the subsidence and westward motion, given the sensing direction of the descending path. However, since Top-of-bench-2 is topographically lower than Top-of-bench-1 according to the high-resolution ALOS2 DEM (Fig. 7c), we believe that westward motion is less likely and that the signal was likely to be caused by vertical subsidence. After accounting for the average incident angle of 32.5 degrees, the actual cumulative vertical displacement was estimated to be approximately -30 cm.

Besides the deformation within the tailings dam, we also observed creeping in the mountainous area abutting the dam (point A in Fig. 5) which began around August 2018 and continued up to the point the

dam failed. This creeping might have been a result of on-going deformation within the dam and contributed to the final failure process.

Fig. 5. Line-of-sight (LOS) displacement time-series from Sentinel-1 SAR interferograms. The LOS displacement map is for the total cumulated displacement between January 3rd 2018 and January 22nd 2019.

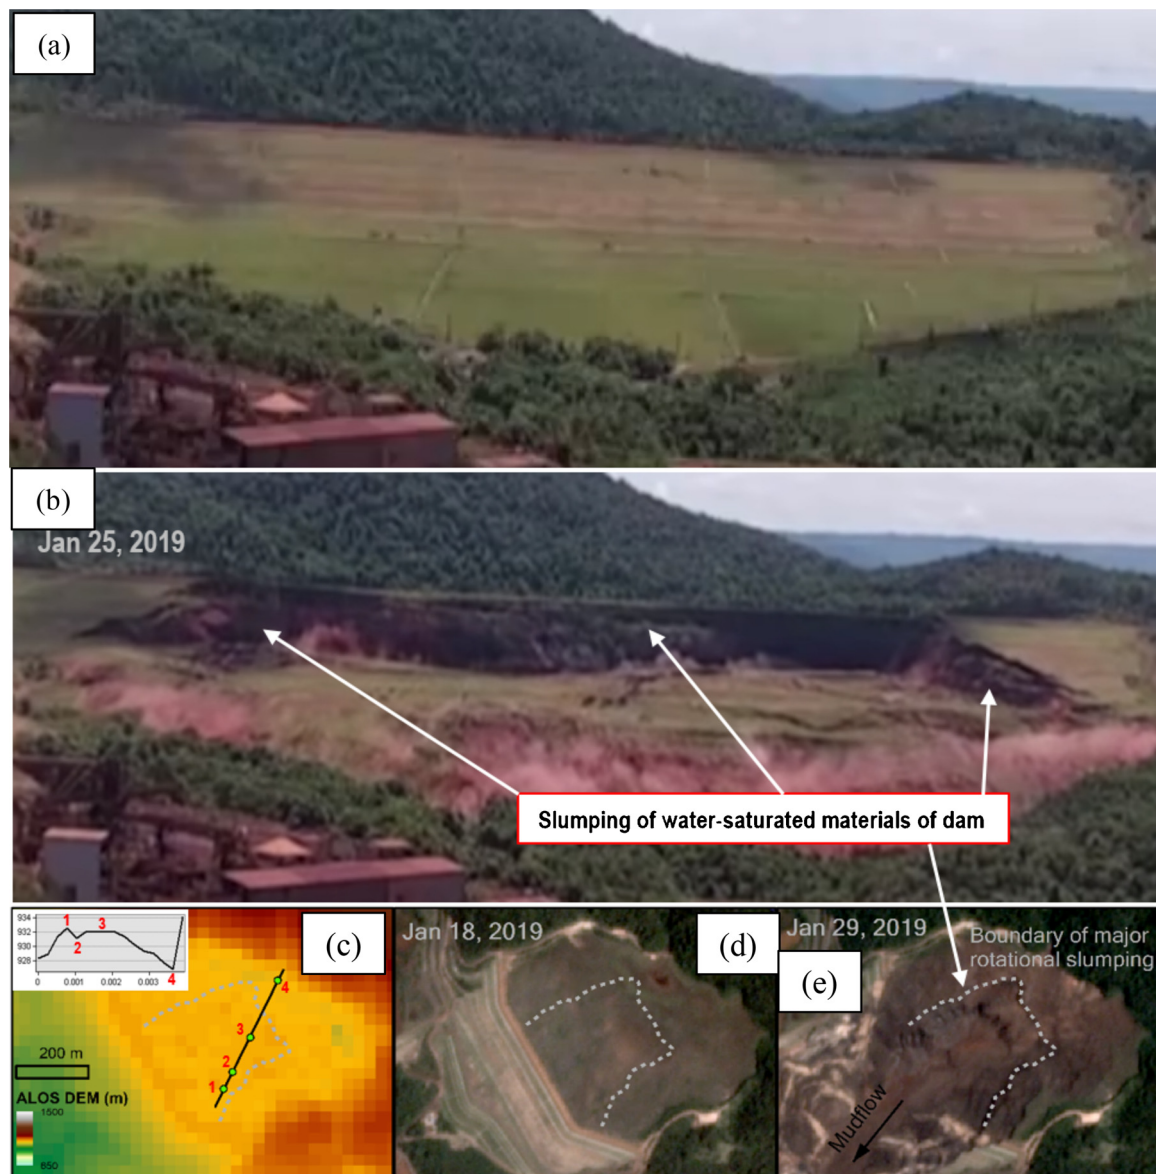
seepage. Upon the dam rupture, it initially seemed like that the failing started at the rear part of the surface (around Top 2(iii)), where the pond was formed close to the mountain area abutting the dam (point A in Figs. 5 and 7b). This failure through instantaneous “slumping” of the fill first happened in this area and was immediately followed by the weakening of the surrounding materials that were saturated with water (Fig. 7b).

The initial collapse at the rear part of the dam, where it experienced dramatic subsidence during 2018 (Fig. 5), triggered similar disturbances and large scale rotational slumping over the other parts of the fill. The mapping of the boundary of the slumping area through high-resolution photographs which were taken immediately before and after the collapse indicates that rotational slumping has occurred on the surface of the dam (Top-of-bench-1 (ii) and 2 (iii) zones) where the shear surface is circular (Fig. 7b, d and e). This implies that the water table was abnormally higher and perhaps reached close to the surface

Fig. 7. (a) Screenshot from the movie (<https://www.youtube.com/watch?v=sKZUZQytads>), immediately before the dam failure on January 25th, 2019. (b) Large scale slumping upon the dam failure. This indicates that the bulk of the fill was water-saturated before failure. (c) An elevation profile over the dam surface based on ALOS DEM acquired between 2008–2011. A depression with a depth around 4 m is shown towards the rear part of the fill, where the water pond is present during the wet seasons (Fig. 6). (d) and (e) High-resolution Planet images prior (Jan 18, 2019) and after the dam failure (Jan 29, 2019).

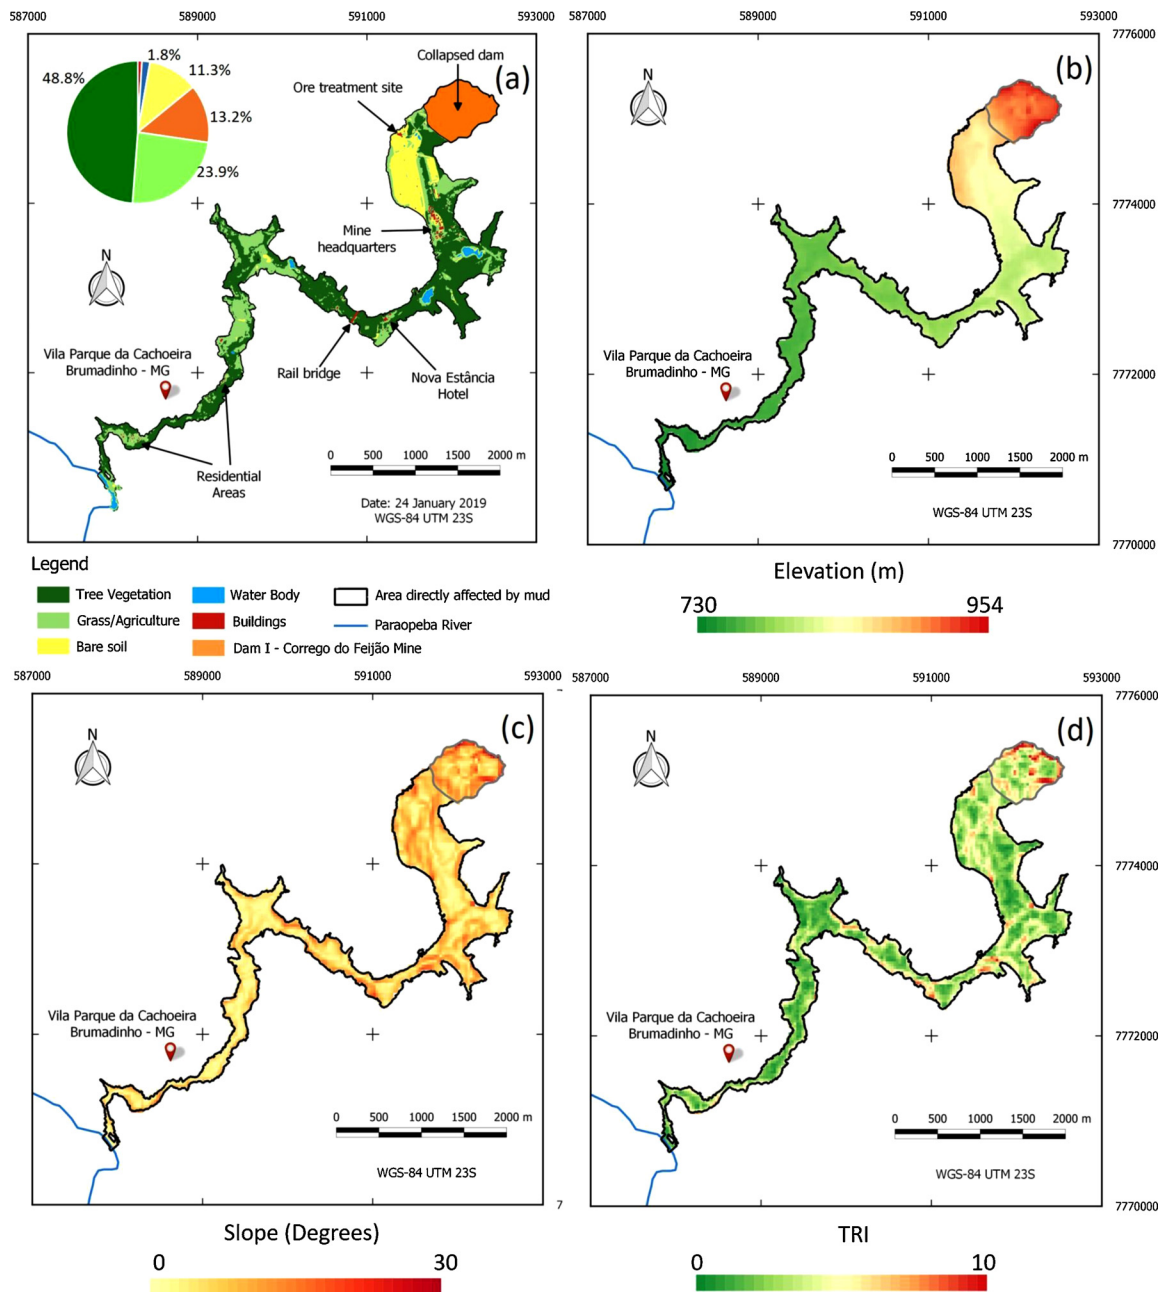
Fig. 8. The LULC map (a), Elevation (b), Slope (c) and Terrain Roughness Index (TRI) (d) of the area affected by the rupture of the tailings dam.

The class “Tree Vegetation” was the most affected by the mud, comprising 49 % of the analyzed area. This implies a huge loss of the ecosystem, with significant impacts on the local flora and fauna. About 24 % of the affected area comprised of regions with grass or agriculture. Agriculture is an important economic activity for people who live in the Vila Parque da Cachoeira. The regions classified as “Bare soil” (11 %) mostly result from mining activities. The tailings dam represents 13 % of the mapped area. The high difference in altitude between the tailings dam and the Paraopeba River (> 200 m as shown in Fig. 8b) and the moderate roughness of the terrain (Fig. 8d) accelerated the mud-flow. The affected area is mainly a mixture of Tree and Agriculture/Grass. Agricultural areas typically have low roughness and mostly occur on flat terrain, whereas trees usually have higher roughness and occupy predominantly steeper surfaces (Fig. 8a, c, and d). Therefore, the roughness of the terrain, depending on LULC, affected the rate at which

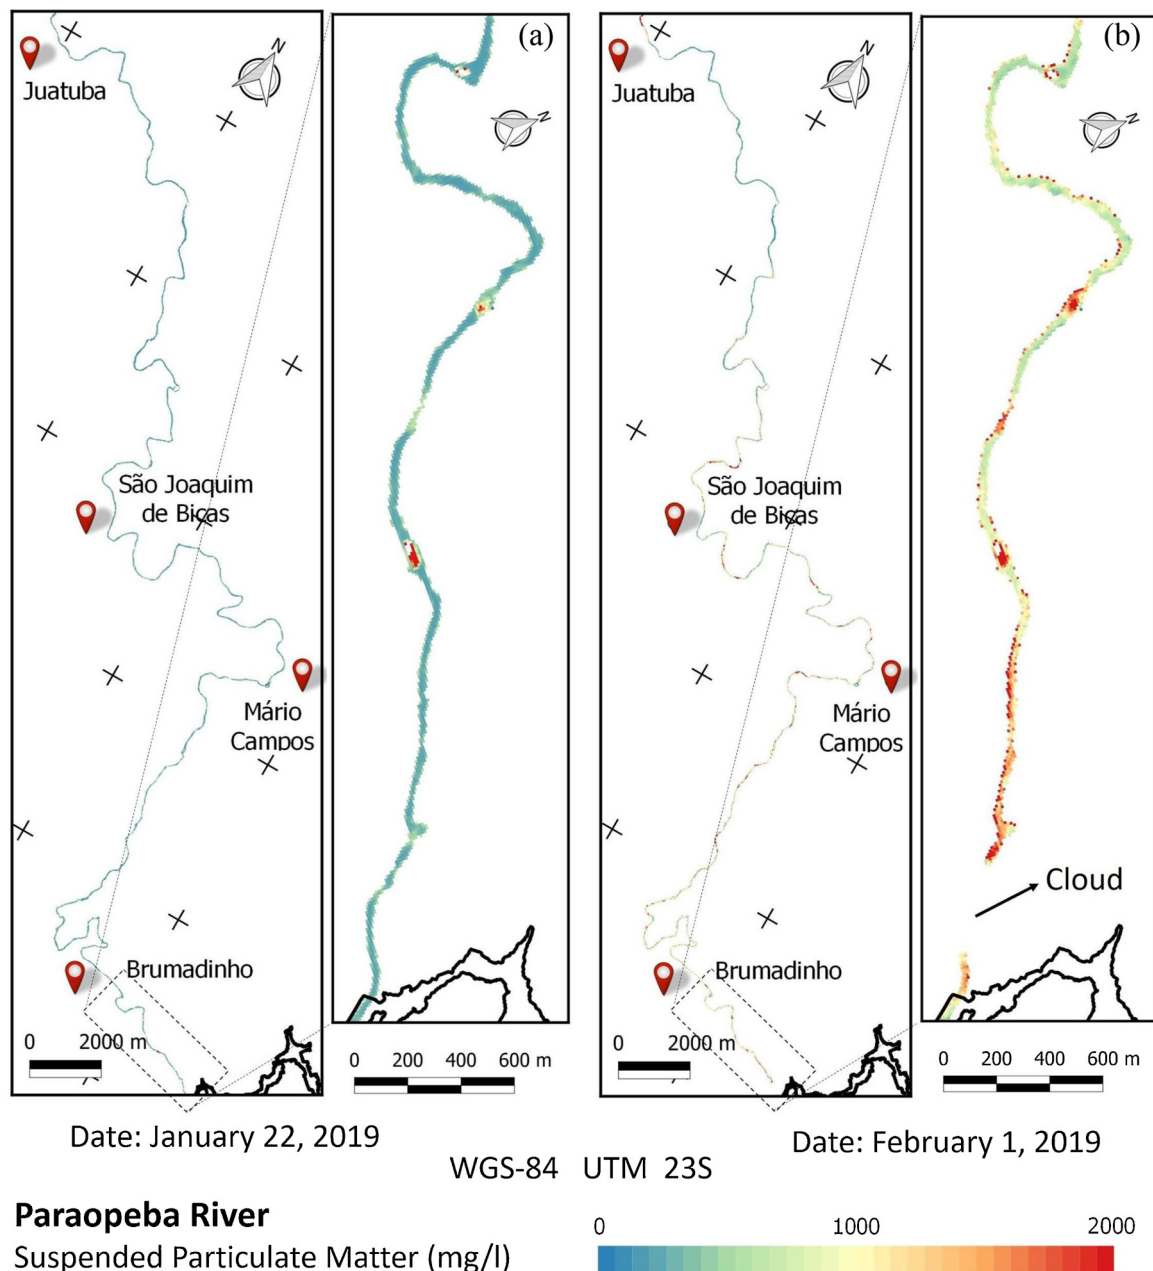
Fig. 9. Suspended particulate matter (SPM) from the affected area and up to 60 km along the Paraopeba River, before (a) (January 22nd, 2019) and after (b) (February 1st, 2019) the dam rupture.

Fig. 9 shows the SPM concentration maps of the Parapeba River before (January 22nd 2019) and after (February 1st 2019) the dam collapse. SPM boxplots are shown in Fig. 10. Using the median of the SPM concentrations of every 5 km along 60 km downstream, we found a remarkable difference between the two maps (Fig. 10). Although SPM values of up to 3000 mg/l are observed in the boxplot after the dam rupture, only a few points exceeded 2000 mg/l. Thus, to better visualize the difference in SPM concentrations, we used a palette ranging from 0 to 2,000 mg/l.

throughout the first 60 km of the Paraopeba river (Fig. 9a), which is also shown in the boxplot (Fig. 10a). Mean values between 200 and 300 mg/l were observed in the river before the dam rupture. On February 1st 2019 (after the accident) the SPM values displayed high variability along the river and the mean concentration dramatically increased, overall indicating the direct impact of the tailings mud. The highest concentrations of SPM (median between 700 and 1000 mg/l) were observed over a distance of up to 40 km. There was a decrease in the SPM values after 40 km; however, SPM values were still higher than those before the dam rupture. We propose that this decrease in SPM values was primarily due to the sedimentation of the suspended solids in that tract, as the river width becomes wider and flow velocity decreased (i.e. due to increased width/depth ratio). An increase in the SPM values on the map of February 1st 2019 was noted at ~60 km from the entry point of mud into the river, close to Juatuba. This increase in SPM may have occurred due to resuspension of solids caused mainly by
