A Tragic Disaster Caused by the Failure of Tailings Dams Leads to the Formation of the Stava 1985 Foundation

Abstract. This paper summarizes the dynamics and causes of the Stava disaster, and highlights some risky design procedures that led to the 19 July 1985 tailings dam failure. It then presents the “Stava 1985 Foundation”, which was formed to focus attention on such risks and to strengthen the culture of respect for human lives and safety.

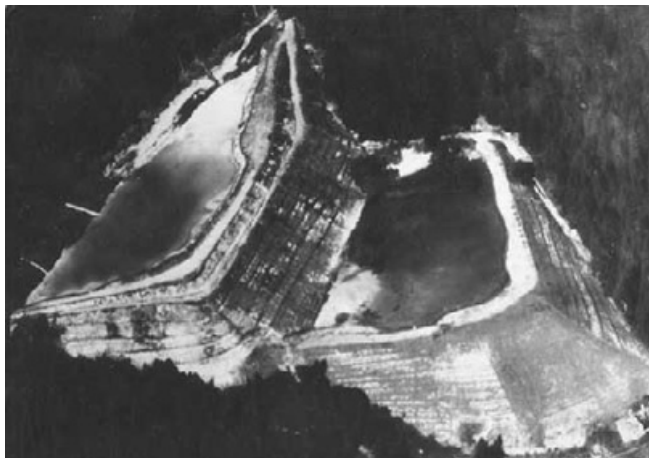
The Prestavel mine tailings ponds were located approximately 120 m higher and 800 m away from the village of Stava, in a small valley lateral to the Stava river valley, and were mostly out of sight from the populated area. Two basins were constructed on boggy and weakly resistant glacio-fluvial deposits lying on dolomitic rocks (Rossi 1973), on an area inclined between 12° and 16°. The area also received runoff water from a 0.12 km² hydrographical basin inflows and from springs coming from other basins (Chandler and Tosatti 1995). The dam of the lower basin was erected on a porous starter dam anchored at the foundation soil, using the “upstream” method, which is the least reliable method with respect to stability. The dam of the upper basin was constructed without prearranging either drainage systems or anchorages, using the “centerline” method, so that as the dam grew higher, its base rested partly on the lower basin tailings (Campanella et al. 1989), and after that, by the “upstream” method. In 1985, the year of the disaster, the difference in altitude between the top of the upper dam and the base of the lower dam was about 50 m. The area occupied by the two basins and the volume of the stored material were, respectively, 30,000 m² and 300,000 m³, which included 15,000–20,000 m³ of free water. The downstream slopes of the lower basin dam and of the upper basin dam varied, respectively, between 26° and 34° and between 32° and 40° (Figure 1).

Figure 1. The tailings ponds of the Prestavel mine before the collapse (from www.stava1985.it)

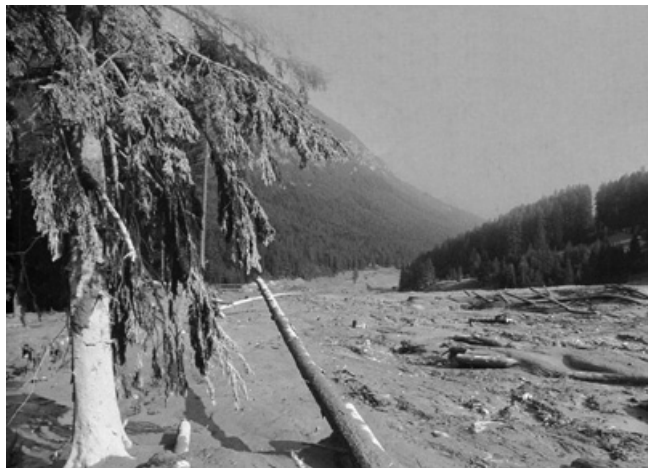
Figure 2. The Stava Valley after the mudflow (from www.stava1985.it)

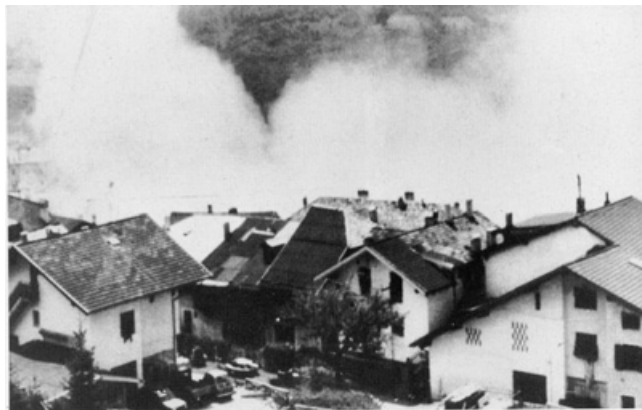
Figure 3. A destructive impact air wave preceded the mudflow: a whitish cloud with fine sand and slime, raised by the pressure wave, stormed through Tesero (from www.stava1985.it)

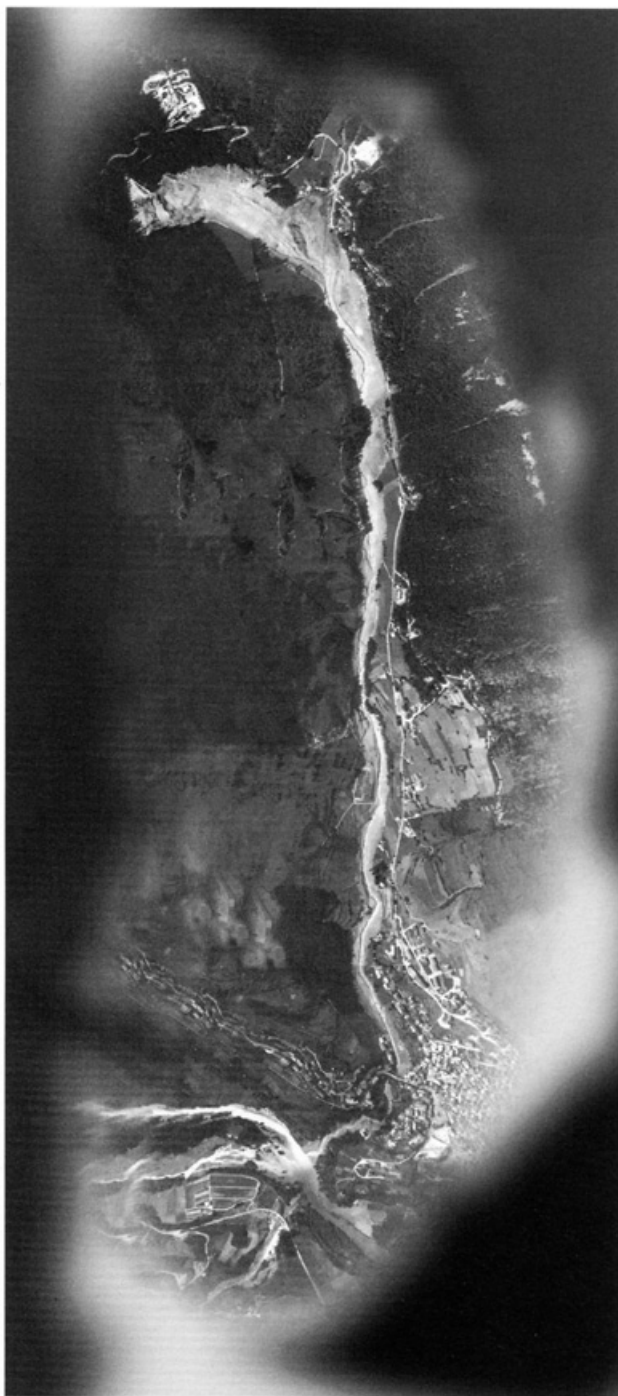
away the Tesero houses that stood along the Stava River, the velocity was about 11 m/s. The phenomenon began to attenuate itself at 12:31'00", probably after most of the mudflow had reached the valley of the Avisio River, into which the Stava River inflows. This mudflow descended 480 m, and covered the 4.2 km distance between the basins and the Avisio River in 425 s, at a mean velocity of 9.9 m/s (Dellagiacoma 1990; Takahashi 1991). During its abrupt descent, the mudflow eroded soil, destroyed buildings and structures and uprooted trees, removing 40,000-50,000 m³ of material from an area of about 27,000 m². Besides this material, the mudflow involved 5,000-10,000 m³ of Stava River water which, together with the free water superincumbent on the tailings and the water contained inside the saturated tailings, contributed to the fluidity of the flow and therefore, its destructive power and its capacity for infiltrating into voids among collapsed structures (Figure 2). Otherwise, it is possible that such voids could have protected some life. But, if the filling of such voids would have been the last destructive effect of the mudflow, the first effect was a powerful impact air wave produced by the quick descent of the fluid mass. This pressure wave preceded the mudflow and formed a white cloud containing water, fine sand, and slime (Figure 3), which caused the destruction of trees and buildings before they were swept away by the mudflow. In particular, witnesses saw trees from a thirty year old wood, adjacent to the basins and located at the same elevation of the lower basin bottom, being uprooted or cut down by the pressure wave, even before the slide reached them (Figure 4).

Figure 4. Aerial view, on the left, and graphic reconstruction, on the right, of the area impacted by the mudflow (courtesy of D.O.C. Doriguzzi)
