# **CORRECTIVE MEASURE IMPLEMENTATION REPORT**

Duwamish Sediment Other Area and Southwest Bank

Boeing Plant 2

Seattle/Tukwila, Washington

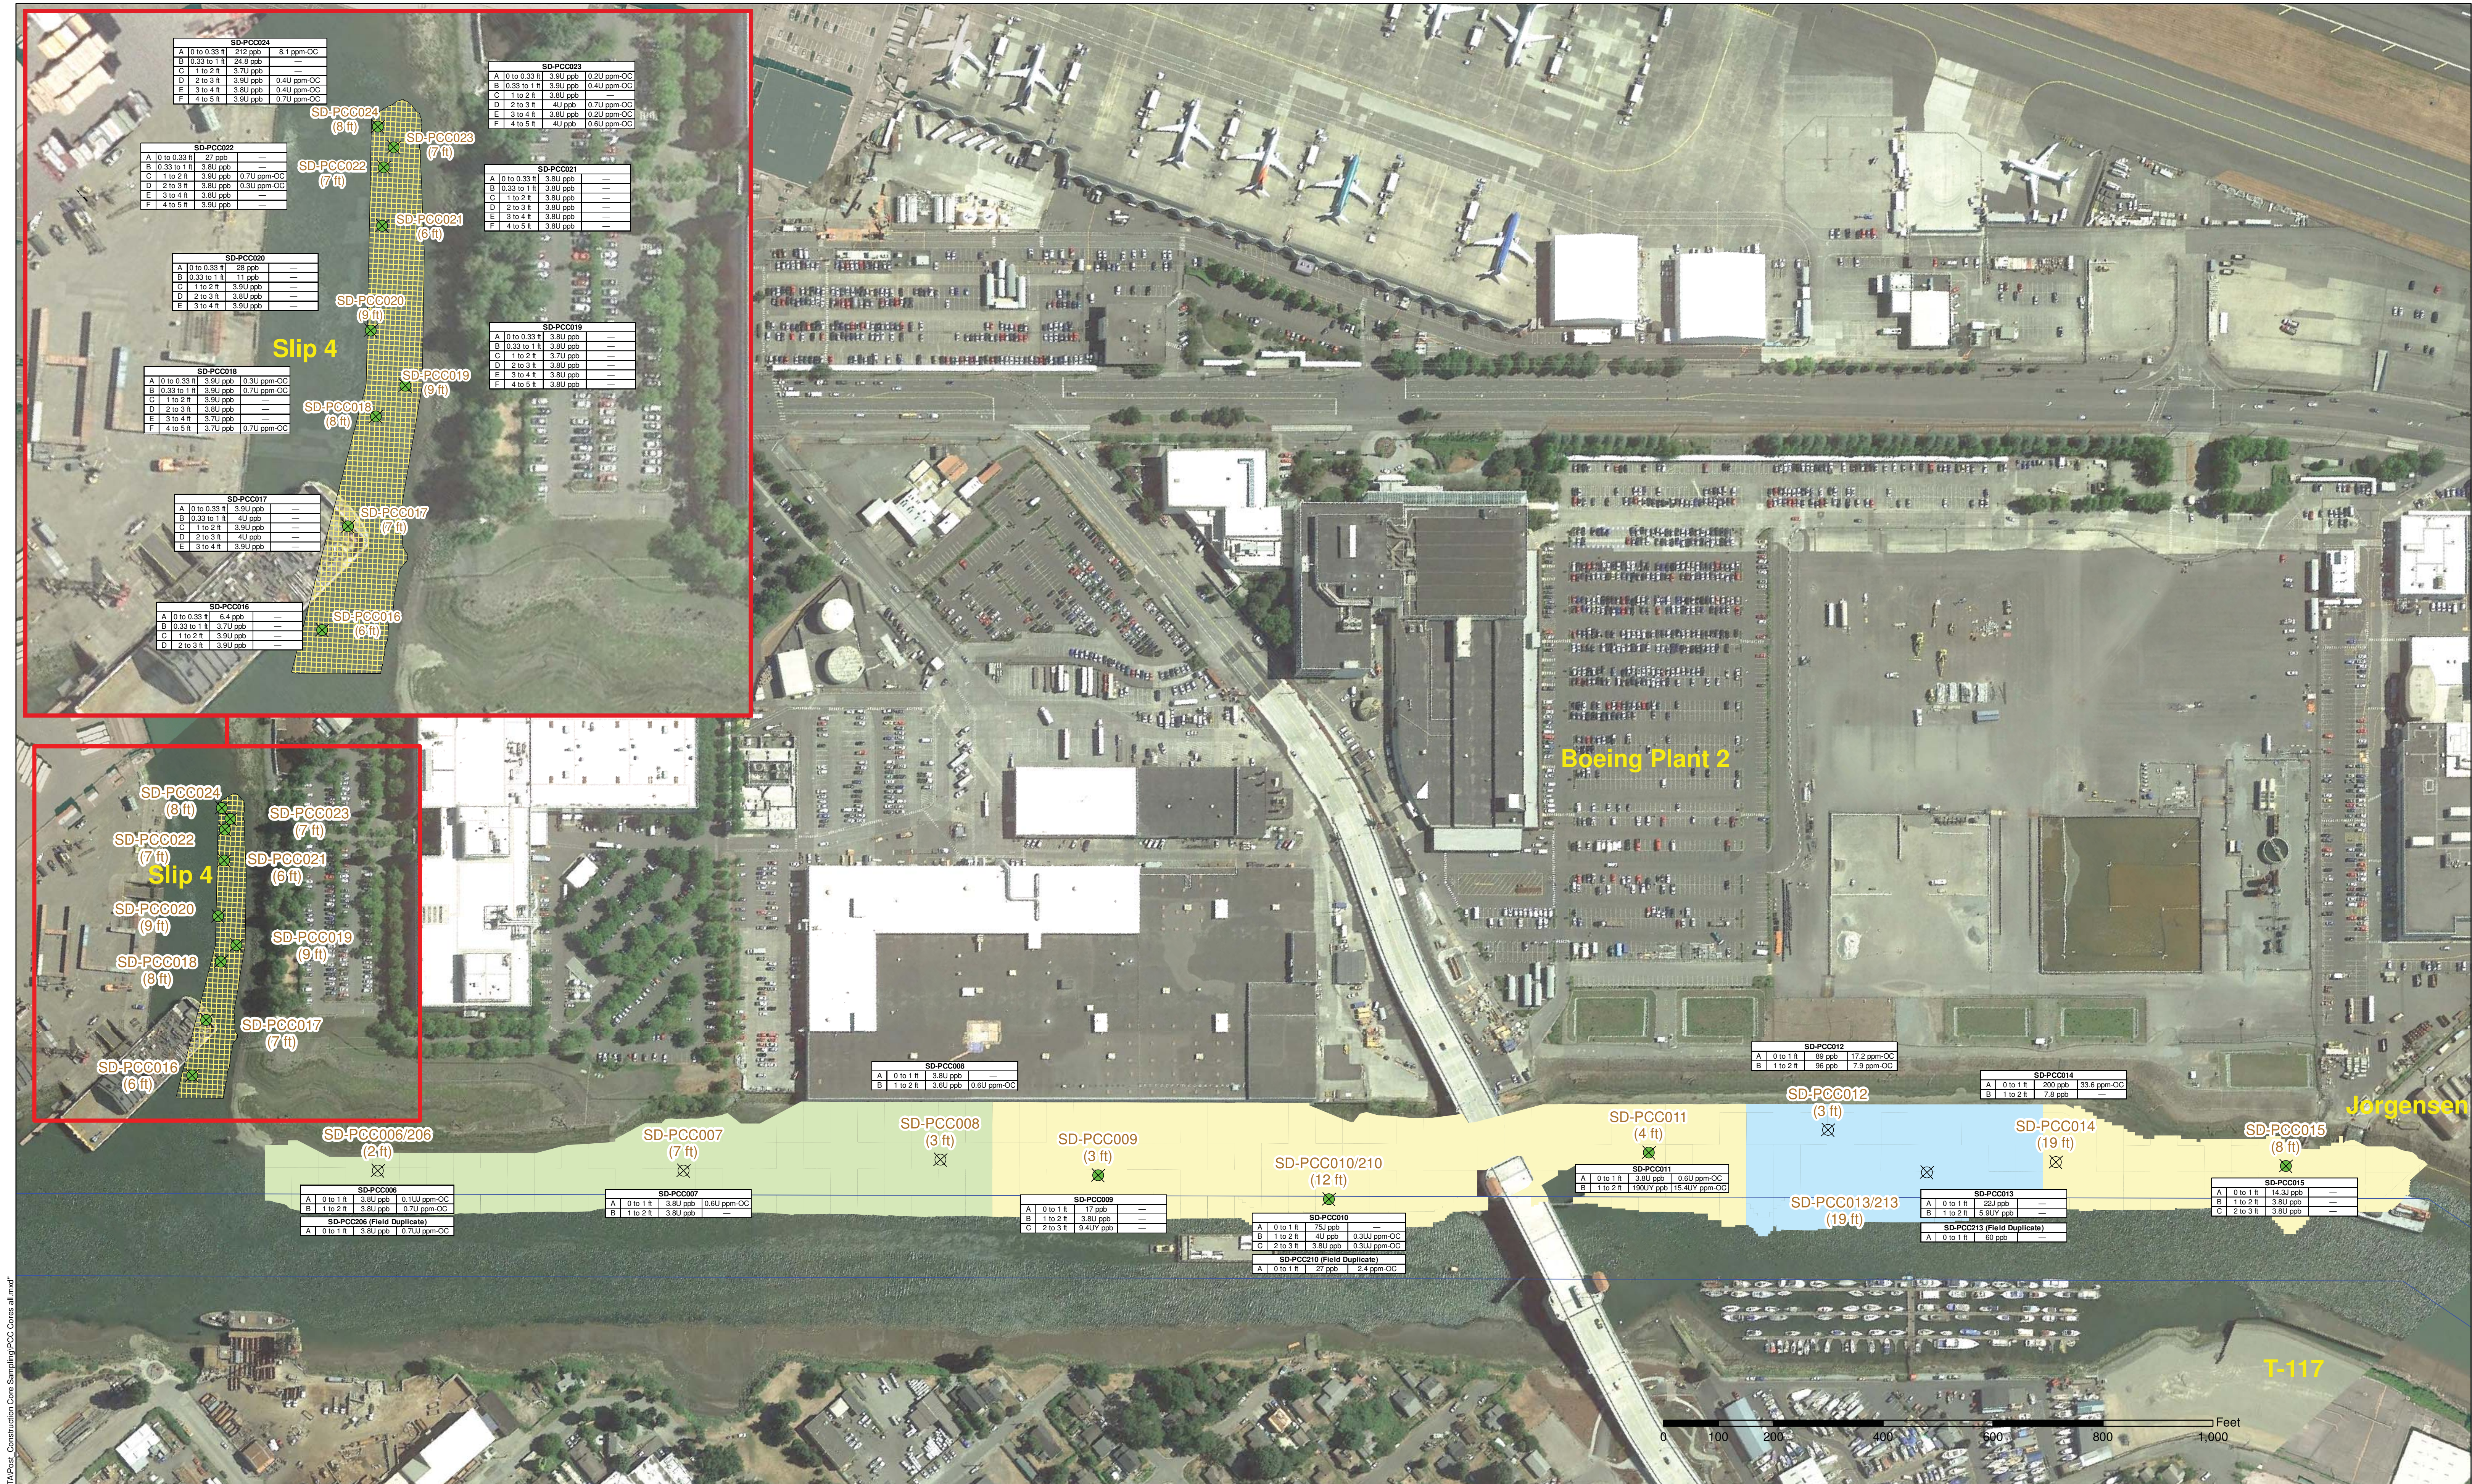
Figure 8

Post-construction Confirmation Cores
