Environmental impacts associated with an abandoned mine in the Witbank Coalfield, South Africa

Keywords: pillar failure; void migration; spontaneous combustion; spoil heaps; acid mine drainage

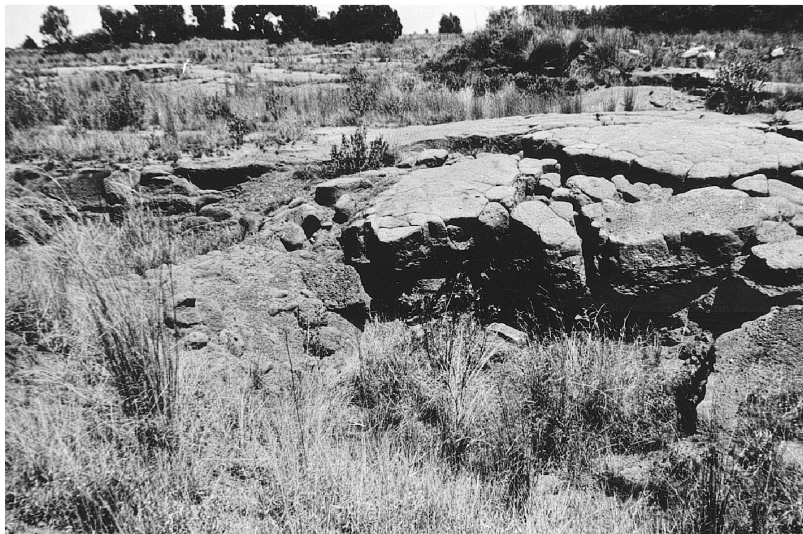
Fig. 4. (a) Subsidence due to pillar failure. (b) Tension fracture developed in sandstone running away from an area of subsidence due to pillar failure.

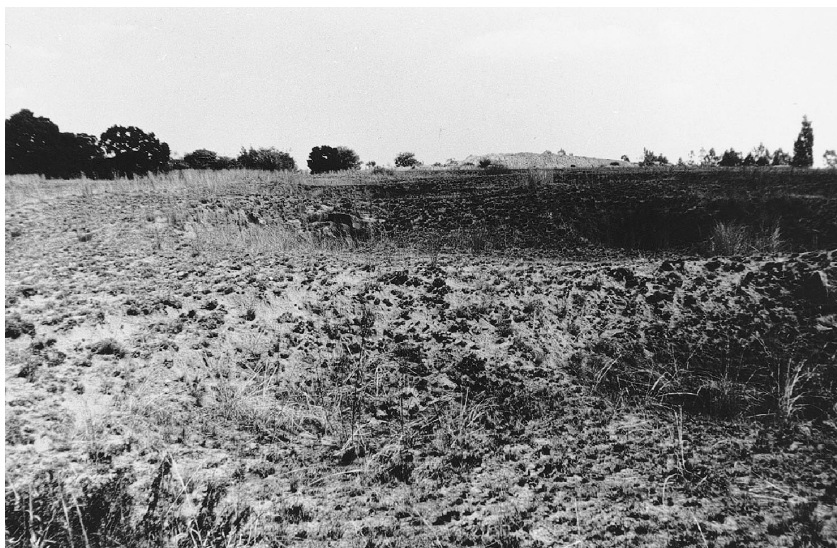
Fig. 5. Development of a large crownhole right of centre with curved tension cracks developed to the left.

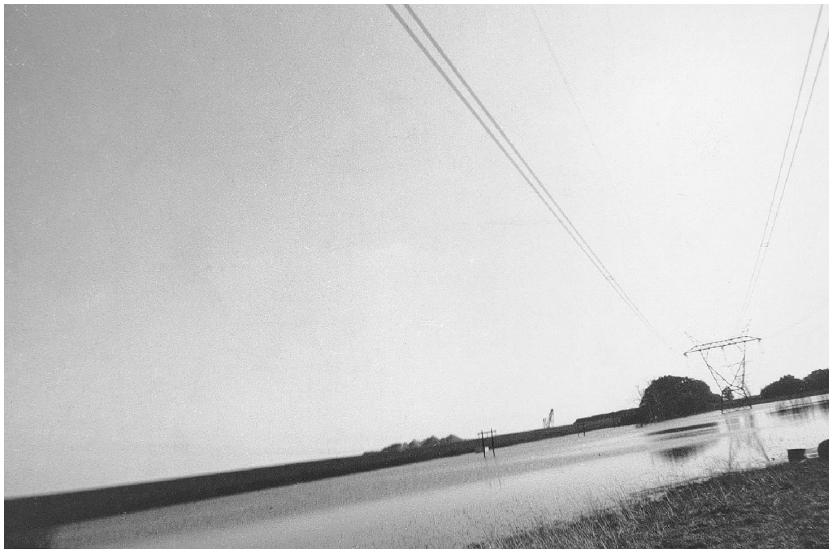
Fig. 6. Flooding due to subsidence.

Subsidence has led to flooding in places (Fig. 6). However, the impact of subsidence on property has been minimal as, fortunately, there is no major infrastructure in the area. Nonetheless, in the early 1980s, a municipal road leading to the local airport was constructed over the mine property. Stabilization of the area prior to road construction was necessary due to the high risk of surface subsidence and the spread of the underground fire. This was achieved by stooping the remaining pillars lying below the western side of the road, thus causing total collapse of the underground workings. Directly beneath and on the eastern side of the road, the bord areas were filled with a sand–cement grout mixture to provide additional support for the road foundation. These measures have been successful, as the road has not been affected by the subsidence, which is common in the surrounding area.

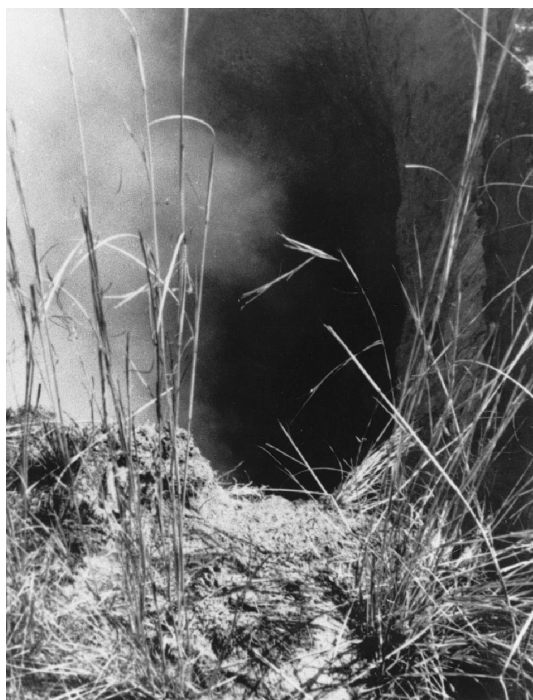
Fig. 7. Sulphurous stream being emitted from a crownhole.

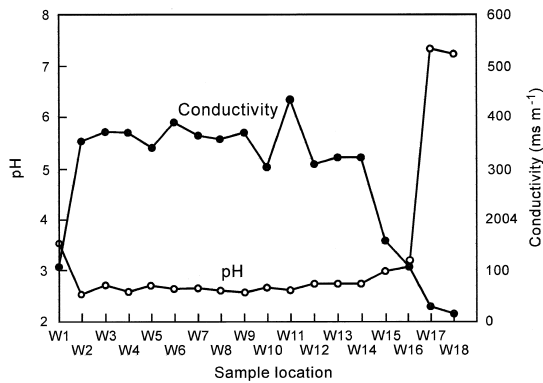
Fig. 10. Relationship of electrical conductivity and pH value of water samples along the Blesbokspuit.

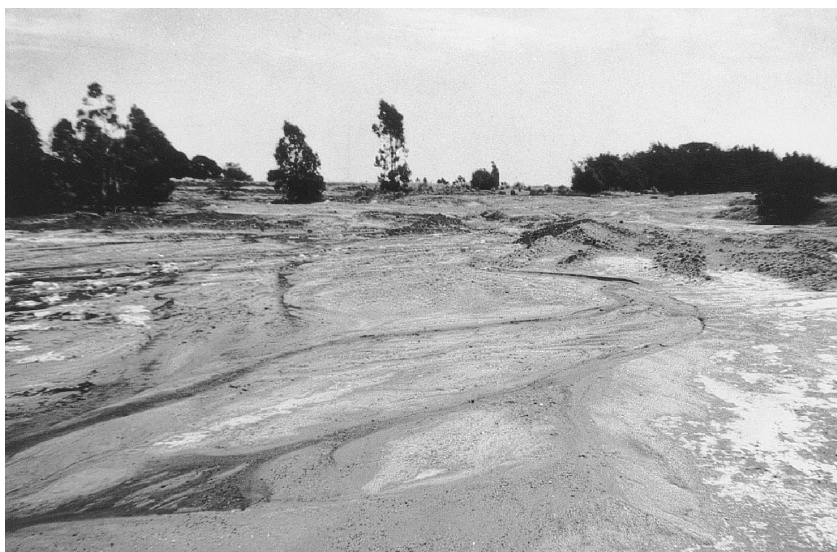
Fig. 15. Vegetation decimated in the seepage area by acid mine drainage. Also note the precipitation of salts.

mine and the decantation ponds. In this area, almost all plant life has been killed (Fig. 15). Dissolved aluminium ions, in particular, are regarded as a major cause of plant toxicity in acid soils. As the total aluminium concentration in the seepage water is over 100 mg l^{-1} , aluminium is likely to have played a significant role in the destruction of vegetation in this area. Other than species of algae, no aquatic life appears to exist in the seepage area, in the pollution control ponds or in the stream.
