**Rock-slope failures in Innerdalen and Innfjorddalen, western Norway:  
rock-slope instabilities and rock avalanches in a changing landscape  
following the melt down of the Scandinavian ice sheet**

vorgelegt von  
Markus T. Schleier  
aus Schweinfurt

Als Dissertation genehmigt  
von der Naturwissenschaftlichen Fakultät  
der Friedrich-Alexander-Universität Erlangen-Nürnberg  
Tag der mündlichen Prüfung: 29.01.2016

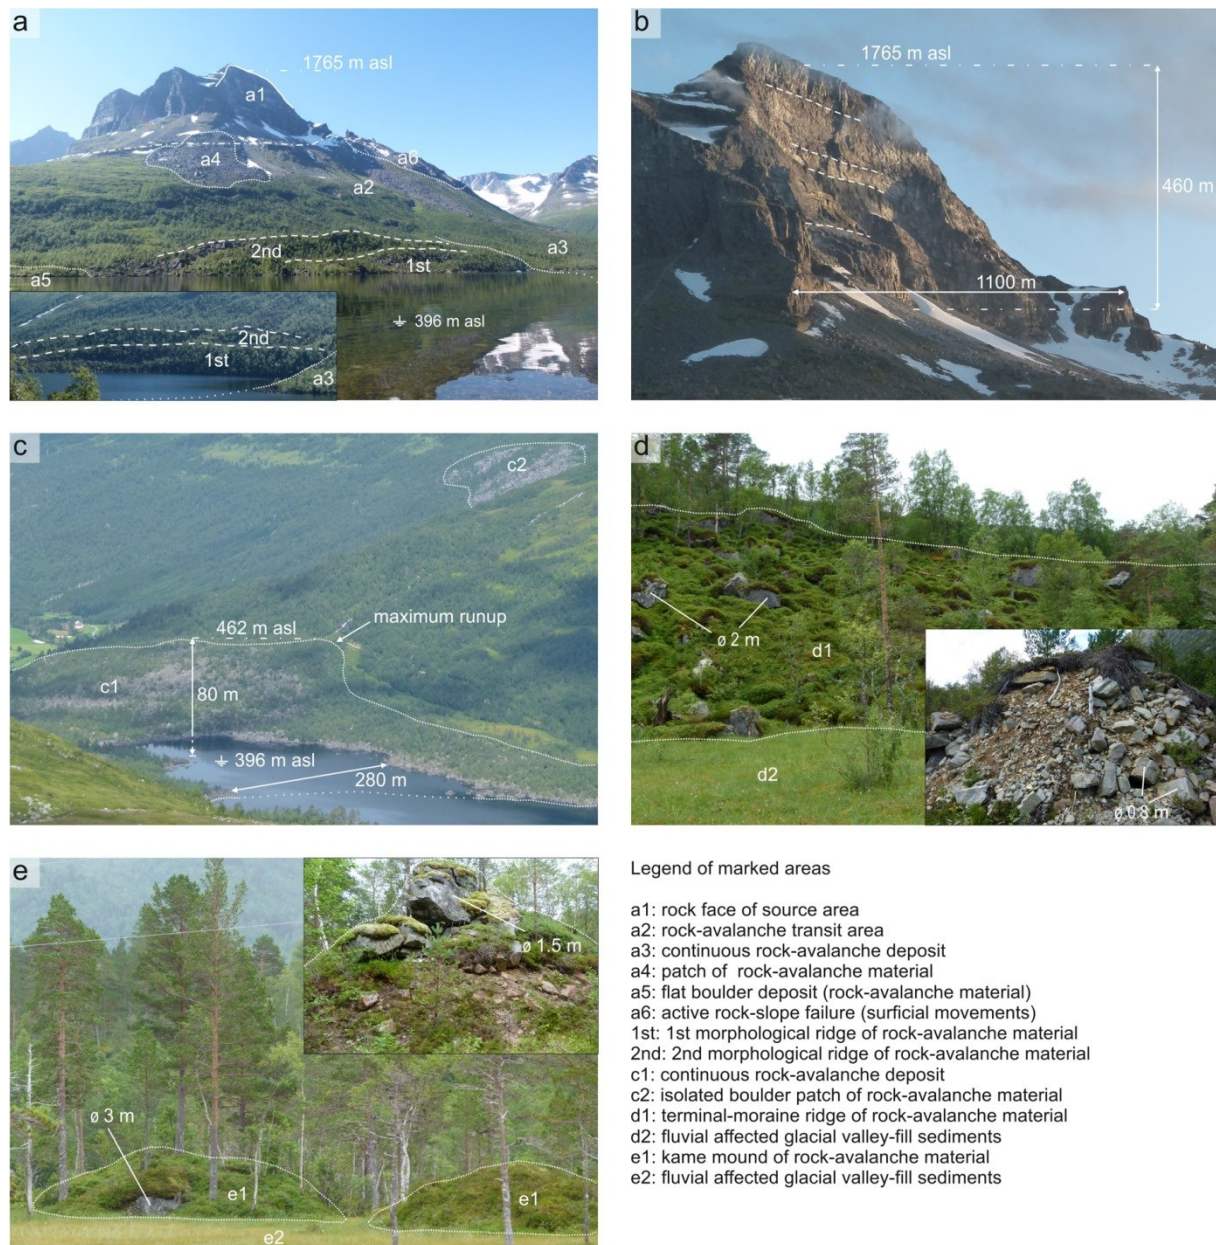
**Fig. 2.9: Photographs of geomorphological units in Innerdalen.** The extents of the units are outlined by dotted lines, and linear structures are outlined by dashed lines. Abbreviations are summarized in the legend. (a) Skarfjellet Mountain (view direction toward SW) showing the source area (main scarp marked by solid line) and transit area of rock avalanches, as well as the valley-parallel ridges along the lake (dashed line). The dashed-dotted line marks the estimated trace of the main thrust fault. The horizontal distance from the viewpoint to the top of the scarp is around 3 000 m, and it is around 550 m to the opposite waterside. The inset is showing the two morphological ridges from another viewpoint looking toward SSE. (b) Closer view of the scarp area at the N-facing steep rock slope of Skarfjellet Mountain (view direction toward WSW). The trace of the foliation is outlined by the dashed line. The average slope angle of the rock face is around 85°, whereas that of the lower slope is less steep, around 40°. (c) Continuous rock-avalanche deposit, showing a natural dam and runup on the opposite slope (view direction toward NW). The maximum runup height is estimated to be 80 m. The isolated boulder patch is part of the discontinuous rock-avalanche deposits and is located around 300 m above the valley floor. (d) Terminal-moraine ridge composed of rock-avalanche material, around 12 m high.

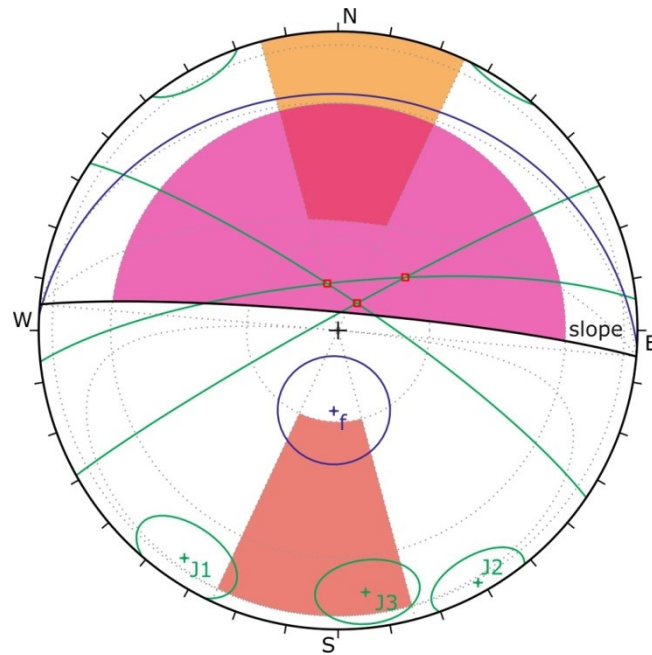
Fig. 2.11: Schmidt net plot of main discontinuity sets in Innerdalen (equal area, lower hemisphere). The discontinuities are the foliation,  $f$ , and the three main joint sets, J1, J2 and J3 (see Table 2.5). The circles display the  $1\sigma$  variability of the mean orientations. The results of the kinematic analyses are outlined by the failure envelopes for planar (red), wedge (purple) and toppling (orange) failure. (Schleier et al., 2015)

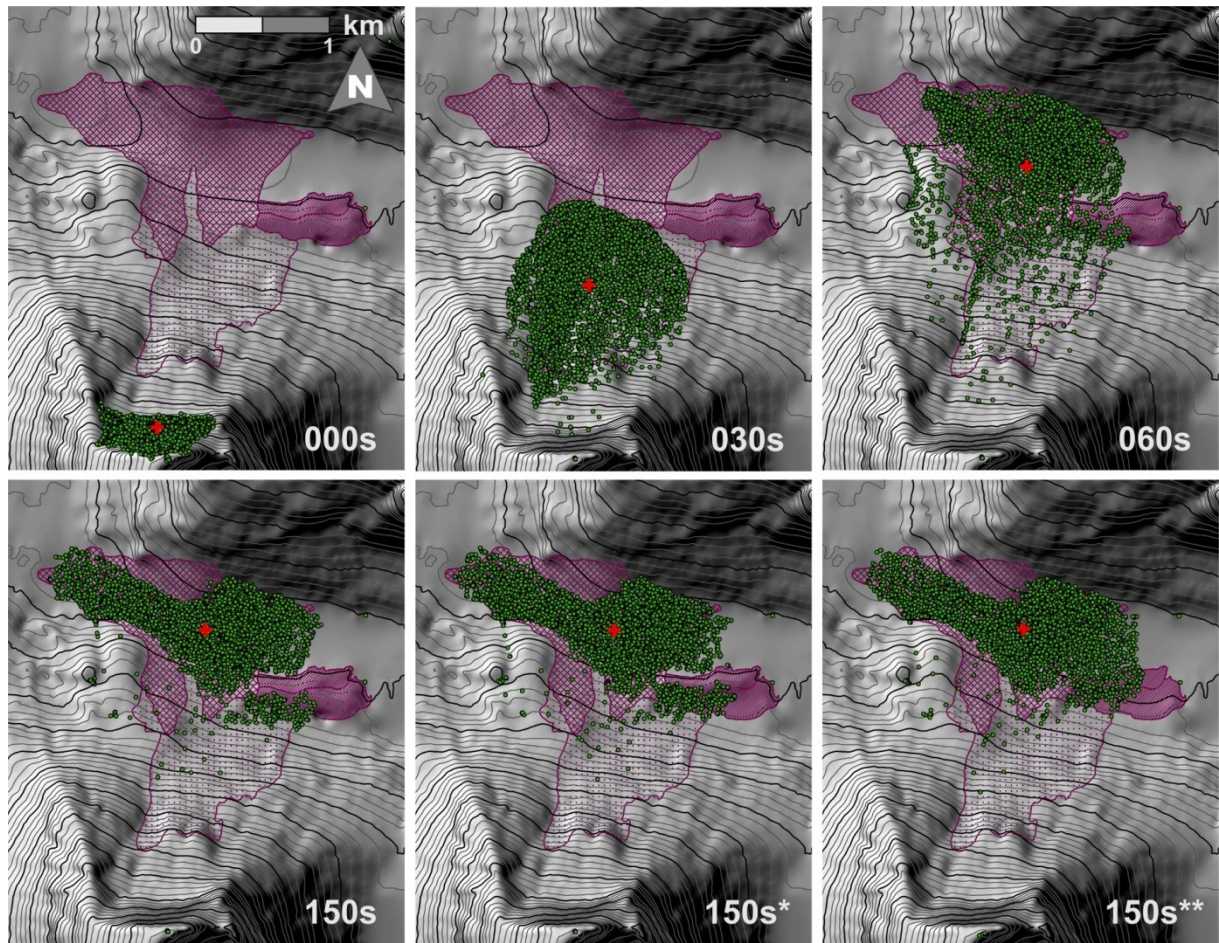
Fig. 2.12: Propagation of the Holocene rock avalanche in Innerdalen simulated with DAN3D. The propagation into an ice-free valley is shown at four time steps (0, 30, 60 and 150 seconds) and is represented by the simulated particles (green dots) and center of gravity (red cross), superimposed on a hillshade and 25 m contour lines. The final time step of 150 s for two additional models with slightly different path topography, that is, removed valley-parallel ridges, are shown (marked with \* and \*\*). The mapped extents of the actual rock-avalanche deposits are indicated by polygons (crossed purple, main rock-avalanche deposit; dotted purple, shallow rock-avalanche deposit, that is, transit area; hatched purple, valley-parallel ridges of rock-avalanche material). For rheology settings, refer to Table 2.1. (Schleier et al., 2015)

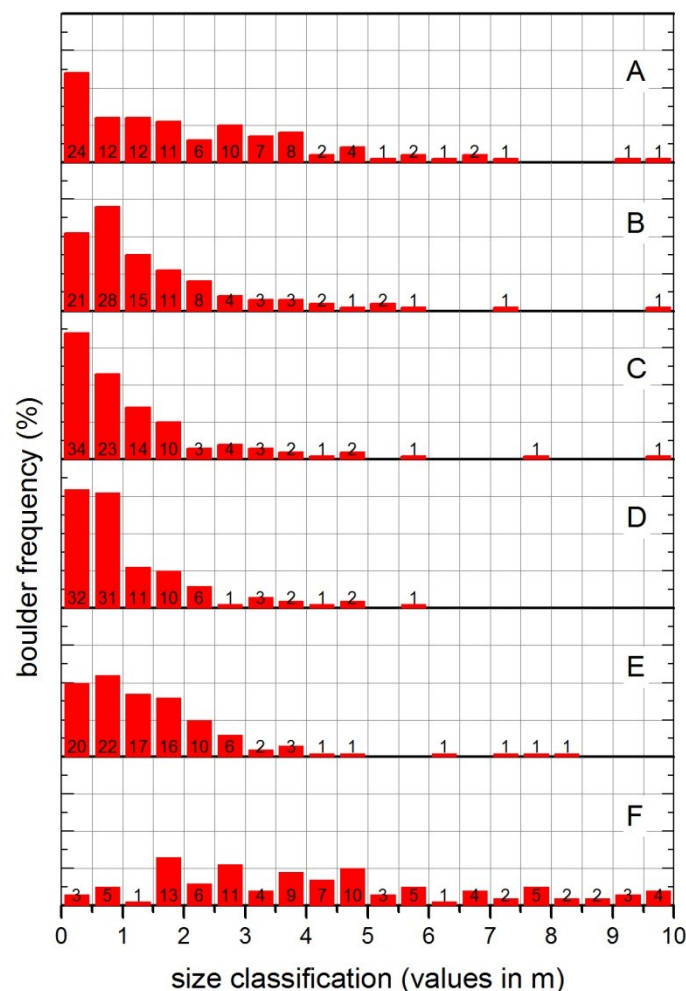
Fig. 3.9: Boulder size distribution for the sampled deposits (A to F) in Innfjorddalen. The horizontal grid lines mark 10% intervals. For location, refer to Fig. 3.6.

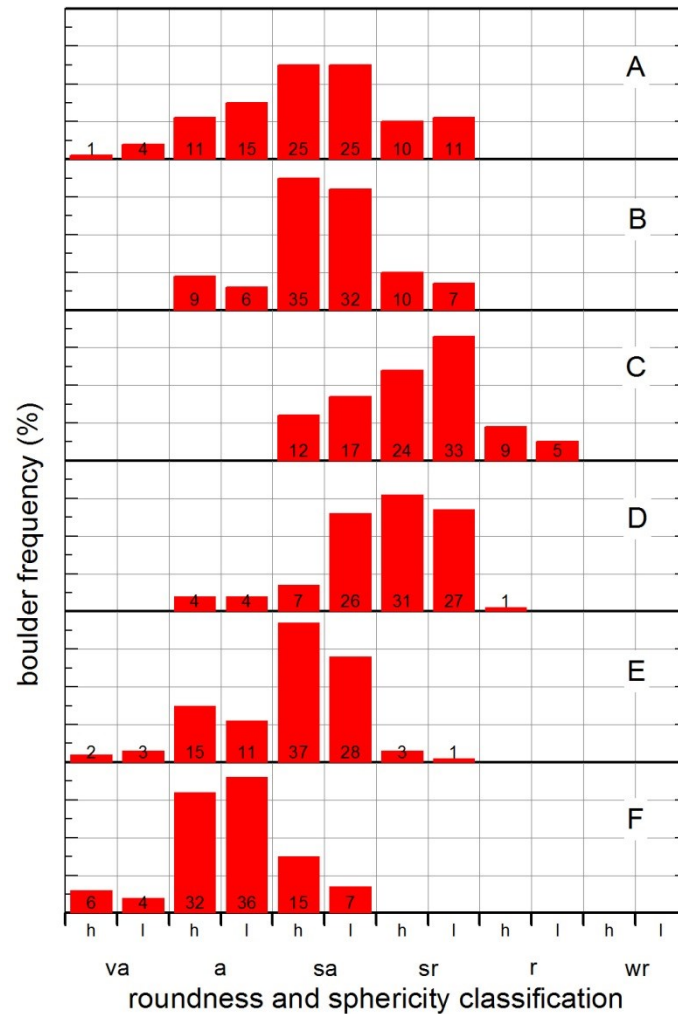
Fig. 3.10: Boulder roundness and sphericity distribution for the sampled deposits (A to F) in Innfjorddalen. The abbreviations are: va, very angular; a, angular; sa, sub-angular; sr, sub-rounded; r, rounded; wr, well rounded; l, low sphericity; h, high sphericity. The horizontal grid lines mark 10% intervals. For location, refer to Fig. 3.6.

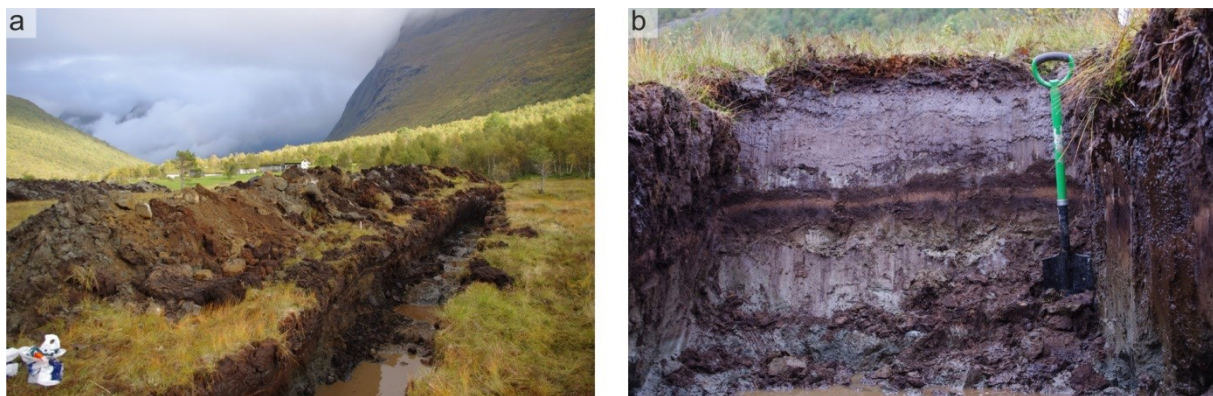
*Fig. 4.13: Exemplary photographs of one trench on the valley bottom below Middagstinden Mountain running parallel to the geoelectric profile P3. (a) Overview of the around 20 m long, 1.5 m wide and 1.3 m deep trench in soft sediments. (b) Closer view of the layered soft-sediments. The observed sediments do not show any distinct deformation structures. For location, refer to Fig. 4.5.*
