## THE STABILITY OF THE FLIMS ROCKSLIDE DAM

A.V. POSCHINGER

Bavarian Environment Agency, Munich, Germany

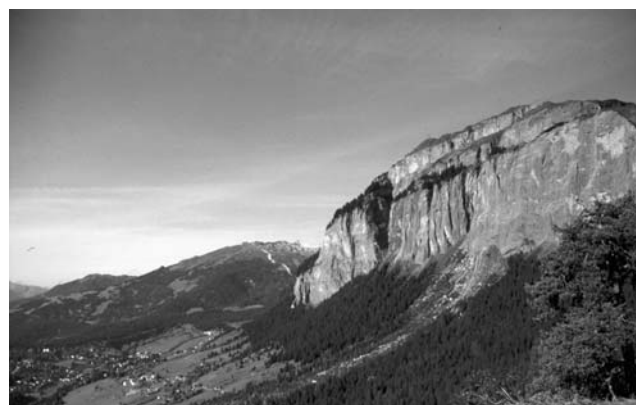
Figure 1 - Scarp of the Flimsenstein as the source area of the rock slide. The pasture area around the village of Fidaz is sub-parallel to the sliding plane. In the area between the forest and the pastures in 1939 a rockfall destroyed a children home killing 18 persons. Several other historic rockfalls from the cliff are reported by EISBACHER & CLAGUE (1984)

Without any doubt the rockslide happened “in one great stroke”, as already ascertained by HEIM (1883). The sedimentary layering of the Jurassic and Cretaceous limestone is almost parallel to the slope and inclined southward at an angle of about  $20^\circ - 35^\circ$ . The whole Flimsenstein mountain as the source area of the rockslide (Figure 1) is not built up by a consequent sedimentary sequence, but is tectonically shaped by several parallel folds and by imbricate thrusts (OBERHOLZER, 1933). Nevertheless, the general main structure parallel to the slope is striking.

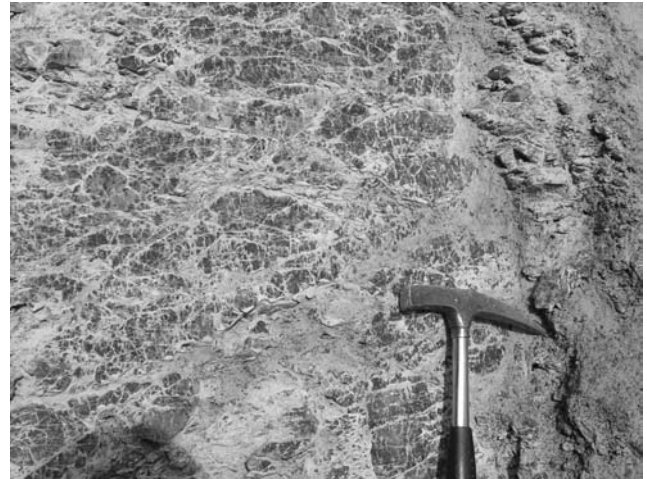
Figure 2 - Crushed jigsaw facies of the rock slide material. The components have perfect fitting, but are completely loose and can be dug out by hand

in many places is still preserved. Nevertheless, the rock is entirely crushed (Figure 2). The degree of fracturing differs from place to place. The undulating form of the slide surface must have caused a first destruction during the motion (ERISMANN, 1988). Also the existence of important steps, some higher than 50 m, within the slide surface must have caused a further internal destruction of the sliding mass. The maximum deformation however happened during the impact of the rock mass onto the opposite slope. Now, the resulting facies differs according to the specific local stress attained during the event. In many places a small scale “jigsaw-puzzle” has been produced, still preserving the original structure. This general structure is intersected more or less densely by deformation planes and -zones. Along those the limestone has been grinded to finest gouge. Often these planes are sub-parallel to the former sedimentary layering (WASSMER *et alii*, 2004). One reason for the creation of these deformation planes may be the sheet on sheet movement as described by Wassmer in POSCHINGER *et alii* (2005). An even more probable reason has been proposed by ERISMANN (1977) for the example of the Köfels rockslide in Tyrol: The lower parts of the moving mass will hit the opposite slope much earlier than the higher parts. That is why during the impact the higher parts have to travel a longer distance and will keep on moving while the lower part has already more or less stopped. This may happen in only few steps as assumed for Köfels, or in many steps or almost progressively as suggested by the author for Flims.

More delicate is the estimation of the stability of the “jigsaw-facies”. In any degree of fracturing it is completely dissected by dense joints (Figure 2). With few exceptions the slide mass has not been cemented and so can not be called a “breccia”. These rare exceptions are either matrix supported breccias or grain supported breccias. Real matrix supported breccias occur within internal shear zones. Rockslide components up to some centimetres are embedded within finest detritic rockslide material. They are to be found mainly

The permeability of the “jigsaw-facies” may be restricted by two facts. First, the gauge along the deformation planes is very fine and may act as an aquitard. Secondly, the particles have a close “grain to grain” contact with exactly fitting boundaries (Figure 2). So, the space between the particles is restricted. Nevertheless, set under water pressure, also the jigsaw-facies is due to its high degree of fracturing quite permeable. But it is very important that the special structure impedes a strong internal erosion. This material is not easy to erode and especially for subsurface water there is almost no chance to transport important amounts of solids.

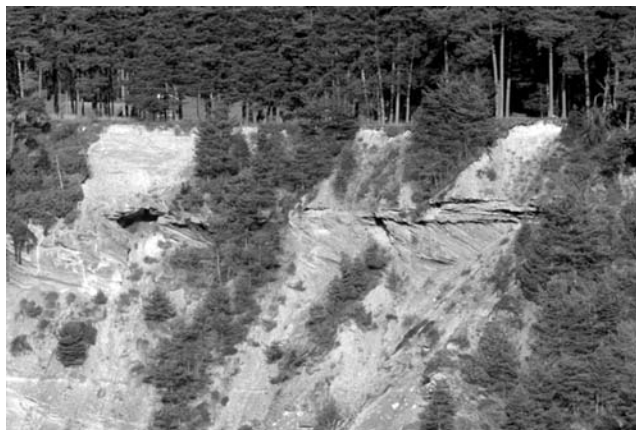
Figure 3 - Delta sediments of Laax. Topset and foreset are clearly developed. The delta sediments and the corresponding plain indicate a lake level of about 820 m

The Flims rockslide has dammed two important lakes and several small lateral ponds (POSCHINGER & KIPPEL, 2006). The biggest lake was Lake Ilanz with a length of about 24 km, an estimated surface of 27 km<sup>2</sup> and a volume of about 1.5 km<sup>3</sup>. These figures refer to an assumed maximum lake level of about 820 m a.s.l. This level is confirmed by many morphological traces and by lake sediments (Figures 3, 4).

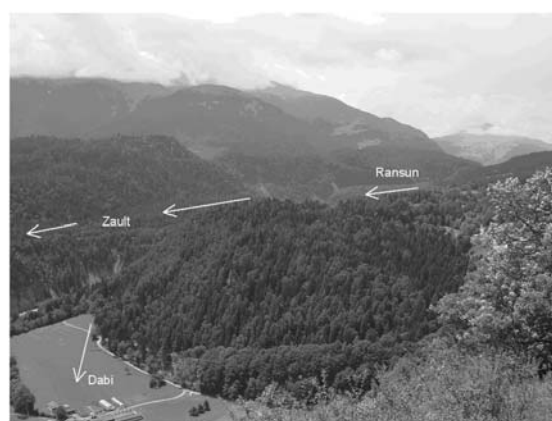
Figure 5 - View from Trin towards SW over the rockslide deposits (forested hills in the centre) to the floodplain (arrows) of Ransun (Ra), Zault and Dabi. The floodplain is related to the outbrake of Lake Ilanz

(e.g. ABELE, 1974) assumed a complete and instantaneous break of the dam with catastrophic circumstances. Almost all refer to the huge erosion- and floodplains (Figure 5), stretching over more than 6 km from Northeast of Versam until Reichenau or even further to the East. Obviously, the morphological features related to those have not yet been studied in detail. The best description until now was made by ABELE (1974) who differed three different levels of terraces. Own field investigations showed that at least 5 and probably even more levels can be mapped. The top of the floodplain has a strikingly constant inclination of about 2-2.5° (4%). The flood plain spreads out laterally up to more than 1 km. It is built up in its proximal part by a top of well sorted and stratified fine angular gravel and sands, laying over coarse boulders of a typical debris flow.

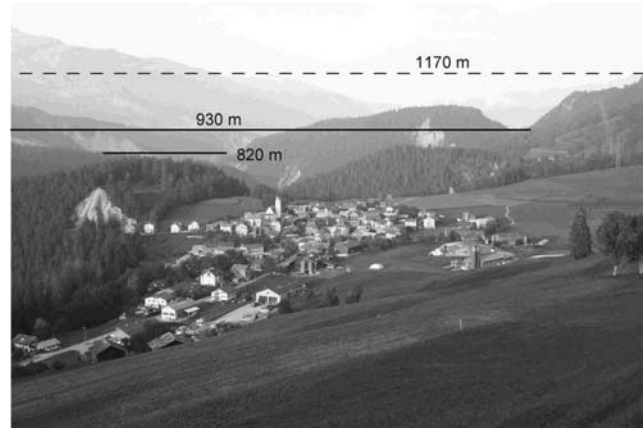
Figure 6 - View in downstream direction (East) to the remnants of the rock slide barrier. In the foreground is the village of Valendas. A maximum lake level is assumed to have reached at least 820m, but not more than 930 m. The postulated level of 1170 m is high up in the air and accordingly has no possible dam

Morphological hints give a maximum lake level of about 820 m a.s.l. Higher levels up to about 930 m cannot be excluded (Figure 6). A level of 1170 m however, postulated recently by WASSMER *et alii* (2004), lacks any realistic geological or morphological proofs. BASTIAN (2005) has calculated a lake volume of 1.89 km<sup>3</sup> for the level of 820 m. The corresponding lake surface of 25 km<sup>2</sup> means a release of  $25 \times 10^6$  m<sup>3</sup> of water in first instance for each metre in altitude. The minimum remaining lake level after the first breakage is represented by the layered silt at 760 m a.s.l. (Figure 4). This "Lake Ilanz<sub>760</sub>" still had a length of 15 km, but its volume only attained about 0.2 km<sup>3</sup>. So, even if the level reduced only about 28 % of its total height, the water volume released was probably about 1.7 km<sup>3</sup> or almost 90 % of the whole lake.
