# Drainage of the 12th Mining Field in the Handlová Mine (Slovakia)

Mária Kromková<sup>1</sup> · Mário Seko<sup>2</sup>

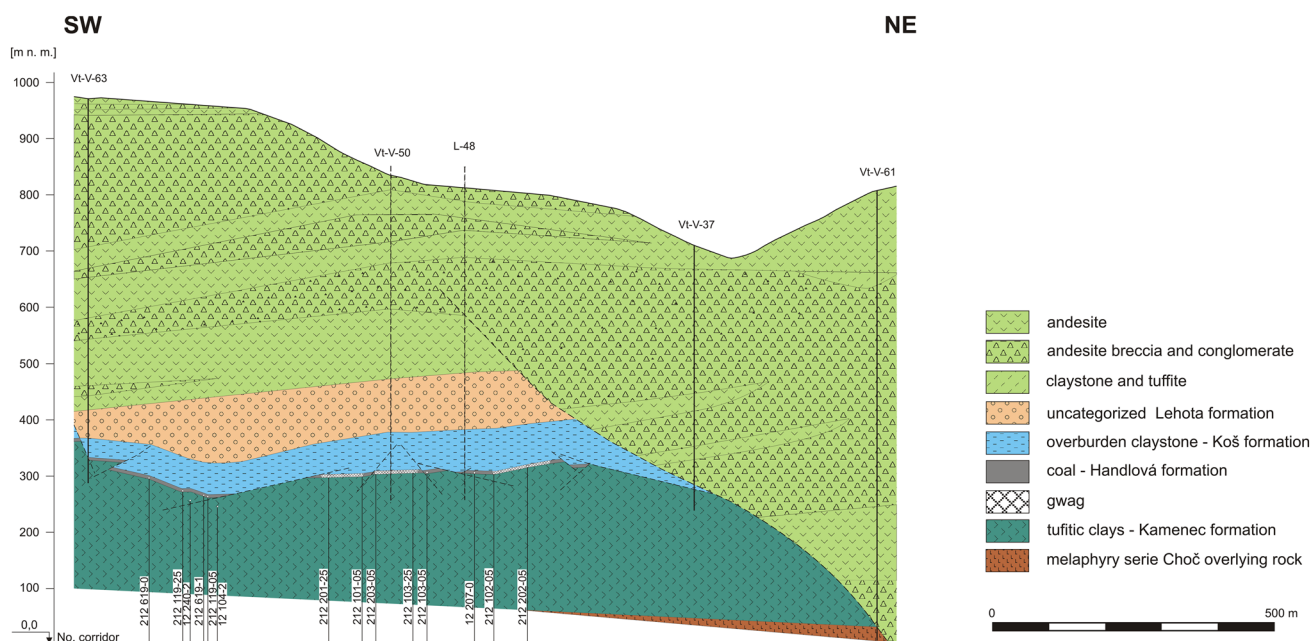
**Fig. 3** A schematic geological profile across the northern part of the 12th mining field of the Handlová Mine

Above the Lehota Formation are volcanic strata (the Vtáčník Formation): andesite breccia and andesites (Kolarovič et al. 1974). These strata have a wide range of hydrogeological properties, associated mainly with fractures in the rock massif, generally caused by regional tectonics (Škvarka 1975). The Vtáčník Formation results from explosive-effusive, and ultimately only effusive, volcanic activity. The northern and western part of this formation is built by andesite gravels and conglomerate towards the south of the 12th mining field, reaching up to 500 m thick. A drilling survey (from a mine working) in the area of the 12th mining field to a depth of 100 m found no volcanic strata, minimizing the risk of a water inrush. However, an underground well drilled for drinking water verified the presence of the Vtáčník Formation strata in the 12th mining field. The overall thickness of the overburden reaches 500–670 m in the 12th mining field (Fig. 3).
