# Acid Mine Drainage from Gold Mining in South Africa: Remediation, Reuse, and Resource Recovery

## Abstract

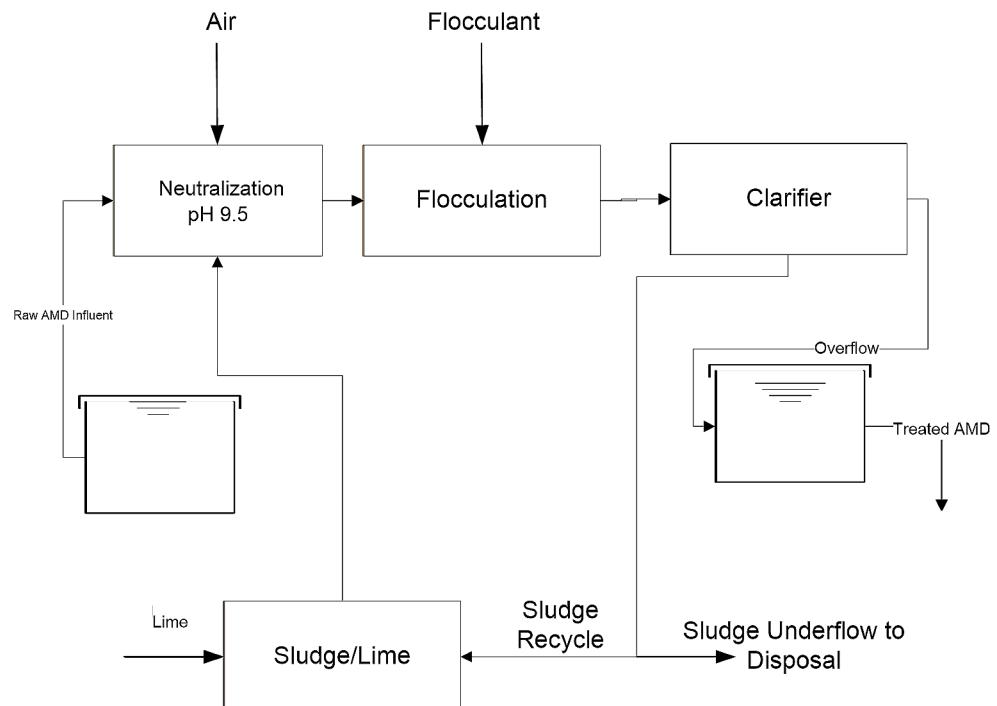
**Fig. 1** Schematic diagram of the SGS HDS technology

Most large AMD treatment plants around the world neutralize the mine water with lime and use some version of the high-density sludge (HDS) technology, which recycles most of the sludge that is generated during neutralisation (Aubé and Zinck 1999). The pH of the treated effluent is adjusted if necessary and then the treated water is released (Aubé and Zinck 1999).

The main advantage of the HDS process is that the sludge density is generally high, which reduces sludge disposal volumes and hence sludge handling and disposal costs (Aubé and Zinck 1999). Furthermore, even though flocculant is used, which effectively raises total chemical cost, the HDS process is efficient and uses less neutralising chemicals, thereby also lowering costs (Aubé and Zinck 1999).

One of the largest HDS treatment facilities in the world, the eastern basin chemical AMD treatment facility, began operations in August 2016. The plant is located upstream of the Blesbokspruit Wetland and close to the closed Grootvlei Mine in Springs, South Africa. The DWS contracted the TCTA to operate and maintain these HDS plants to ensure that the quantity and quality standards of treated water are met and that water recharge into the mine voids meet their respective environmental critical levels (Aubé and Zinck 1999). Even though these treatment plants are effective at rectifying water quality parameter concentrations to within acceptable ranges, the treated water is still characterised by elevated TDS and EC (Chetty et al. 2021c). Figure 1 illustrates the process flow diagram of the HDS treatment technology.

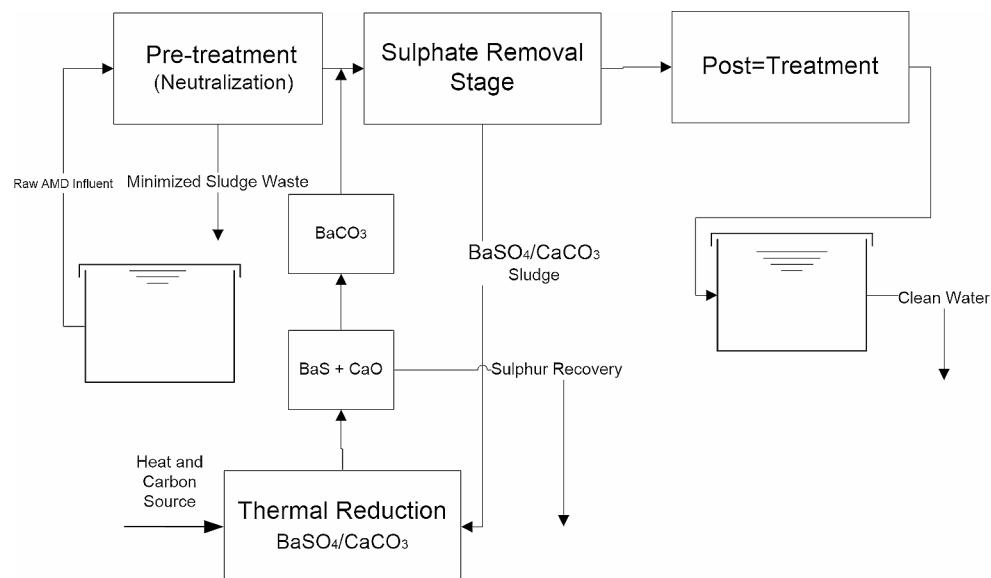
**Fig. 2** Schematic diagram of the CSIR ABC technology

The ABC process is fundamentally a precipitation-based process that was developed by our research division within the CSIR in South Africa. This method has three major phases, specifically neutralization and metal removal (stage 1), sulphate removal using  $\text{BaCO}_3$  (stage 2), and sludge processing (stage 3). The first stage enables the removal of acids and metals by the addition of lime and BaS to the mine water. Then the barium carbonate is added to the pre-treated effluent, which removes most of the sulphate from the water by the precipitation of barium sulphate (Simate and Ndlovu 2014a). The last stage, which involves sludge reduction via a coal-fired kiln, allows the recovery of much of the lime and barium carbonate and creates an all-new, low-waste technology (Mulopo et al. 2015).

This AMD treatment process was first demonstrated at a 1  $\text{m}^3/\text{h}$  pilot plant constructed in the western basin of

the Witwatersrand goldfields, to which AMD was pumped directly from a gold mine shaft for treatment. Mine water was fed into the plant, which operated on continuous mode for 24 h per day and 7 days per week. Water samples were collected and analyzed on-site to measure pH, sulphate, calcium, Mg, and Fe at different stages of the process (de Beer et al. 2010). The results indicated that the CSIR ABC process effectively neutralizes AMD, lowers TDS by 86%, removes metals, lowers sulphate to values less than 100 mg/l and recovers the raw materials utilised in the sludge processing stage. Figure 2 illustrates the process flow diagram of the CSIR ABC treatment process.

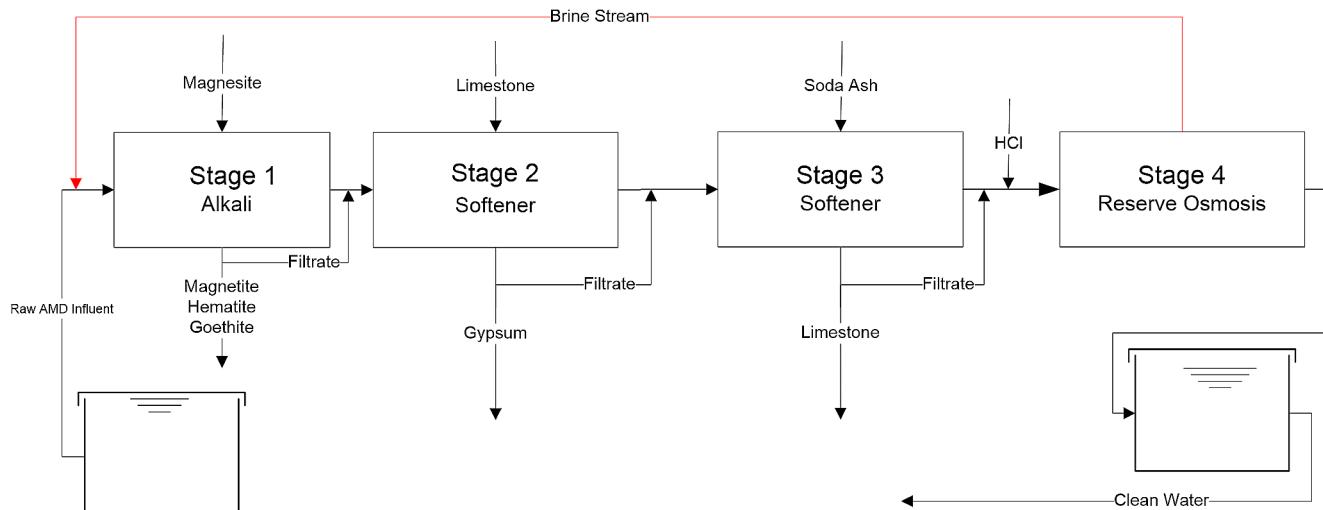
**Fig. 3** A schematic presentation of the CSIR MASRO technology

Another AMD treatment technology recently developed by the CSIR in South Africa is called MASRO (magnesite, softeners, and reverse osmosis) technology. The MASRO technology is a five-stage process with a clarifier that also acts as a mixer. The first stage involves the use of magnesite to neutralize the AMD and remove all metals from the mine water; the sulphate stays in solution as a  $MgSO_4$  complex. Thereafter, the residual sulphate and Mg are removed as gypsum and brucite respectively by the addition of limestone in stage 2 of the process. Stage 3 involves the synthesis of limestone by the addition of soda ash, which in effect removes the residual calcium and hydrated calcium carbonate. Thereafter, stages 4 and 5 include HCl dosing to neutralise the water, water filtration via a reverse osmosis process, and the storage of products (brine and water) in separate tanks.

The pilot plant demonstrated at the CSIR research innovation site, Pretoria, South Africa treated 3500 L of gold

AMD per day and produces water that is compliant with the SANS 241 drinking water standards as well as valuable minerals, namely gypsum, limestone, and iron-based minerals (Masindi 2017). These minerals can be sold to offset the operational costs of the plant, rendering it both environmentally sustainable and self-sustaining. However, some areas that were found to require improvement prior to full-scale industrial implementation include the evaluation of plant stability, factoring in of maintenance costs, establishment of quality grading for the recovered materials, running of the plant for more than six months at the CSIR site or on-site to test the sustainability of the developed system under harsh ecological conditions. Figure 3 shows the process flow diagram of the MASRO treatment technology.

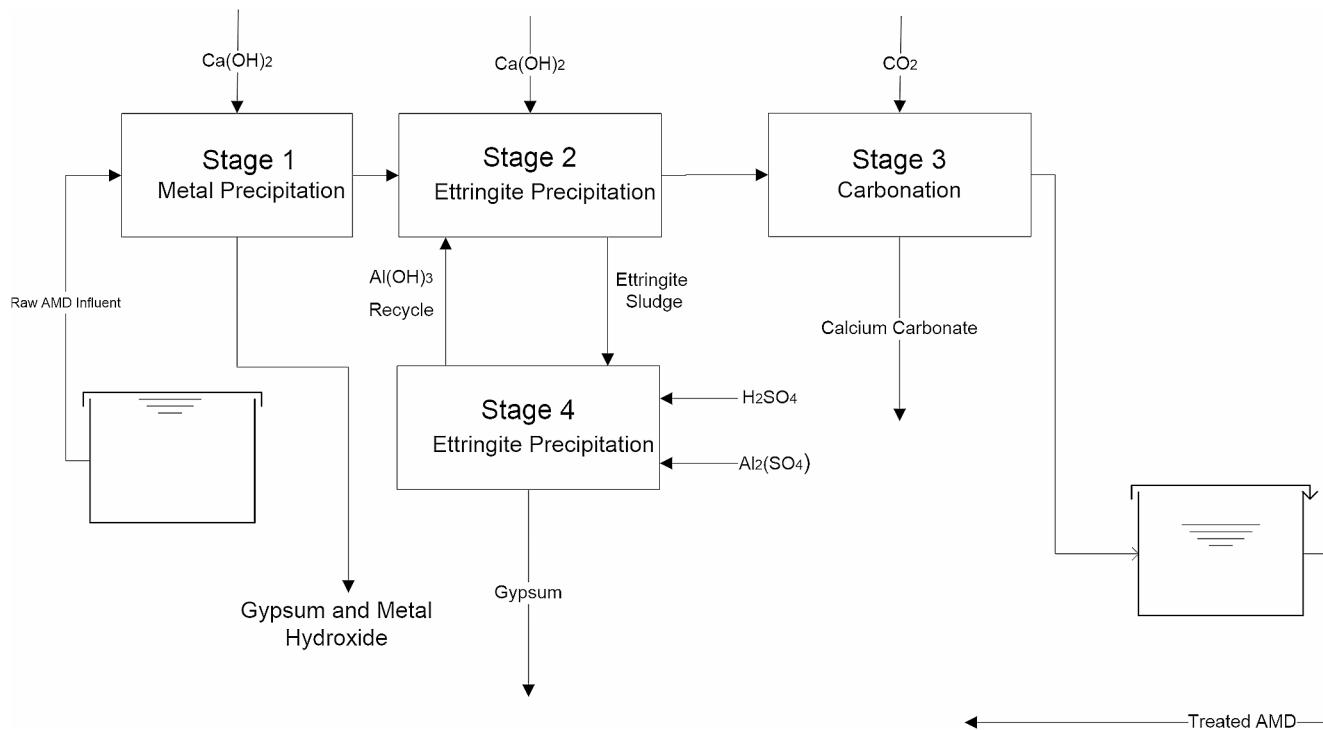
**Fig. 4** A schematic presentation of the Mintek SAVMIN technology

The technology of sulfate removal by precipitation as a component of ettringite was developed by Mintek, Randburg, South Africa and called the SAVMIN technology. The SAVMIN technology is a six-stage gold mine AMD treatment technology, which utilises successive stages of precipitation to remove sulphate from mine water. First, lime is added to the mine water to increase its alkalinity to a pH of 12 to promote the precipitation of metal and magnesium hydroxides. In stage 2, gypsum is precipitated and removed from the supersaturated solution, catalysed by the seeding of gypsum crystals therein. Thereafter, stage 3 involves the addition of aluminium hydroxide to the water, which is still supersaturated with gypsum, resulting in the precipitation of both calcium and sulphate in the form of ettringite. Removal of the ettringite from the feed water is accomplished through filtration and subsequent thickening. Stages 4 and 5 involves the use of sulphuric acid to decompose the ettringite slurry

at a pH of 6.5 in a solution supersaturated with gypsum. Aluminium hydroxide is produced, which is recycled to the third stage of the process, the gypsum supersaturated solution is diverted to stage 2 where it's seeded with crystals to remove gypsum, and the remaining solution is recycled (van Rooyen et al. 2021). The lowering of the feed water's pH by the addition of  $\text{CO}_2$  is the last stage, during which  $\text{CaCO}_3$  precipitates. Even though waste disposal is expensive due to the large amount of sludge generated by this process, the potable water, metal hydroxides, gypsum, and calcite can be marketed and sold.

A SAVMIN demonstration plant was erected at the Witwatersrand gold mines in the western basin that treated 500  $\text{m}^3$  of gold mine water at throughputs of up to 1100 L/hr. The dissolved sulphates and metals were removed to very low levels in the treated water. The dissolved metals and sulphate content met the target water quality for the three different purposes considered, specifically for discharge, high quality industrial use, and potable water. Recently, further developments on the SAVMIN technology have been made in partnership with Veolia Water Solutions and Technologies. The original design of the SAVMIN technology consisted of five stages as described above; this was improved by eliminating two reactors and two thickeners from the technology as shown in Fig. 4. As reported by van Rooyen (2016), development was performed around the reagent regeneration process step, resulting in an impressive reduction in the operating cost of the process.

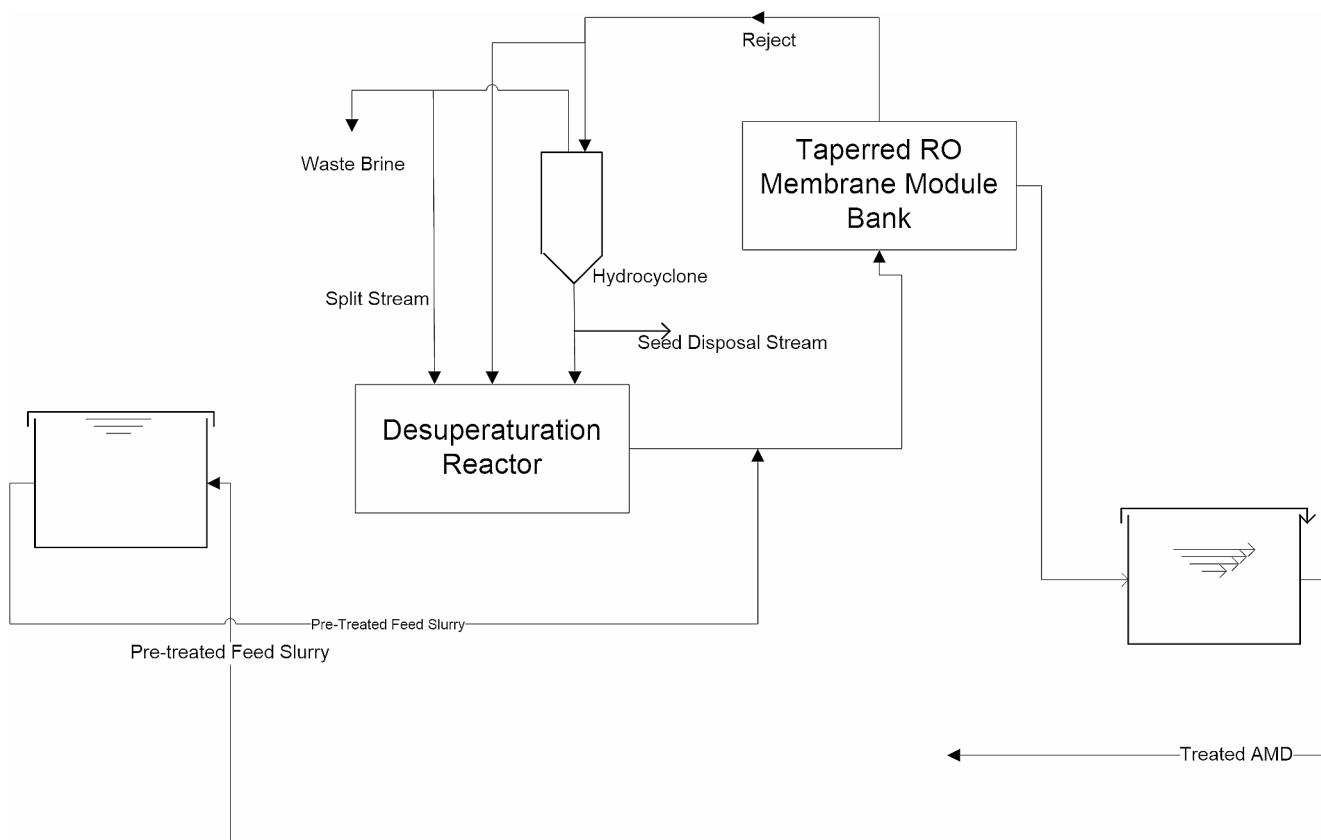
**Fig. 5** A schematic process flow diagram of the COMRO SPARRO technology

(slurry precipitation and recycling reverse osmosis) technology. As shown in Fig. 5, SPARRO uses membrane desalination to treat AMD. The SPARRO technology was designed to augment water recovery in waste disposal of an AMD with high calcium and sulfate concentrations. In this process, calcium sulphate removal precedes membrane treatment and involves the addition of seed crystals into the feed water by the recycling of waste slurry. According to Pulles et al. (1992), RO system operation at a high recovery was enabled by recycling a slurry of calcium sulfate seeds, which provides preferential precipitation sites to the supersaturating solution. The erosive effect of the needle-like gypsum crystals flowing through the membrane is the SPARRO process' troublesome aspect.

This process was piloted at the eastern basin of the Witwatersrand gold mine where a pilot plant of 3.1  $\text{m}^3/\text{h}$  was designed, constructed, and commissioned by COMRO at the Hercules Shaft of the East Rand Proprietary Gold Mine. The findings indicated that although the process demonstrated high salt rejection and water recovery, its development was constrained by its high energy consumption, limited control of  $\text{CaSO}_4$  seeds, and membrane fouling (Juby 1996). Hence, developing membranes to improve their performance may increase the economic feasibility of the SPARRO technology.

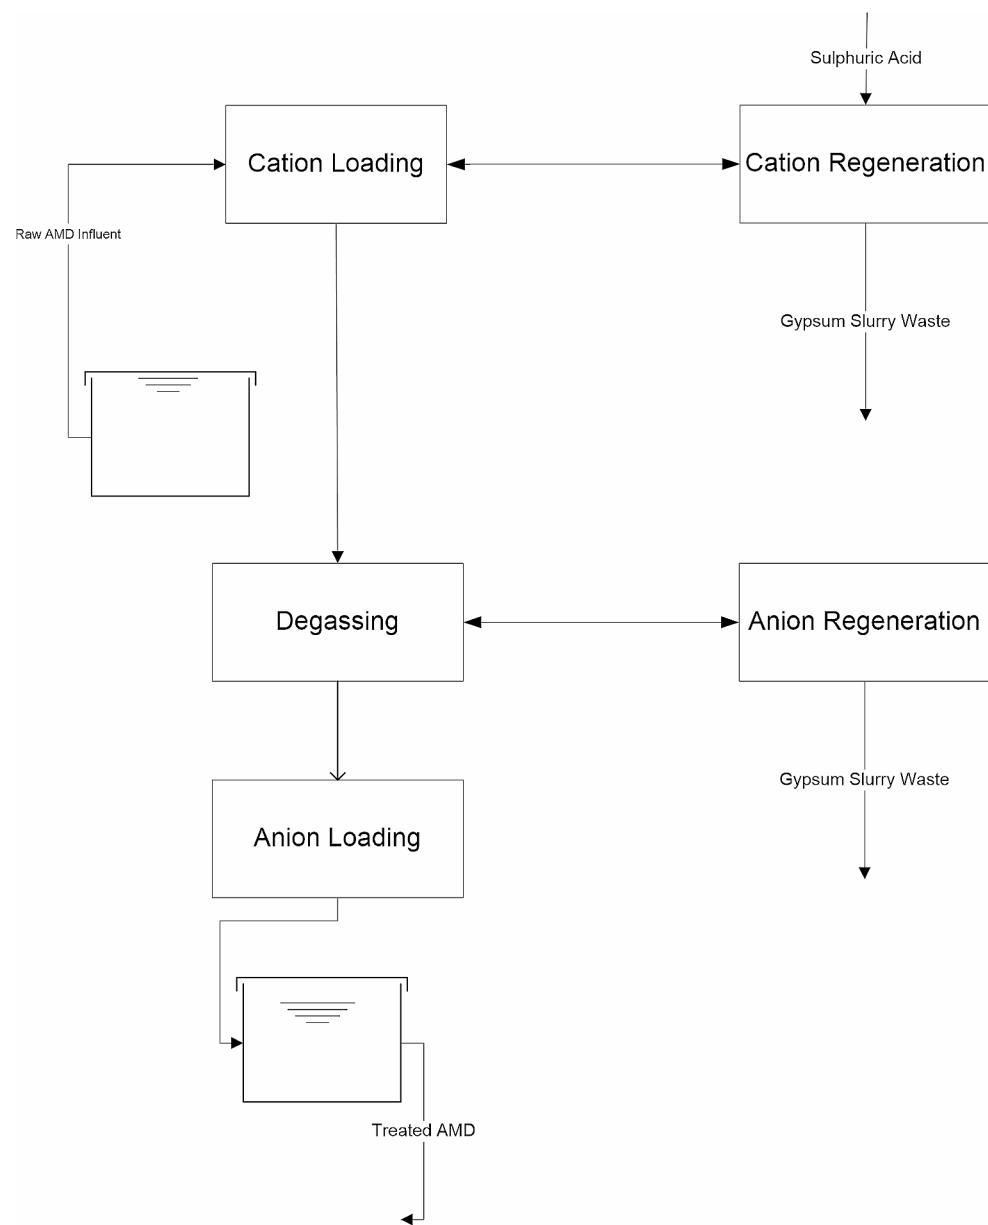
**Fig. 6** A schematic process flow diagram of the GYP-CIX technology

Another process developed in South Africa is gypsum – continuous ion exchange (GYP-CIX). It is a continuous fluidised bed ion exchange process designed to remove calcium and sulphate from gypsum-saturated waters such as neutralised AMD (Schoeman and Steyn 2001). During the first stage of the GYP-CIX process, cations are removed

by cation exchange resins. After cation removal, anions are then removed by anion exchange resins. When required, the anion and cation exchange resins are regenerated by lime and sulphuric acid, respectively. This can provide a treated water that has a neutral pH and low levels of dissolved calcium, sulphate, and metals.

Application of the GYP-CIX process was tested at a 11.4 m<sup>3</sup>/h pilot plant constructed to treat AMD generated by the Grootvlei gold mine. Flows of feed and treated water were continuous and uninterrupted with flow rates of 13.6 m<sup>3</sup>/hr and the process reduced the TDS levels in the mine water from 2000 to 4000 mg/L to less than 240 mg/L at water recoveries of 50–90%. It was found that GYP-CIX, similar to the SPARRO process, was suitable for the treatment of scaling mine waters, produces water of a high quality that

can be used or sold as drinking water, and generates a brine that would have high disposal costs. Other benefits of this process include its use of low-cost chemicals and the generation of calcium and sulphate precipitates of relatively high quality with potential for reuse (Juby 1996). It was also suggested that the inclusion of a lime or limestone pre-treatment process could reduce the operational costs of this process. The study also indicated that the use of phosphoric or nitric acid for cation resin regeneration and ammonia or potassium carbonate or hydroxide for anion resin regeneration will increase costs but provide an opportunity to generate effluents that can be reacted with each other to produce ammonium and potassium nitrates and phosphates, which can be used as fertilizers. The process flow schematic of the GYP-CIX technology is shown in Fig. 6.

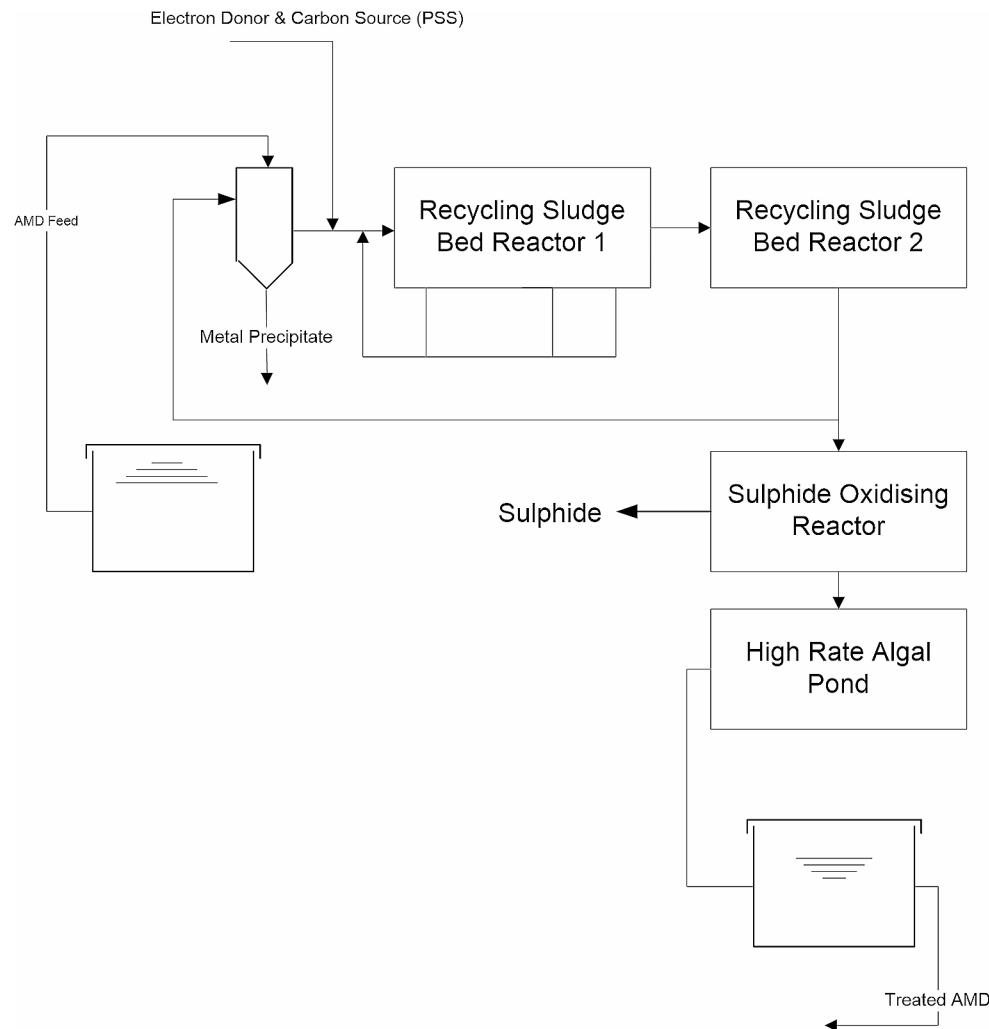
**Fig. 7** A schematic process flow diagram of the Rhodes BioSURE technology

The Rhodes BioSURE process, developed in the early 1990s at the Rhodes University in South Africa, is a biological treatment used to remove acid from AMD using sewage sludge or organic wastes. Bench-level studies of the BioSURE process conducted at the University were followed by the construction and operation of a 40 kL/d pilot plant at the Grootvlei Mine in Springs and thereafter the construction of a technical-scale 2 ML/d plant at Ekurhuleni Water Care Company's (ERWAT) Ancor wastewater treatment plant, which was connected by a 2.4 km pipeline to the Grootvlei Mine feed water. The success of this initiative prompted the design and construction of a full-scale 10 ML/d plant that was operated using primary sewage sludge from the treatment plant as an electron and carbon donor with the aim of reducing the sulphate content of the mine water. Figure 7 depicts the BioSURE process flow diagram.

However, findings of the series of experiments and pilot-scale tests indicated that the re-use of sewage sludge or organic waste provided a considerable advantage of the BioSURE treatment process, which would reduce landfill loads and costs. It was thus both a cost-effective and environmentally sustainable treatment process (Corbett 2001). While using these wastes will make treatment cheaper, they could also be a potentially limiting reagent if sufficient stock is unavailable.
