The Abandonment of the Killingdal Sulphide Mine, Norway: a Saga of Acid Mine Drainage and Radioactive Waste Disposal.

David Banks
Department of Earth Sciences
University of Sheffield
Dainton Building
Brookhill
SHEFFIELDS3 7HF,
United Kingdom

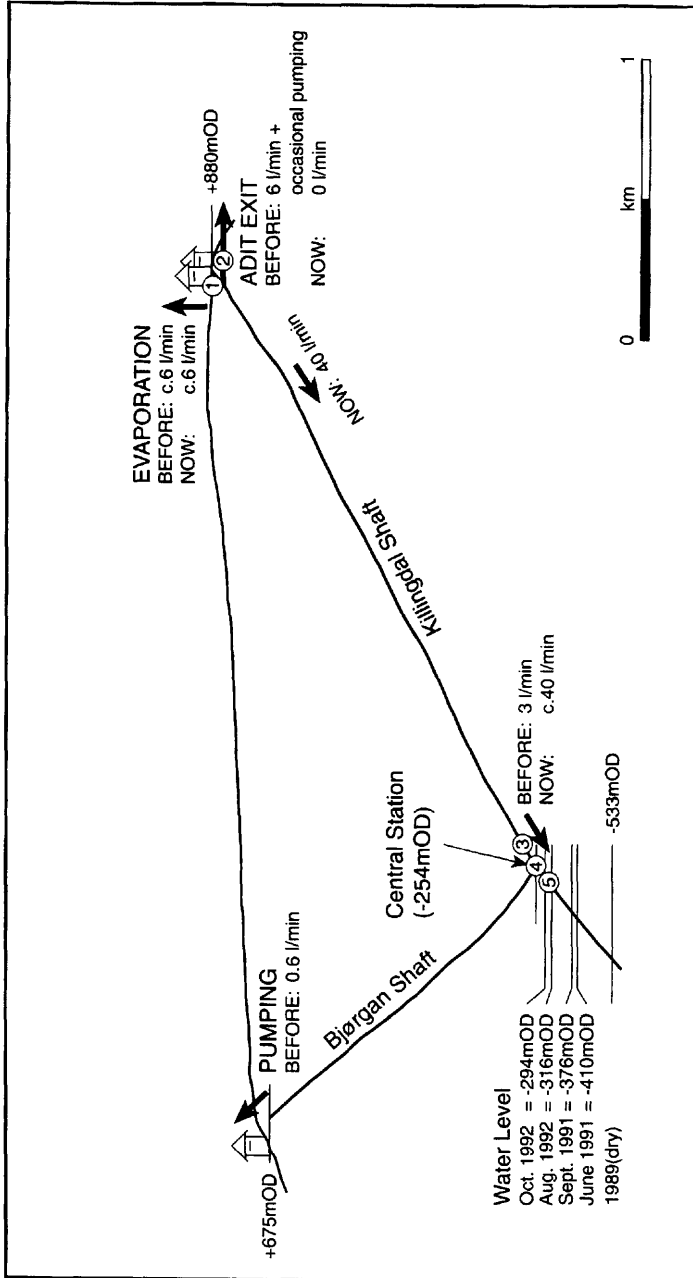
Fig 2. Cross section through Killingdal Mine, showing water balance before and after remedial works at spoil tips and the rising water level in the mine (after Banks 1993). mOD = metres over sea level. The locations 1-5 illustrate the sampling points corresponding to the analyses in Table 1.

reached the base of the mine. Other water fluxes removed from the mine comprised (Figures. 2-3):

- 0.6 l/min water pumped from shallow levels of the Bjørgan Shaft,
- 6 l/min drained from the horizontal adit near the top of Killingdal shaft,
- variable, but relatively small quantities, pumped from intermediate levels in the Killingdal shaft on an *ad hoc*, as needed basis

The rate of water level rise was found to be some 7 m per month (Noteby 1992), with the possibility of some seasonal fluctuation. The quality of water was seen to decline during its path from the surface, down the Killingdal shaft, to the standing water level (Banks 1993), due to either (or both) (Table 1, Figure 4):

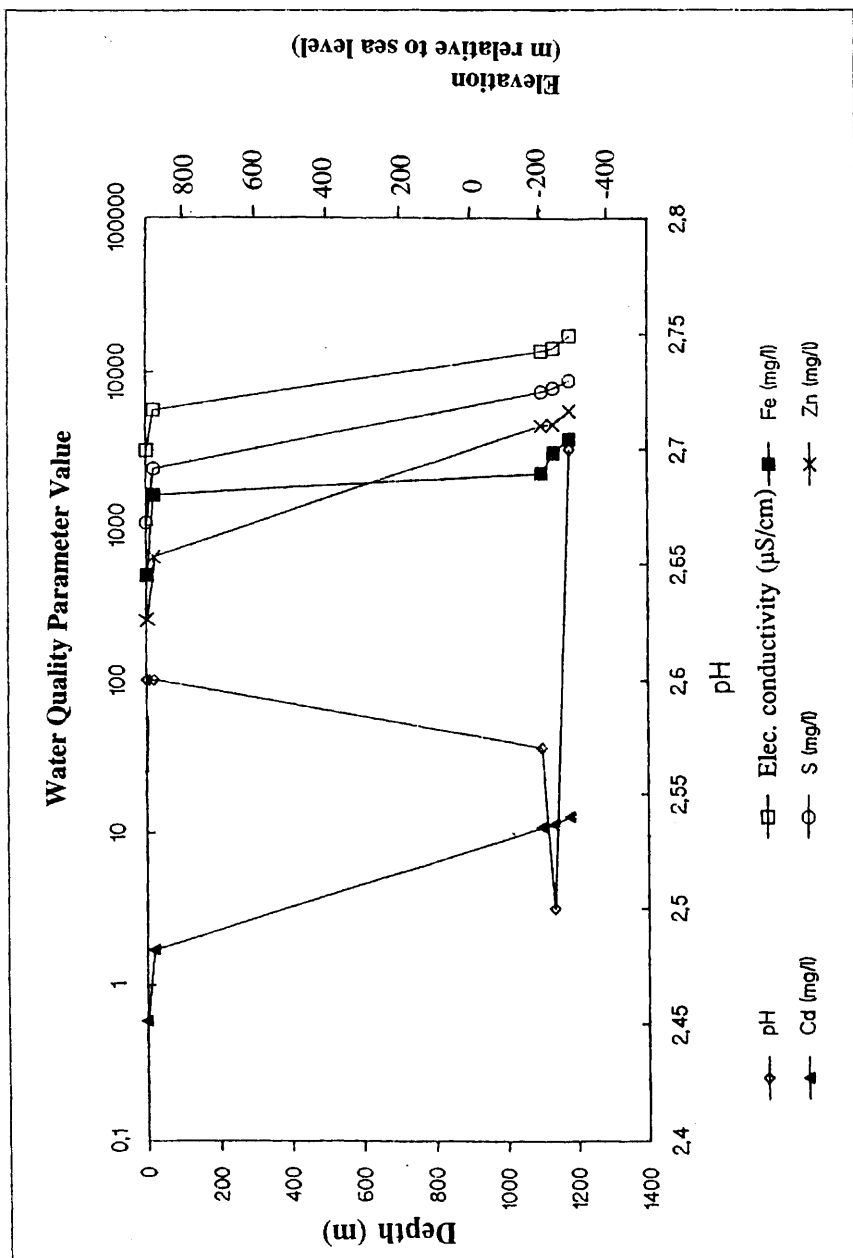
Fig. 4. Change in chemical composition (pH, electrical conductivity, SO_4 -S, Fe, Zn, Cd) of mine spoil leachate during its passage through Killingdal mine (after Banks 1993). Data derived from Table 1 (points 1 - 5, as shown on Fig. 2).

The fact that Na and Cl concentrations remain at constant, low levels (Table 1) indicates that evaporation is not likely to be the cause of the increase. It is worth noting that Ca and Mg concentrations increase dramatically in the inflowing spoil leachate with depth, possibly indicating the dissolution of calcite and other Ca/Mg minerals from the rather calcareous host rocks. This may exert some buffering effect on pH and partially explain why pH remains relatively constant (although very low) with increasing depth.
