## The Forgotten Uranium Mine of Paukkajanvaara, North Karelia, Finland

Alfred Colpaert

Department of Geography, University of Joensuu

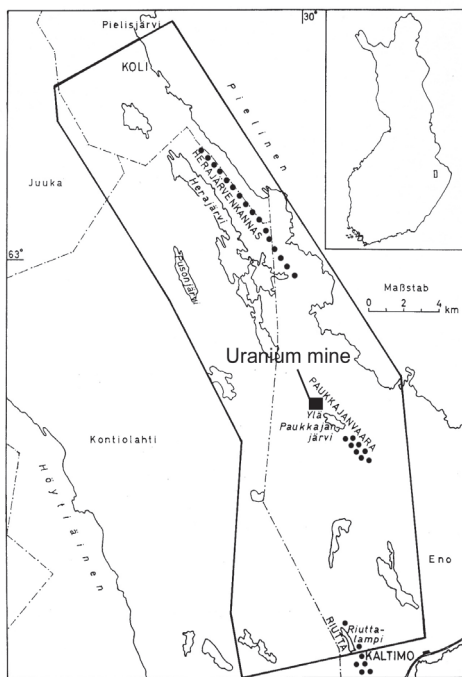
Figure 1. Location of the boulders containing uranium ore (black dots) and the uranium mine (from Piirainen 1968, modified by the author).

In 1957 two brothers, Eino and Martti Justander from Eno, North Karelia bought a Geiger counter and started exploring the area around their home near lake Herajärvi (Fig. 1). Soon they found a radioactive metabasite outcrop from which they sent samples to Atomenergi Oy, the Finnish firm responsible for atom energy in Finland at the time. Further field investigations by the geologist Piirainen revealed radioactive erratic boulders. Samples from these proved to contain 1.5 % uranium and this led to intensive exploration in the area (Piirainen 1968). The average concentration of uranium in the earth's crust is far less, about two to three mg/kg, which is 10.000 times less than the samples from Eno. The

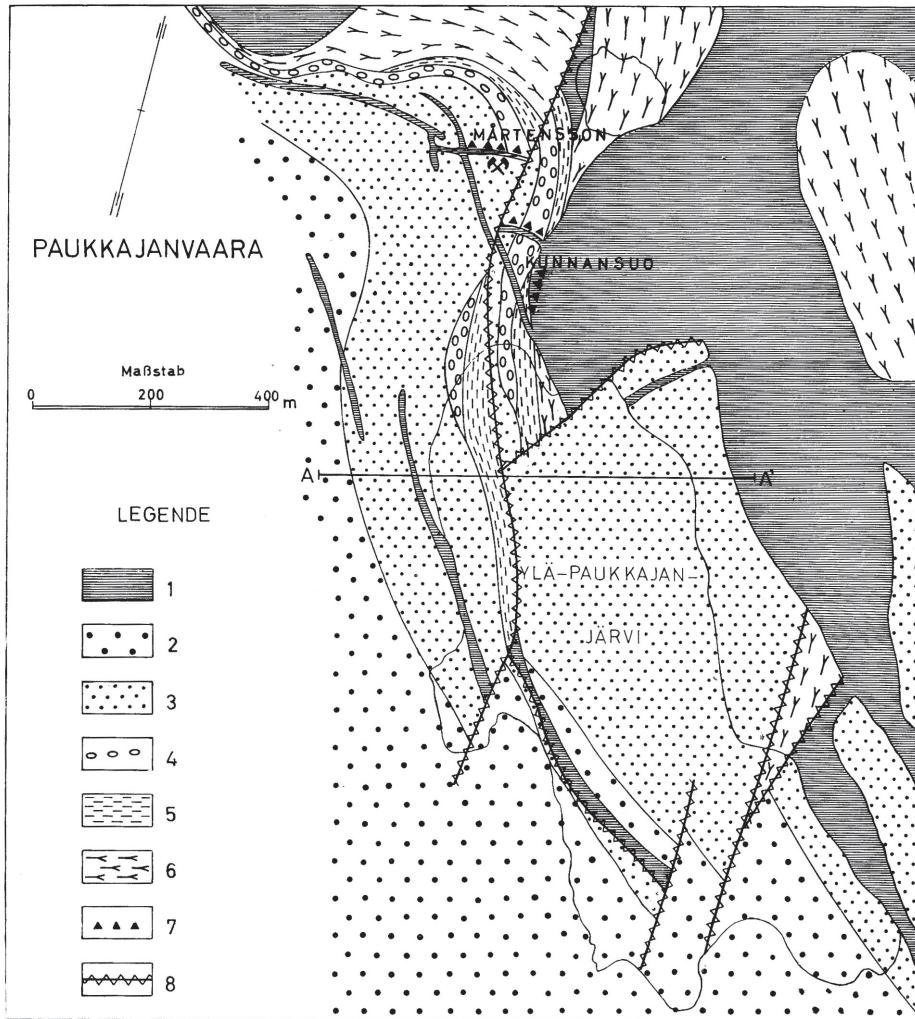
Figure 2. Geology of the Paukkajanvaara area (Piirainen 1968). 1 = metadiabase, 2 = arkosic quartzite, 3 = ortho quartzite, 4 = conglomerate, 5 = sericite quartzite, 6 = granite, gneiss, 7 = uranium ore, 8 = fault (Piirainen 1968, published with permission from the author).

The radioactive boulders were deposited in a string-like fashion in NW-SE direction, as they have been plucked from the bedrock and transported during the last glaciation. The uranium is deposited in small local metadiabase dykes and metamorphic-sedimentary contacts with these intrusions (Fig. 2).

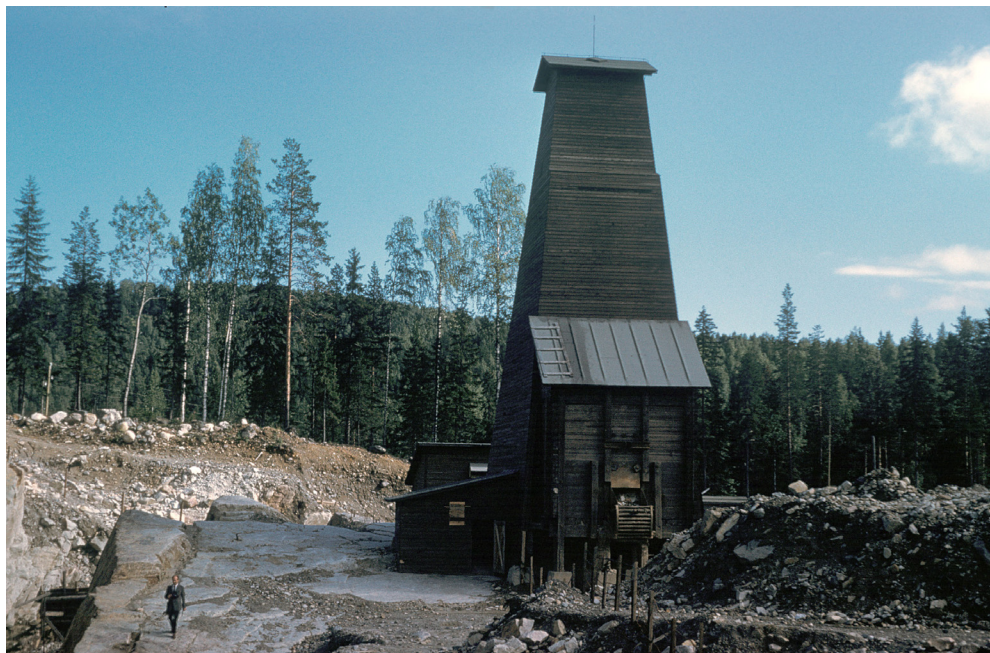
Figure 3. The Mårtenson uranium mine in 1960. Photo: Ilkka Laitakari, Geological Survey of Finland.

In 1959 a small mining operation was started at the northern shore of lake Ylä-Paukkajanjärvi, called the Paukkajanvaara mining site (Fig. 3). The mine was basically a test facility to assess the feasibility of large scale uranium mining. The site consisted of the Mårtenson quarry, which was soon transferred into an underground mine and close to this a second, smaller quarry. The ore was milled and enriched at the mining site. Several tens of workers were employed at the mine. No special protective gear was used but workers were however obliged to carry dosimeters (Tauno Piirainen, pers. comm.). Radiation caused by radon gas has been a major problem in many mines due to insufficient ventilation. At present dust and other normal mining hazards are probably more important health issues. Although radiation is higher near uranium bearing rock the dose is still low, for the Paukkajanvaara site it is in the range of 1 – 9  $\mu\text{S}/\text{h}$ , the Finnish average being about 0.1  $\mu\text{S}/\text{h}$  (Mustonen & al. 1989). From the Paukkajanvaara mining site there have been no reports of negative effects on the health of workers, which would of course be difficult to prove due to the limited number of personnel and short production period.

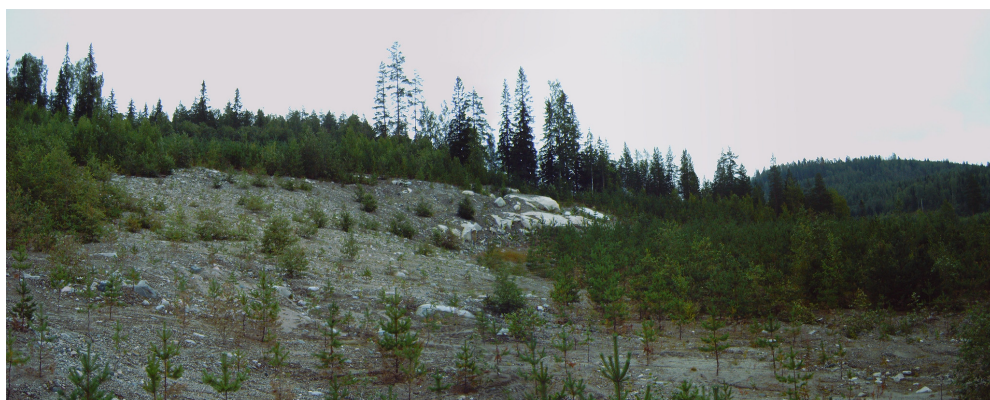
Figure 5. The rehabilitated mining area. Photo: Alfred Colpaert 18.8.2004.

The rehabilitated area itself looks like any planted pine forest (Fig. 5), some quarry areas can still be distinguished. The area is still drained by a small ditch running through the middle of the area. We did some radiation measurements with a DGM meter from Kata Oy, and did not find signs of radiation above the normal base level ( $0.08 \mu\text{S/h}$  on our device). Only in the gravel near the entrance of the area slightly higher values were found  $1.32 \mu\text{S/h}$  (Fig. 6).

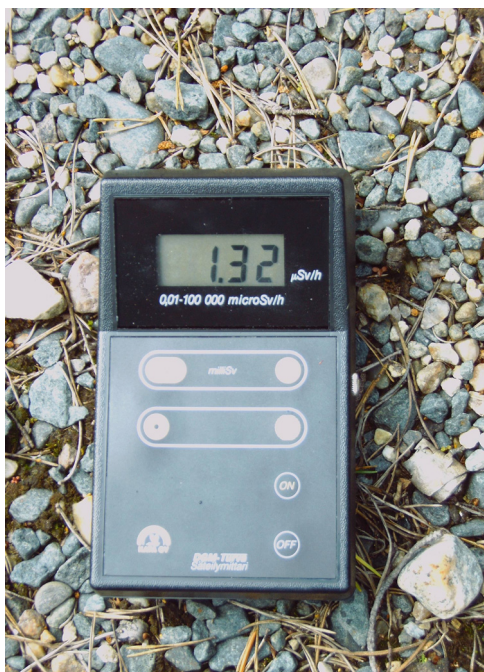
Figure 6. Radioactivity measured at the former gate, 1.32  $\mu\text{S}/\text{h}$ . Photo: Alfred Colpaert 18.8.2004.
