## Tracer Test in a Settling Pond – The Passive Mine Water Treatment Plant of the 1 B Mine Pool, Nova Scotia, Canada

Christian WOLKERSDORFER

*Cape Breton University, Industrial Research Chair in Mine Water Remediation & Management, PO Box 5300, Sydney, Nova Scotia, B1P 6L2, Canada, c.wolke@cbu.ca*

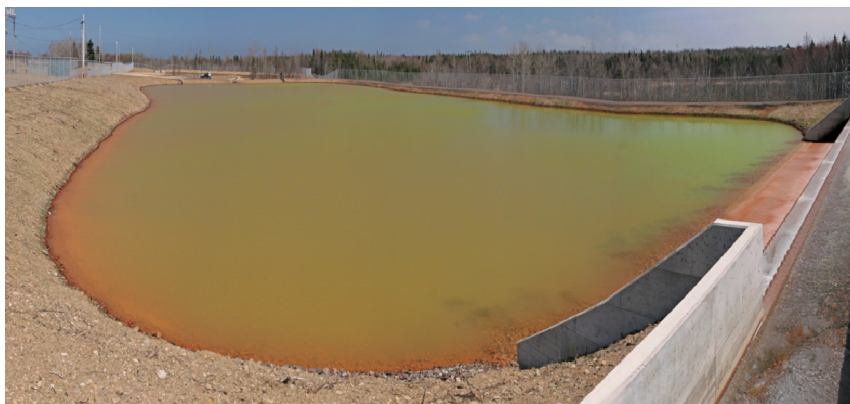
**Figure 1** View of the Neville Street settling pond with the mine water inflow and cascade on the right and the outflow in the upper left corner. Length of the settling pond 150 m, width 60 m

In case of the 1B mine pool of the flooded Sydney Coal Mine field, with a water volume of  $76 \cdot 10^6$  m<sup>3</sup> of mine water, the water in the passive treatment system first flows over a 2 m high, 4 step aeration cascade, then into a 11,000 m<sup>2</sup> and 2.6 m deep settling pond (figure 1) and finally into a 12,200 m<sup>2</sup> reed bed. Between 2005 and 2008 the mean flow from the pumps of the Neville Street Wellfield, which controls the mine water level in the 1 B mine pool, reached 7–9 m<sup>3</sup> min<sup>-1</sup> at mean Fe<sub>tot</sub> concentrations of 0.4–5.2 mg L<sup>-1</sup> (Shea 2009). Based on that data, a mean residence time of 15–18 hours ( $t = V / Q$ ) and a Fe<sub>tot</sub> concentration of less than 1 mg L<sup>-1</sup> was calculated and defined as design criteria for the settling pond (Bamforth 2008).

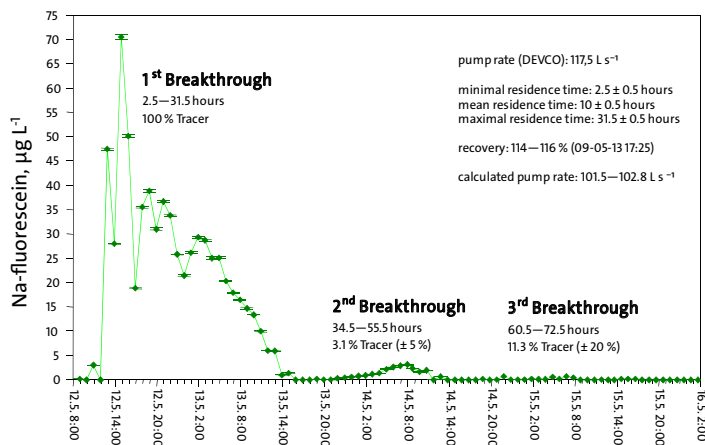
Figure 2 Breakthrough curve of the May 2010 tracer test in the Neville Street settling pond

Recovery rates based on the Grayline Ultrasonic flow measurement were 115 % in May and 102 % in August 2009, while those based on the bucket and stopwatch method were  $100 \pm 2$  %. Between the May and the August tracer tests the ultrasonic flow measurement system was re-calibrated and therefore the August tracer test matches the recovery rate of the bucket and stopwatch method. During the May tracer test the first tracer arrived 2.5 hours (figure 2) and in the August tracer test 4 hours after injecting the tracer (figure 3). The mean residence times were  $10 \pm 0.5$  hours and  $18 \pm 1$  hours with a maximum residence time of  $31.5 \pm 0.5$  and  $28.5 \pm 1$  hours. This difference is due to the dissimilar flow conditions with a mean flow of  $\approx 102 \text{ L s}^{-1}$  in May and  $\approx 54 \text{ L s}^{-1}$  in August. Both tracer tests show 3 peaks (breakthrough 1 to 3), which are due to two facts: the flow condition within the settling pond itself and potential seepage of the mine water back into the flooded mine workings. The first breakthrough after 3–32 hours belongs to fast flowing near surface water and slower flowing water in the deeper parts of the settling pond. Organoleptic in-

specimens clearly proved that the first tracer arrival is related to fast flowing near surface water ( $v \approx 1 \pm 0.2 \text{ m min}^{-1}$ ). In both tracer tests the first breakthrough summed up to a recovery rate of 100 %. The second and third peaks are less obvious. Yet, the time difference between the first tracer arrival for each breakthrough in both tracer tests is, independent from the flow rate,  $27 \pm 2$  hours. In addition, they show a low pass filtered curve progression. Consequently, the hypothesis that the second and third peaks result from re-circulated mine water was tested. As described in the introduction, the settling pond discharges into a natural wetland of Cadegan's Brook. From previous studies and from statistical investigations of the mine water chemistry it is known that Cadegan's Brook infiltrates into the mine workings. Therefore, those two peaks are related to water seeping back into the mine workings and being repumped by the mine water pumps. Using the data of the May tracer test it can be calculated that  $\approx 3 \pm 5 \%$  of the water is infiltrating through the natural wetland back into the mine workings.

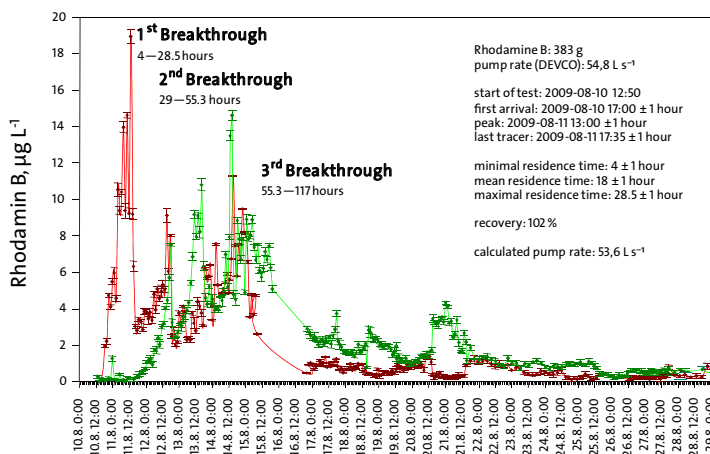
Figure 3 Breakthrough curve of the May 2010 tracer test in the Neville Street settling pond. The 2 curves belong to the sampling locations at the settling pond outflow (higher concentrations) and the outflow wetland (lower concentrations)
