Water Infiltration Control to Achieve Mine Water Pollution Control

WATER INFILTRATION CONTROL TO
ACHIEVE MINE WATER POLLUTION CONTROL

A FEASIBILITY STUDY

Project 14010 HHG

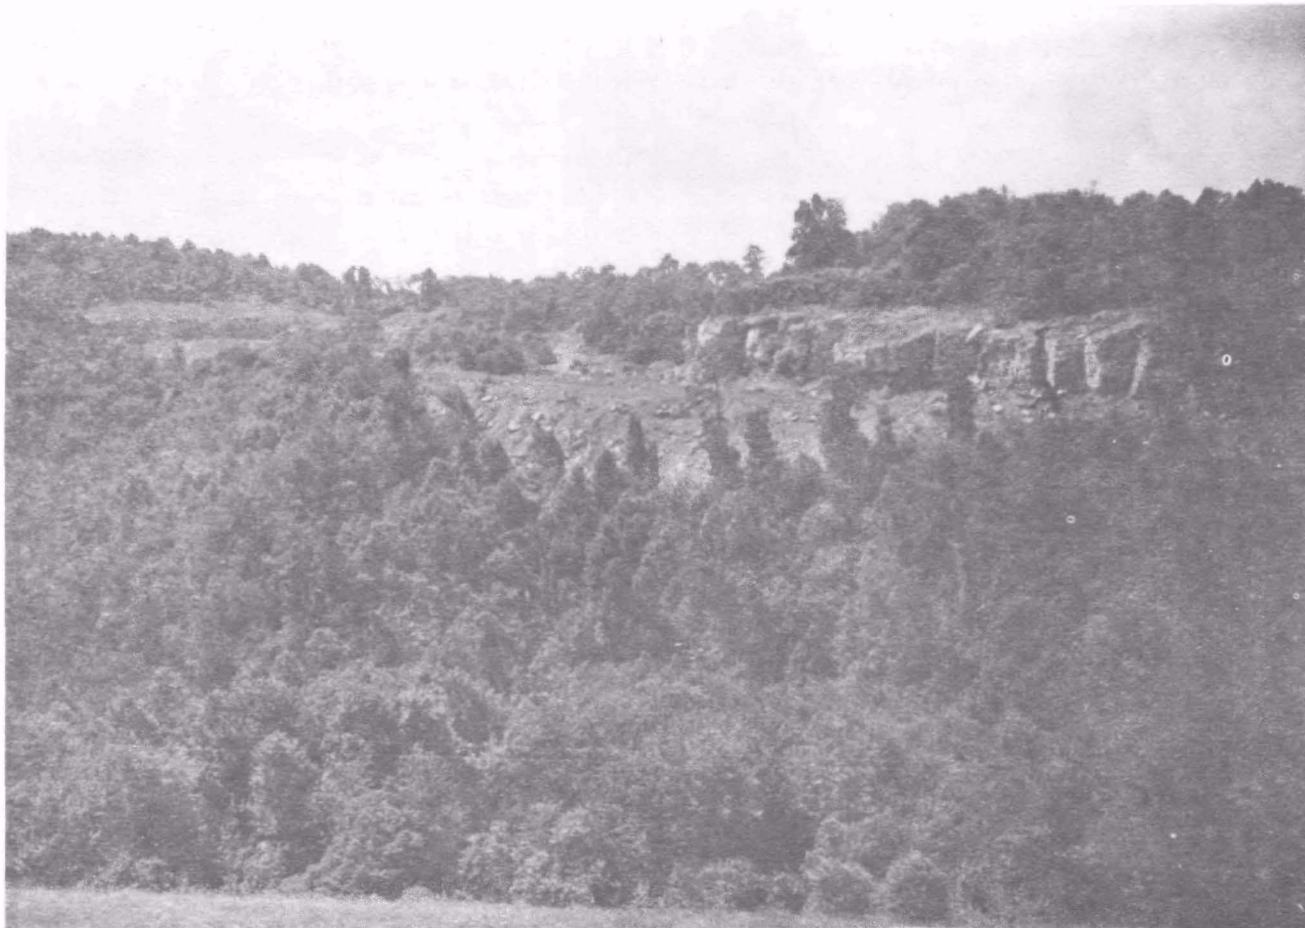
EXPOSED HIGHWALL
SECTION C, STRIP AREA B
FIGURE 22

in operable condition and should be removed. This strip mine is highly visible from one of the secondary roads in the area and may be visible from Interstate 79. Figure 22 shows a portion of the exposed highwall of this strip site as viewed from W. Va. Route 46. There is one drift mine entry in the extreme southern section of this strip (drift mine opening 2). The roof of this entry has collapsed and is overgrown with underbrush. There was no drainage from this entry at the time of inspection and no evidence of any significant drainage at any time in the past. Recommended reclamation at the site includes removal or burial of solid waste and heavy equipment, burial of acidic material present, regrading of spoil banks and outslope to contour or pasture backfill conditions, soil conditioning required to establish a firm vegetative cover and replanting of the area in some species of trees.

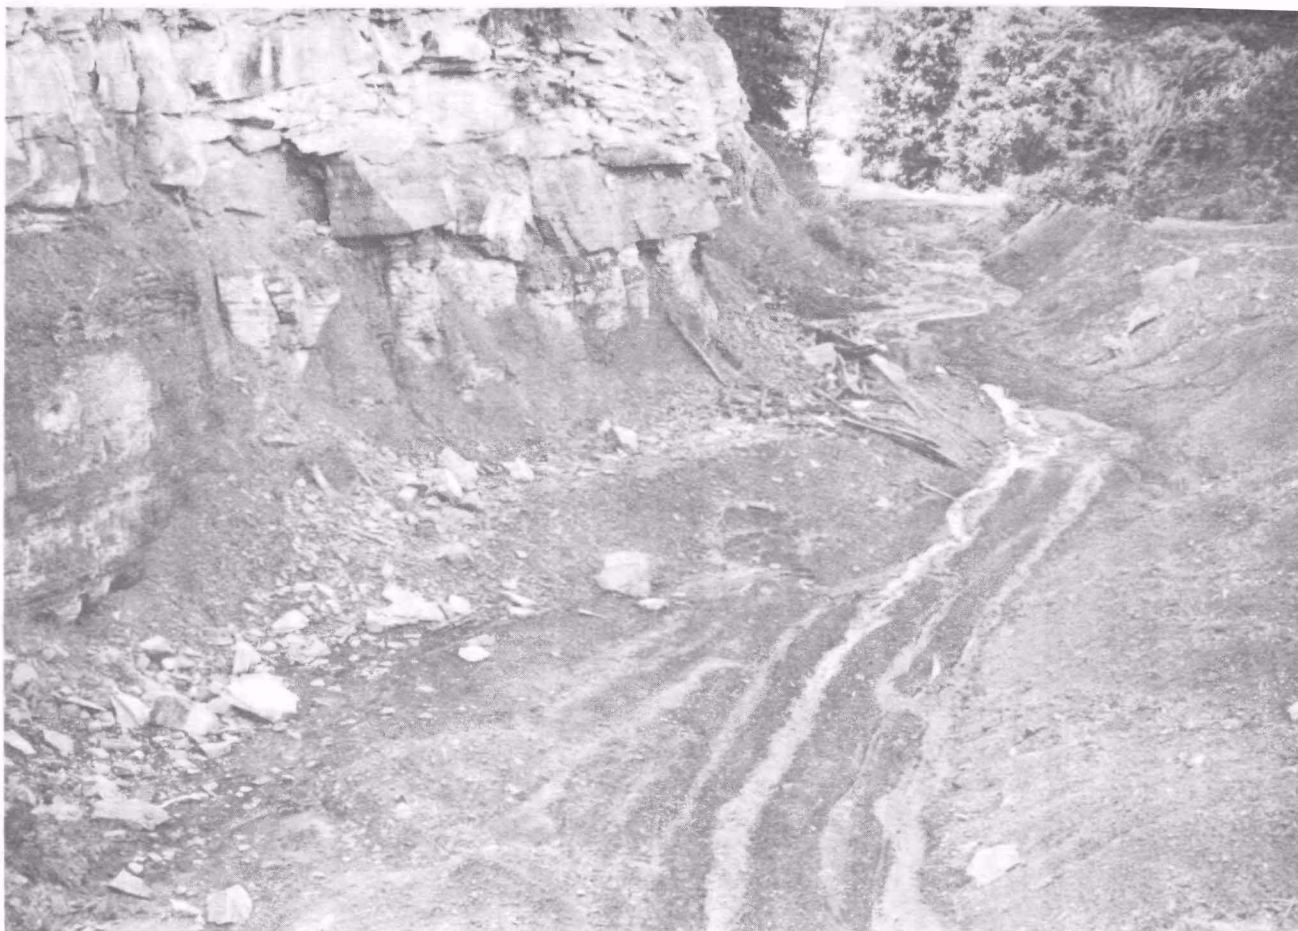
HIGHWALL AND BENCH SHOWING SURFACE WATER RUNOFF
SECTION C, STRIP AREA C
FIGURE 23

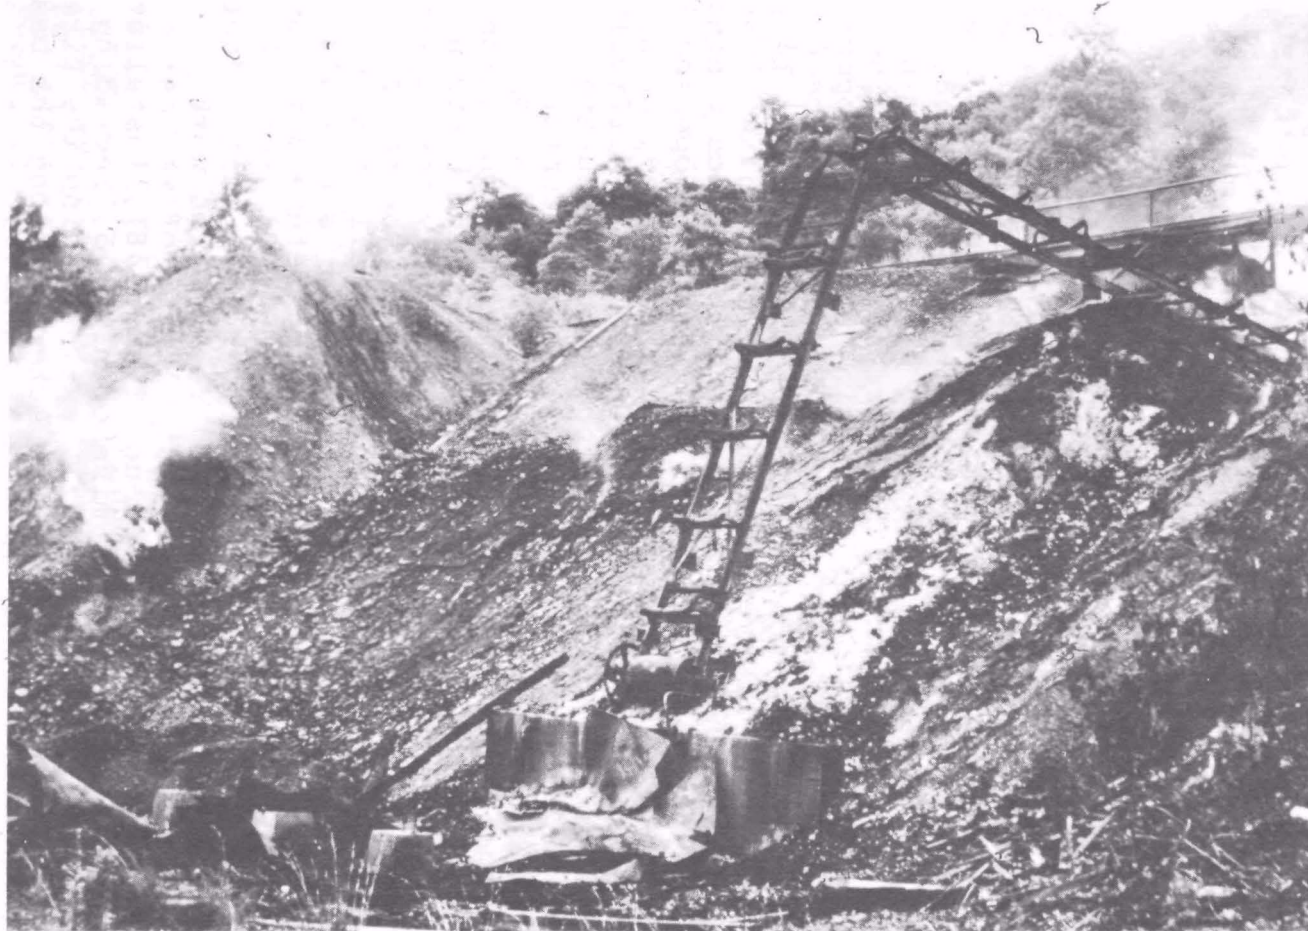
BURNING REFUSE DUMP
SECTION C, STRIP AREA J
FIGURE 24

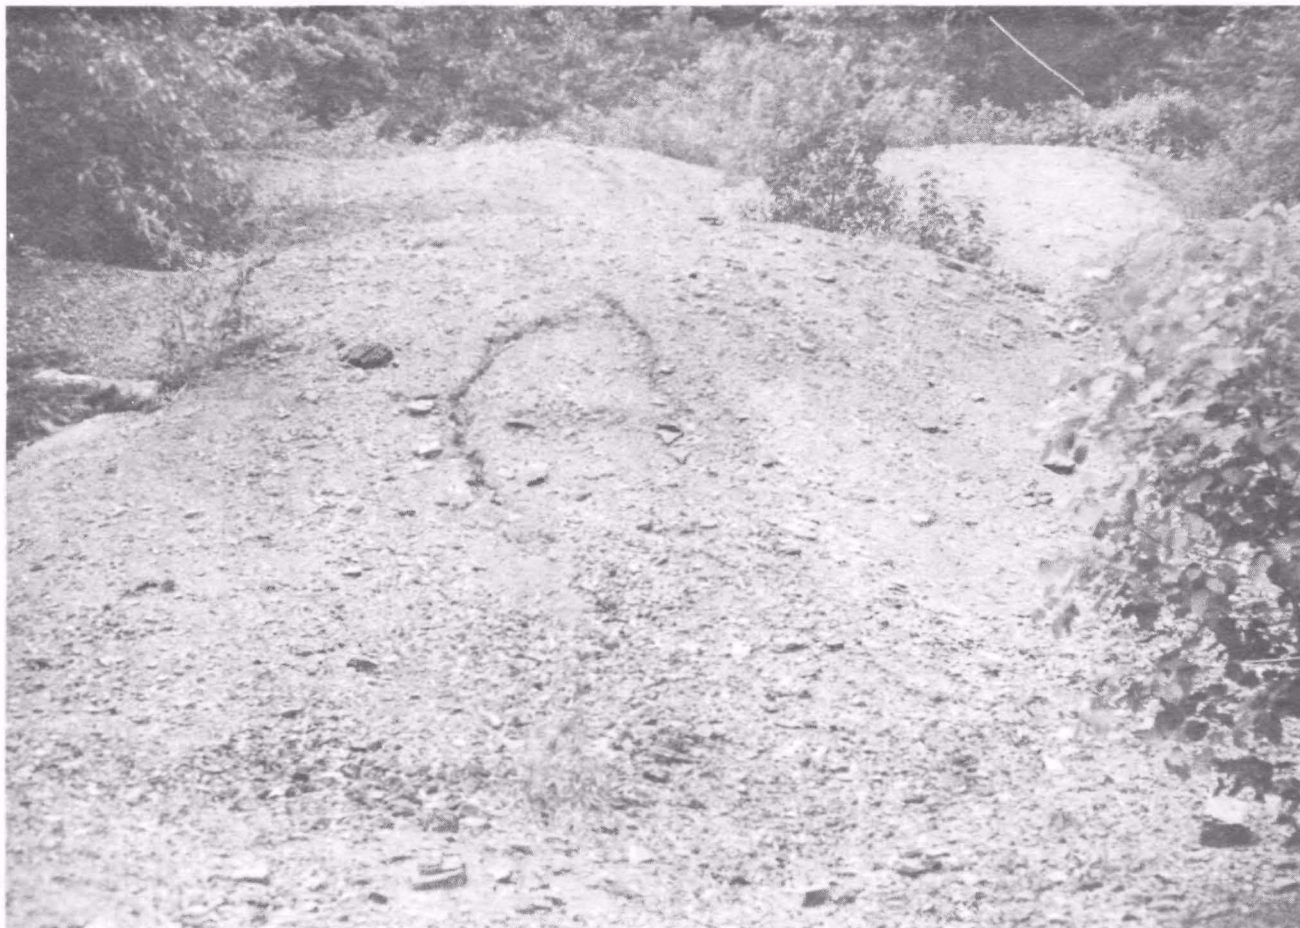
ABANDONED REFUSE DUMP
SECTION C, STRIP AREA S
FIGURE 25

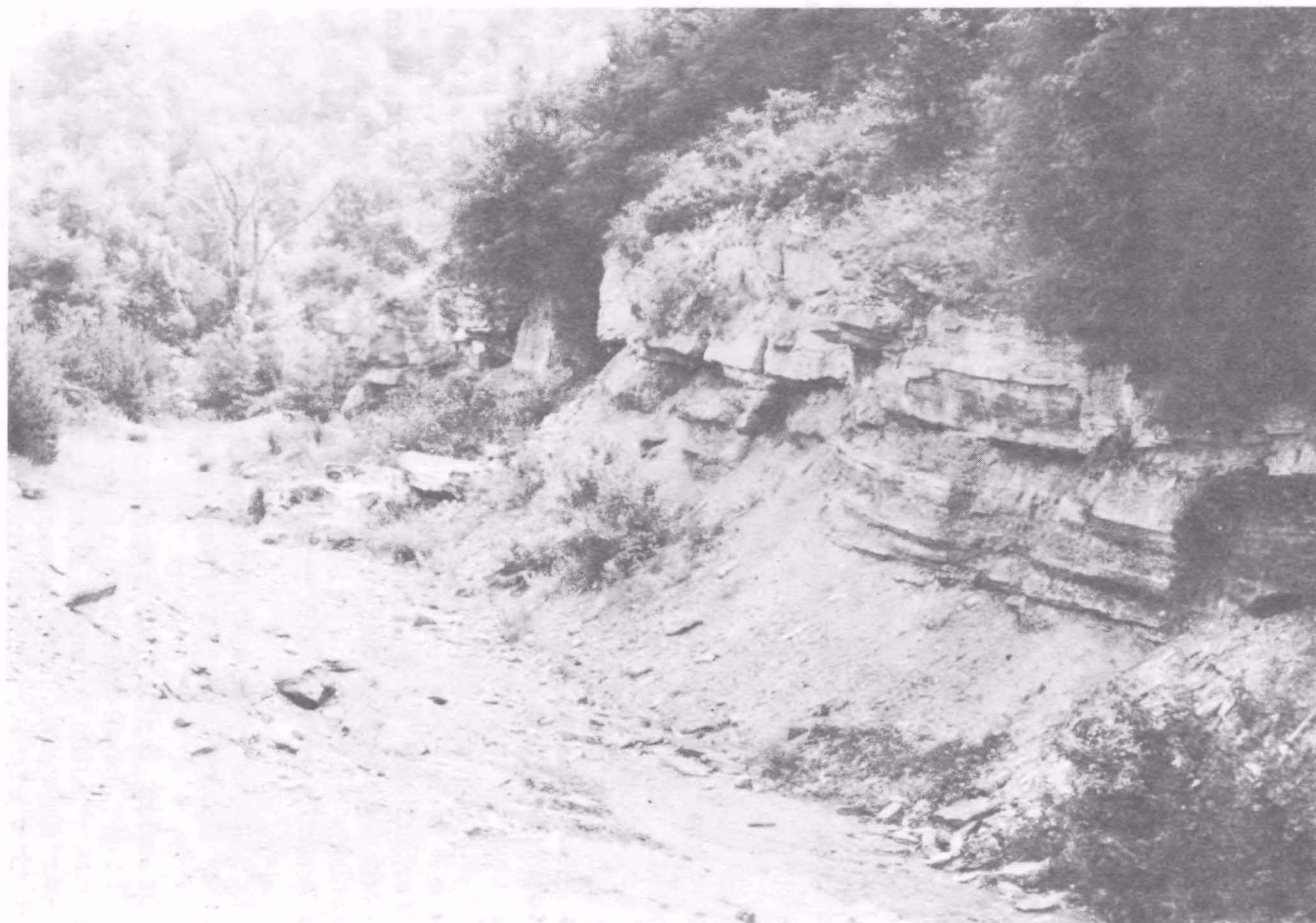
TYPICAL REVERSE TERRACE BACKFILL
SECTION F, STRIP AREA B
FIGURE 27

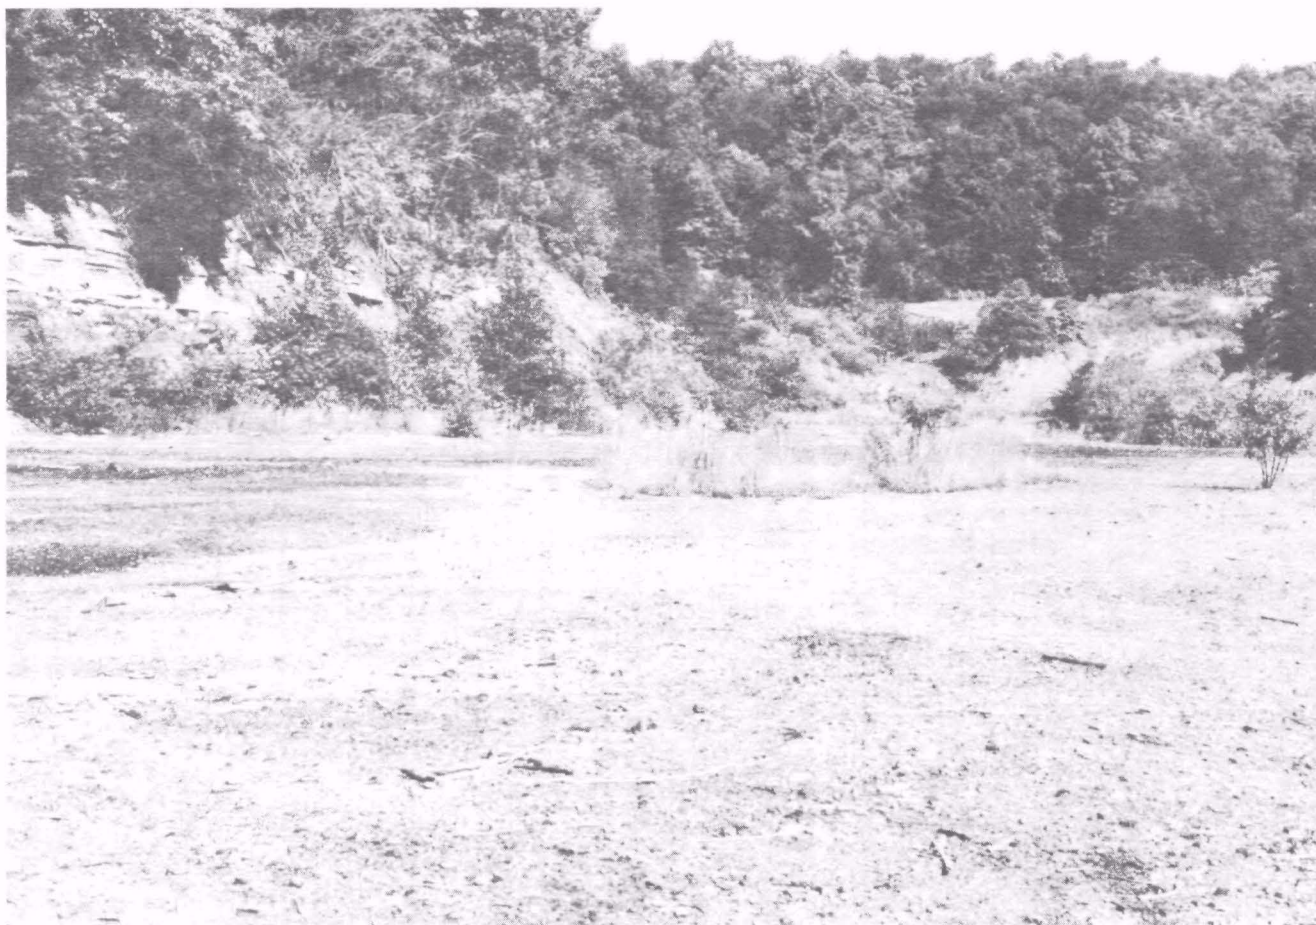
REGRADED BENCH AREA SHOWING LACK OF VEGETATION
SECTION G, STRIP AREA C
FIGURE 28

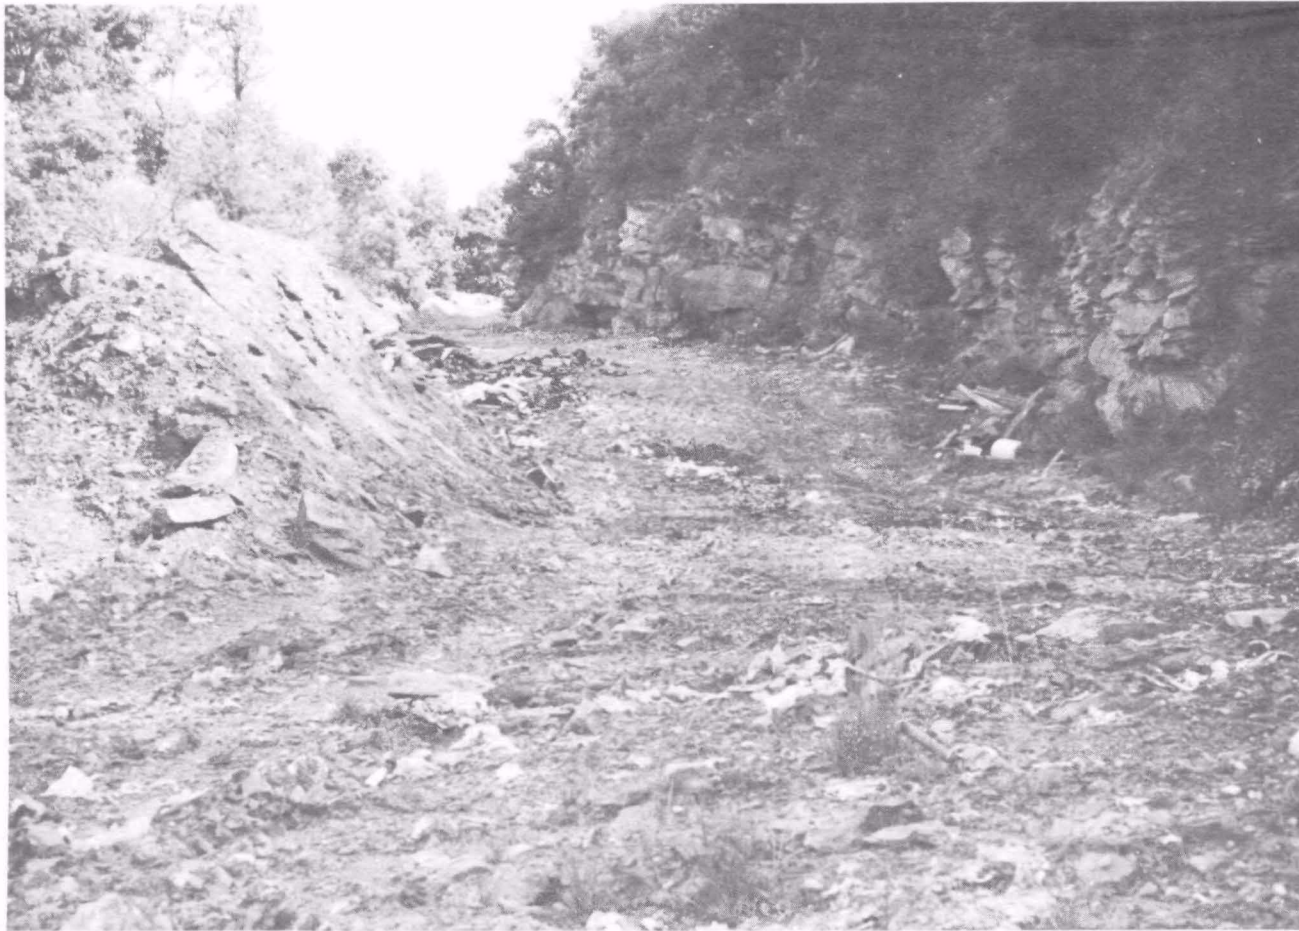
SANITARY LANDFILL
SECTION G, STRIP AREA J
FIGURE 30

This area is presently being used as a sanitary landfill for the towns of Westover and Granville (see Figure 30). The sanitary landfill operator has stated that the expected life of the strip area as a landfill operation is between four and five years; however, recent public

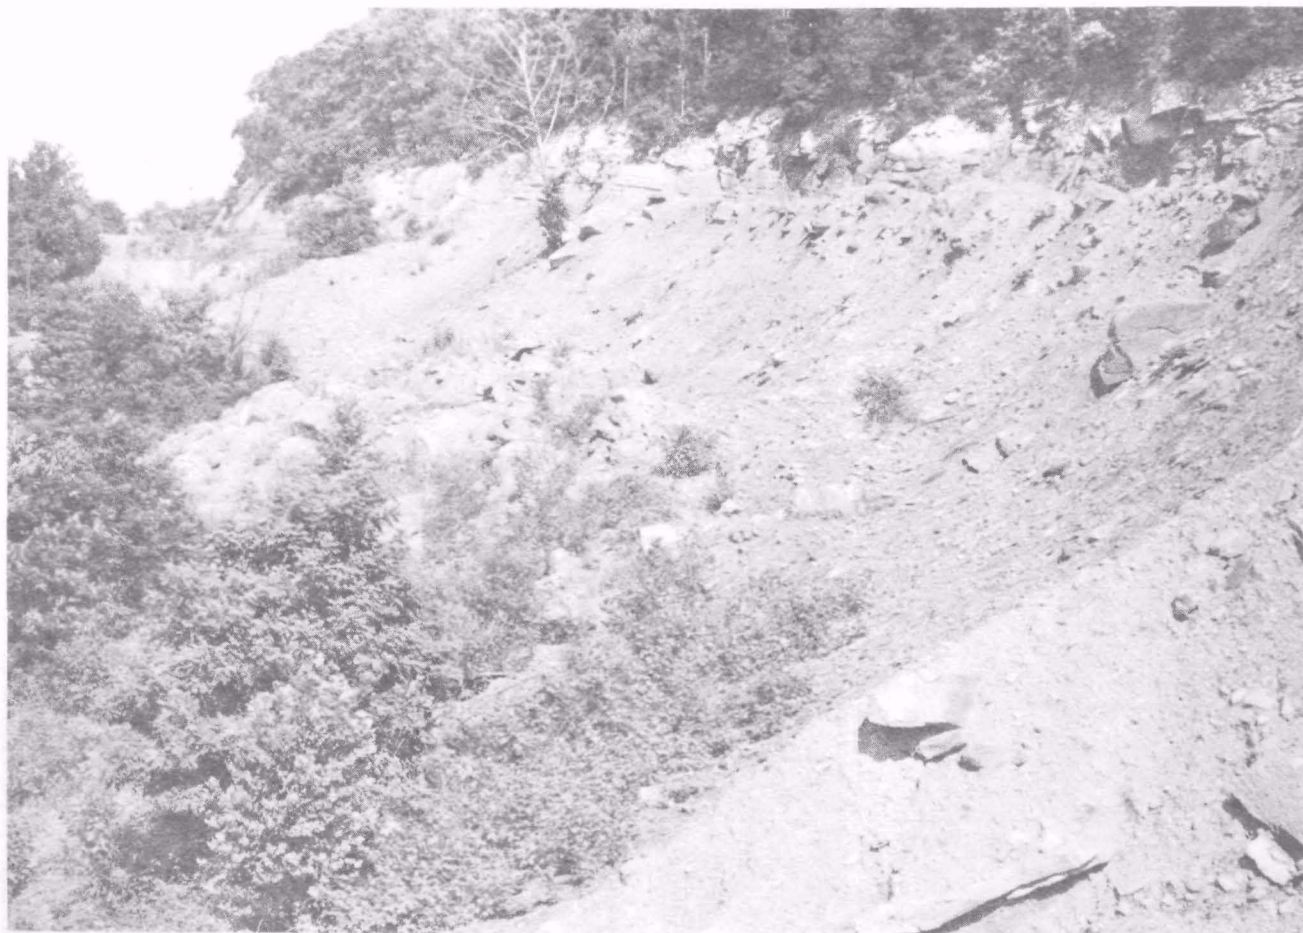
TYPICAL CONDITION OF "REGRADED" OUTSLOPE
SECTION G, STRIP AREA Q
FIGURE 31

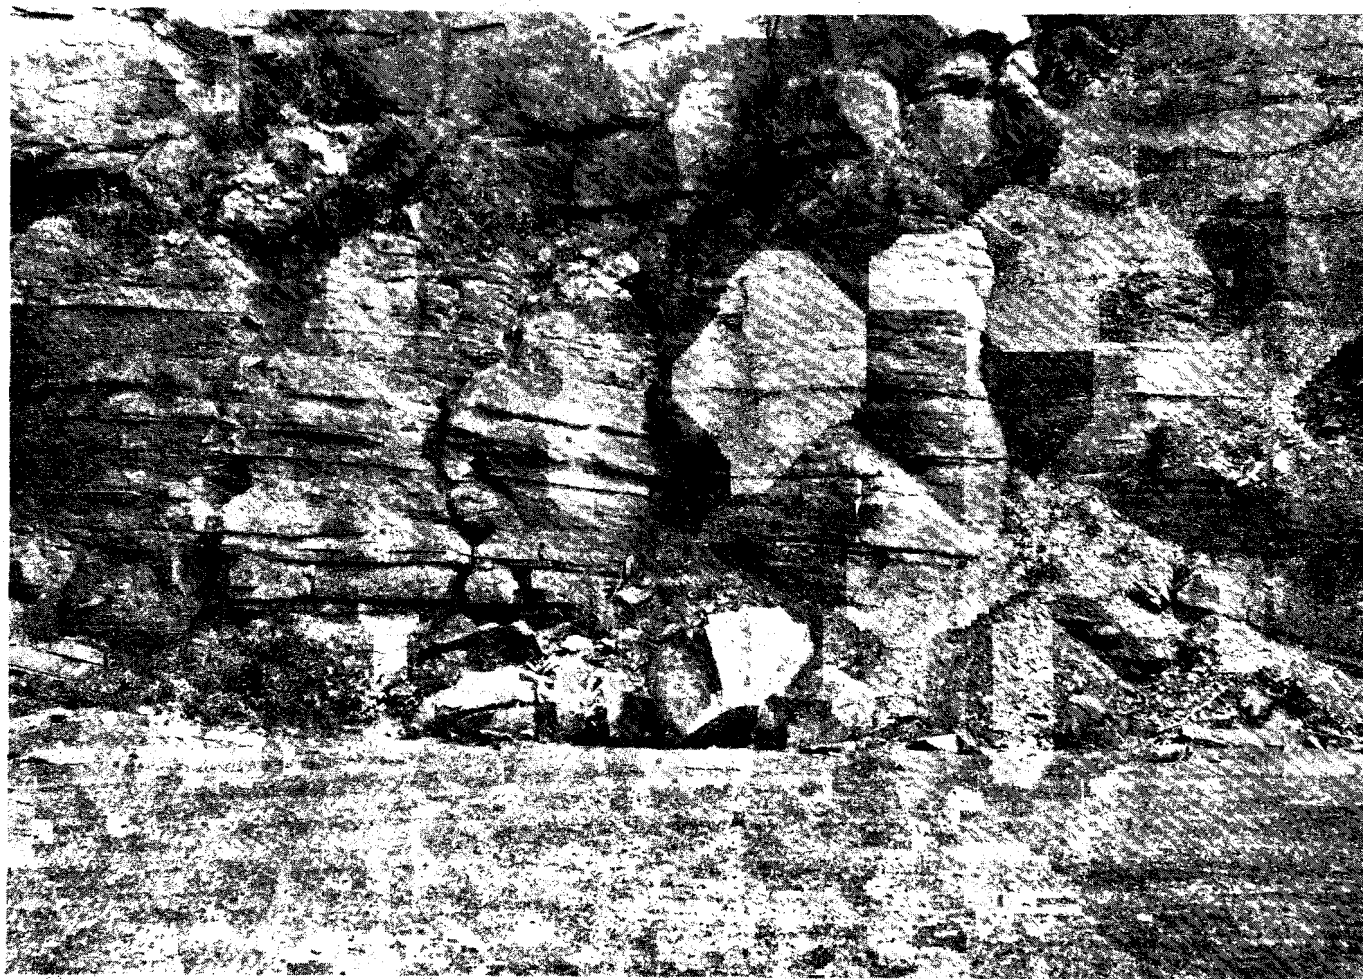
FRACTURED HIGHWALL
SECTION G, STRIP AREA Q
FIGURE 32

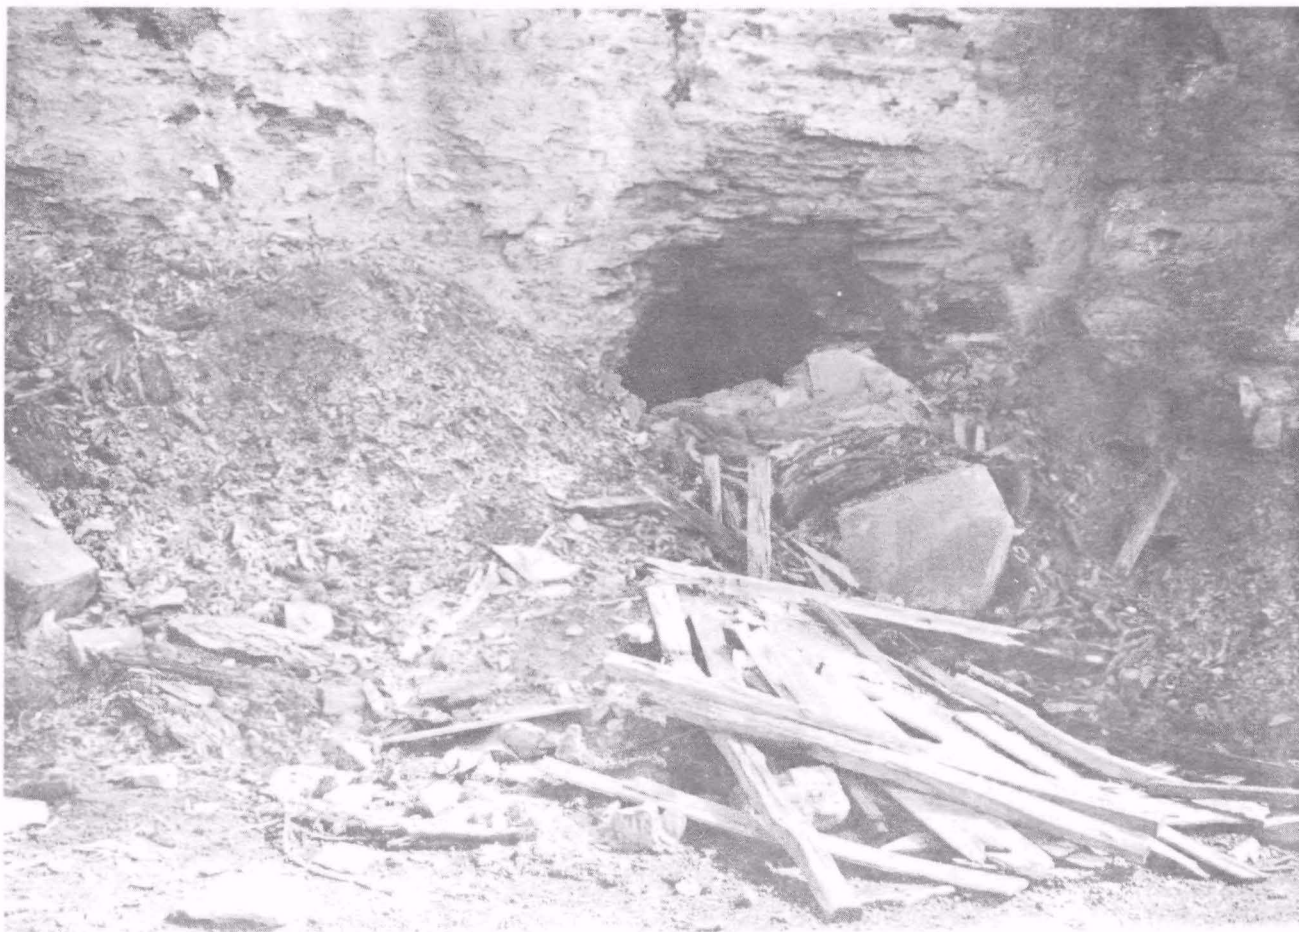
TYPICAL DRIFT MINE ENTRY
SECTION G, STRIP AREA Q, MINE OPENING 53
FIGURE 33

Mine opening 53 was apparently a main haulage route. It has partially fallen in and the present opening is approximately twelve feet wide by four feet high (see

Figure 33). There is drainage from this opening amounting to approximately two gallons per minute (refer to sample 18, Table 22).

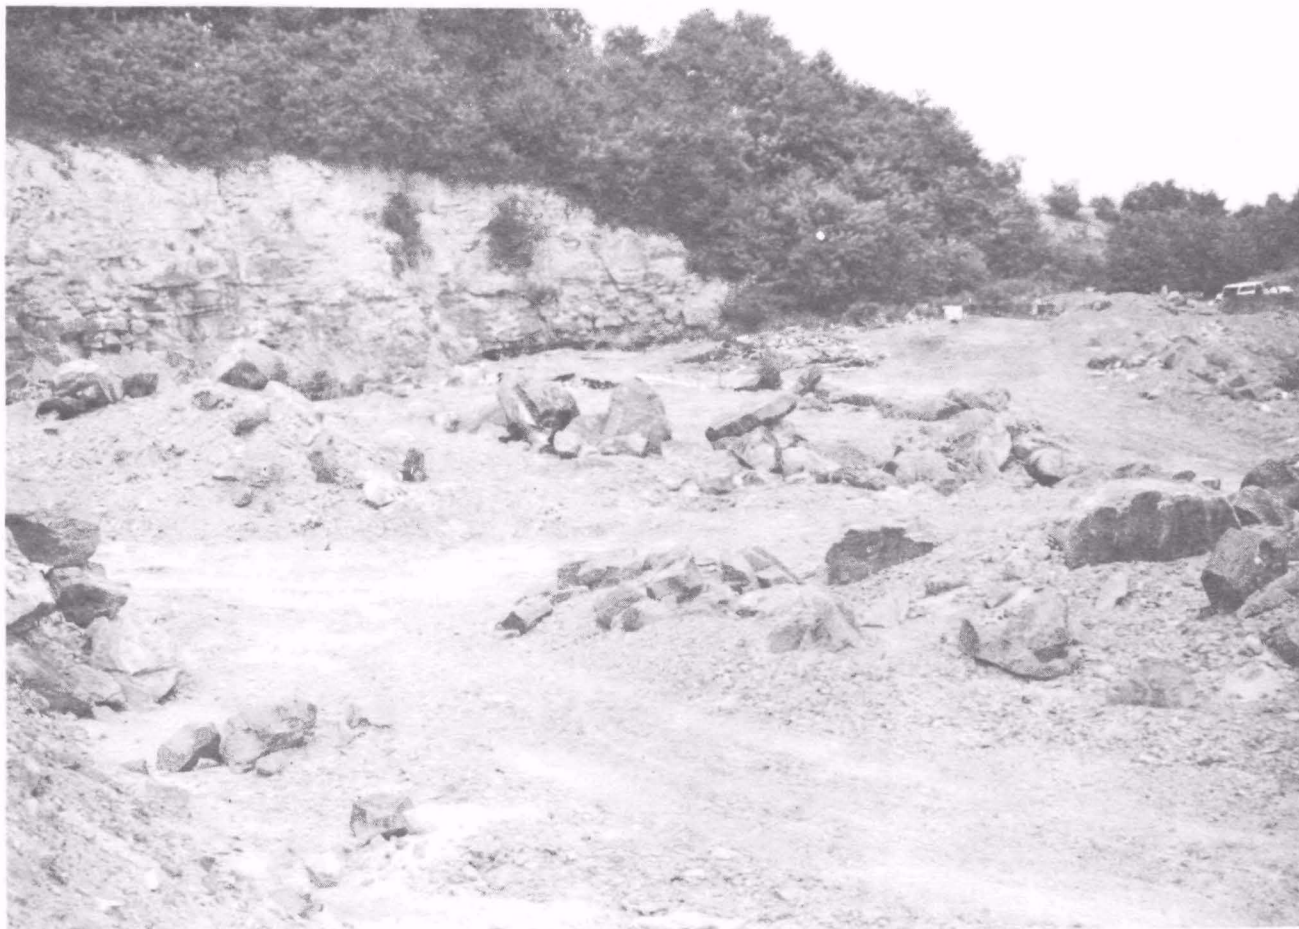
TYPICAL CONDITION OF BENCH AND HIGHWALL
SECTION G, STRIP AREA R
FIGURE 34

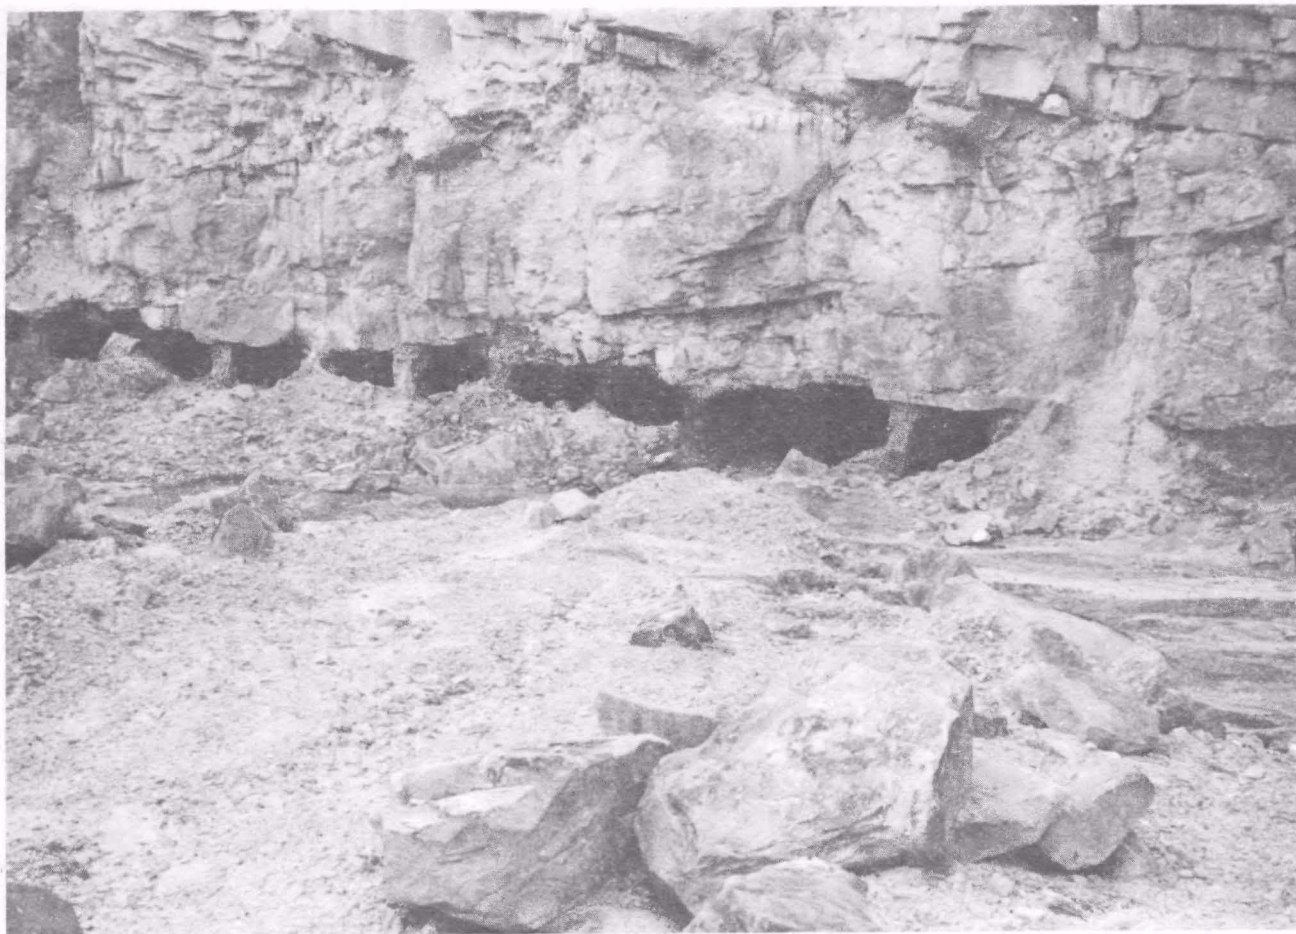
TYPICAL AUGER OPENINGS
SECTION G, STRIP AREA R
FIGURE 35

The highwall in the east section is forty to fifty feet high, the width of the bench is approximately two hundred fifty feet and the outslope is forty to fifty feet high. The strip mine has not been backfilled, and there is no vegetative cover on either the bench or the outslope in this area (see Figure 34). There is considerable solid waste in the area which could probably be buried in the highwall when the strip area is backfilled. The highwall is highly fractured in certain areas due to extensive auger mining. There are twenty visible auger openings (see Figure 35). It is estimated that there may be as

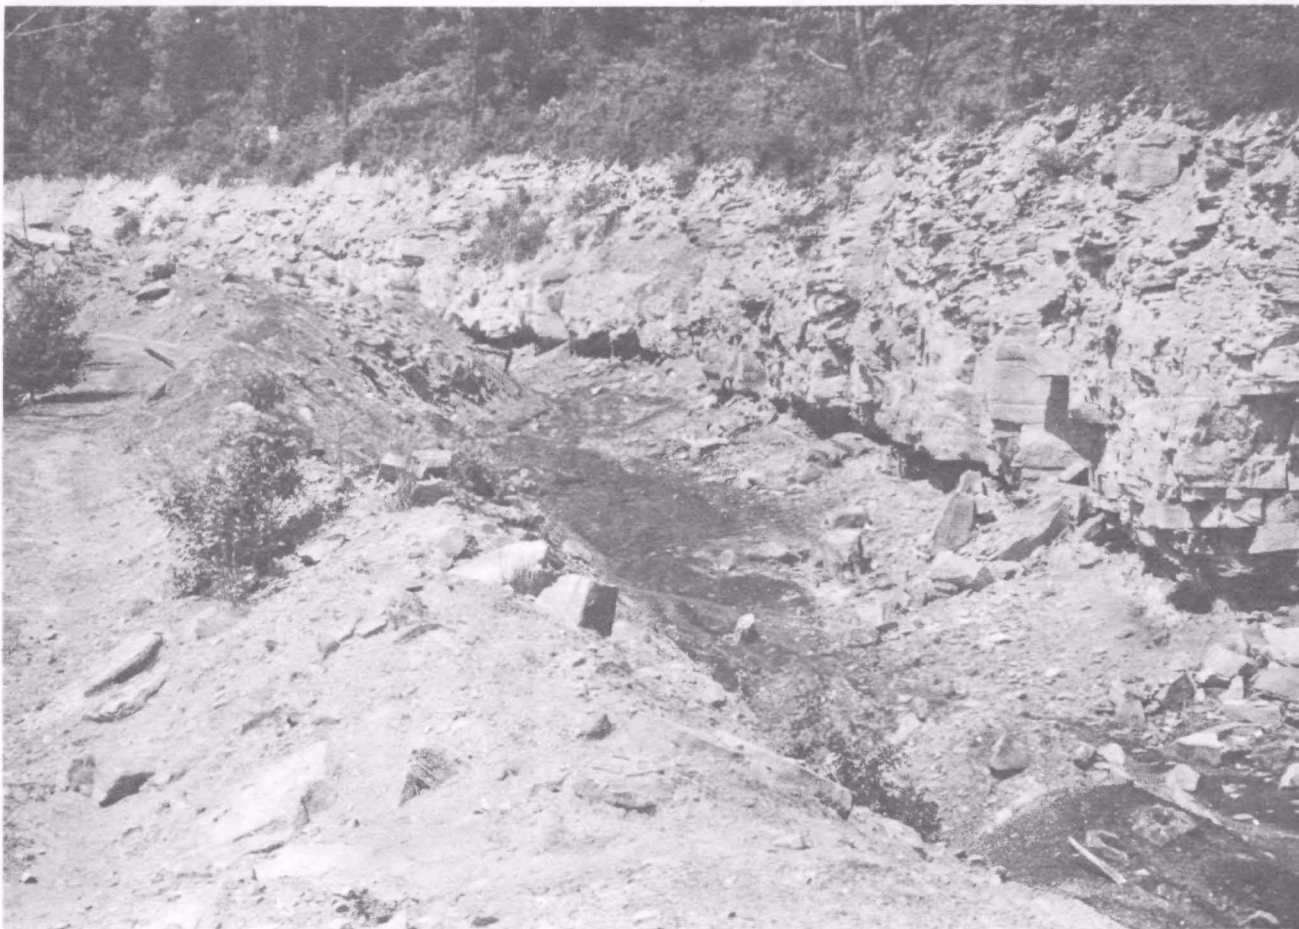
FRACTURED HIGHWALL RESULTING FROM EXTENSIVE AUGERING
SECTION G, STRIP AREA R
FIGURE 36

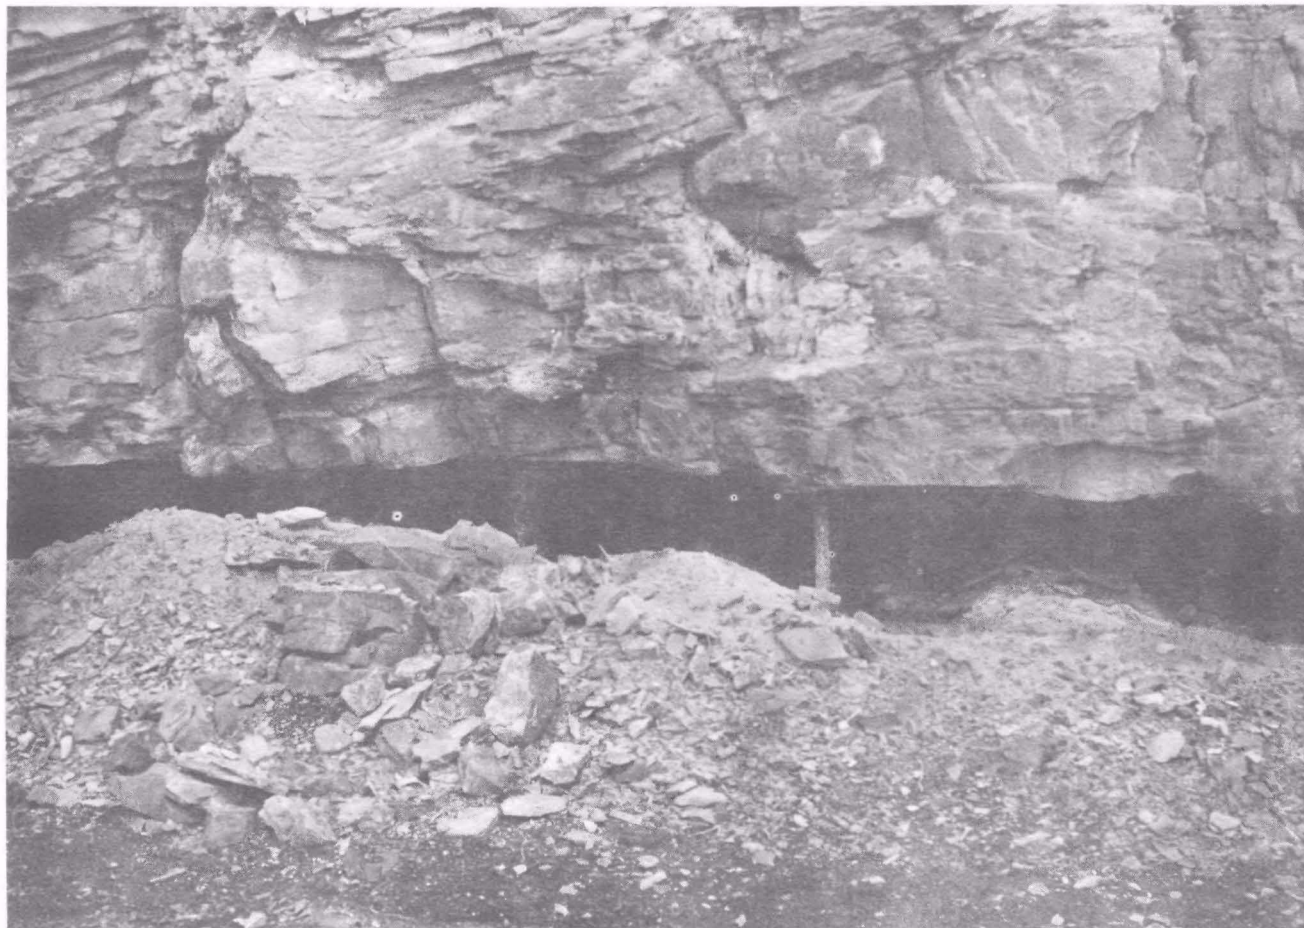
AUGERED AREA ILLUSTRATING EXTENT OF HIGHWALL UNDERMINING
SECTION G, STRIP AREA R
FIGURE 37

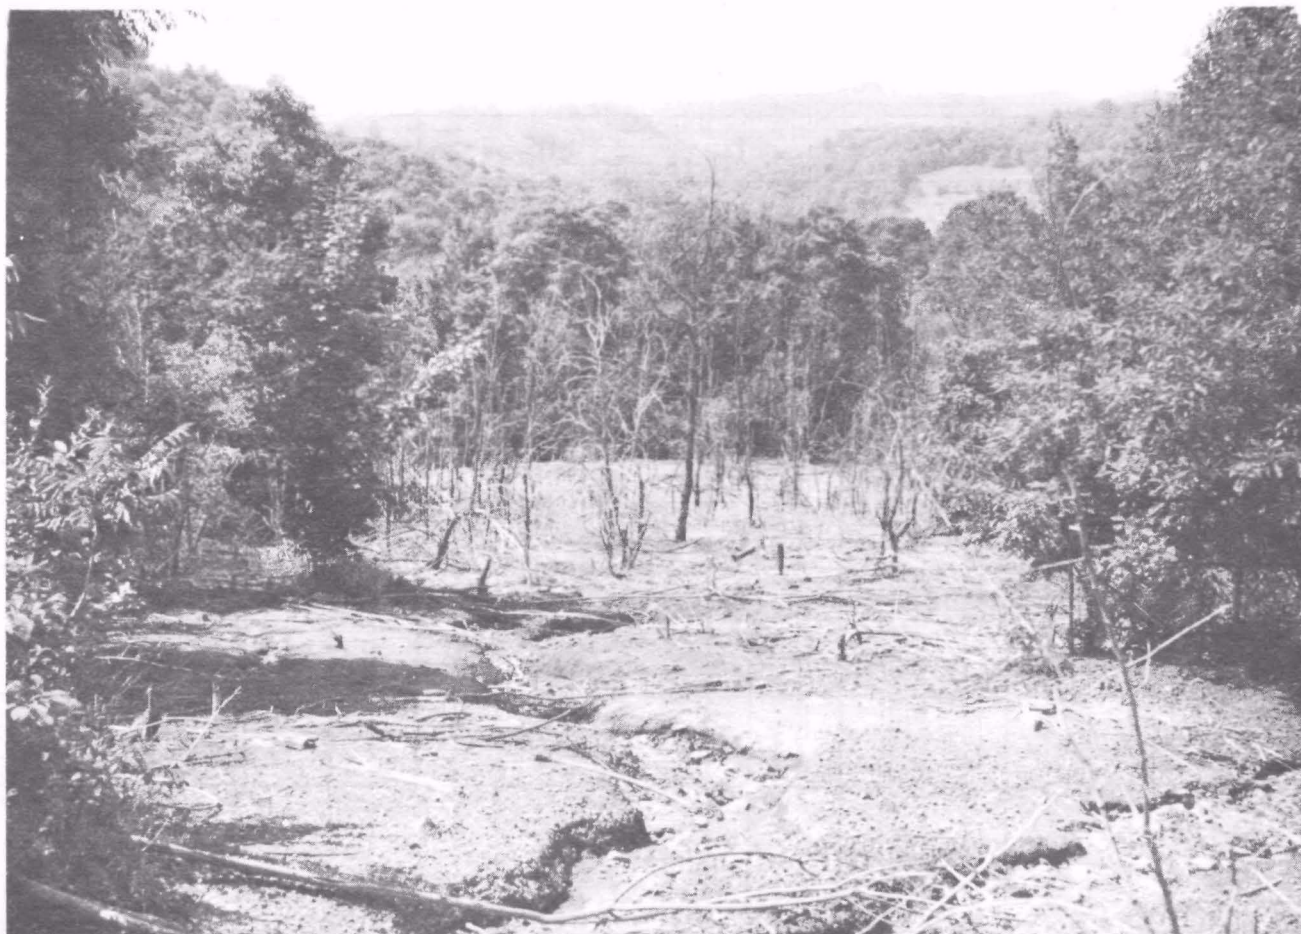
"HOT SPOT" AREA
SECTION G, STRIP AREA W
FIGURE 38
